LESSONS LEARNT FROM THE ROOT CAUSE INVESTIGATION ON THE SAD-LP SOLAR ARRAY DRIVE MECHANISM

Brian Wood, Paul Joachim Schüngel, Guido Sutter & Andrew Skulicz

*Oerlikon Space AG, Schaffhauserstr. 580, 8052, Zürich, Switzerland
brian.wood@oerlikon.com*

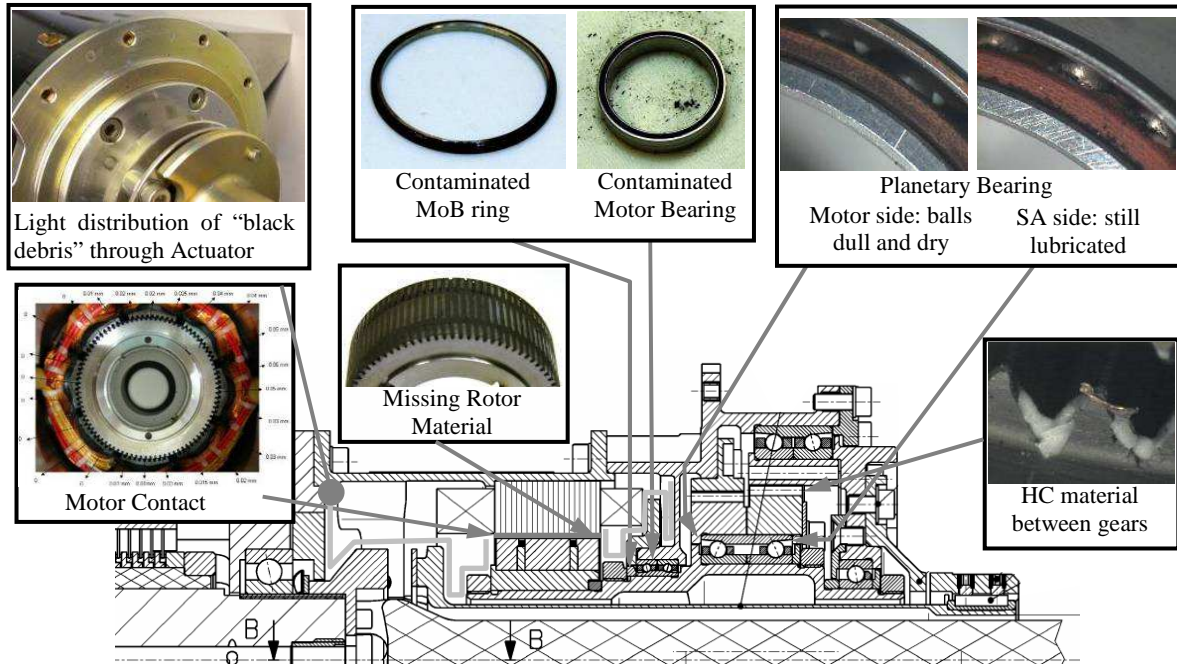
- There had been contact between the motor rotor and stator.
- There were extensive deposits of dry black particles on the motor.
- Wet particles were distributed throughout the actuator which could be attracted by a magnet.
- The bearing nearest to the motor (MoB) was highly contaminated with black particles & was dry. The bearing ring was highly

- contaminated with dry black particles which were 'fused' together.
- The next bearing in the chain was dry on the motor side and far less contaminated on the other side.

- Lubricant on the other bearings and the gears was in good condition as was the creep barrier.

Figure 1: Pictures of Disassembled SAD-LP components and Key Findings.

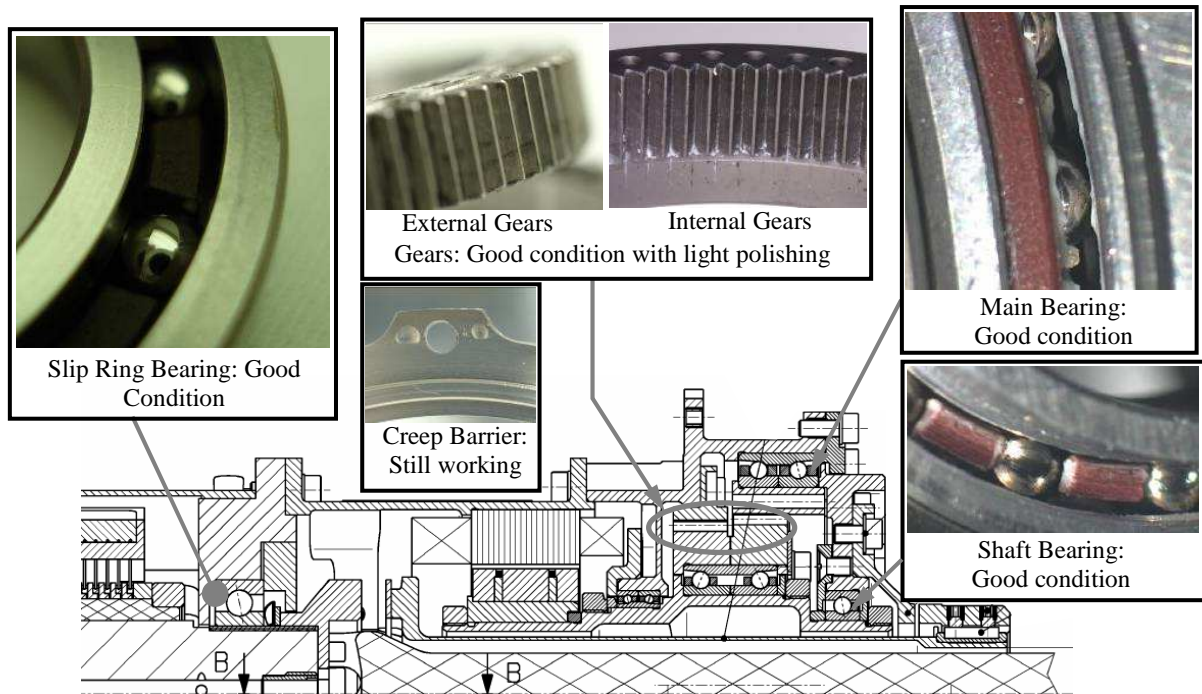
Figure 2: Pictures of Disassembled Gears and Bearings.

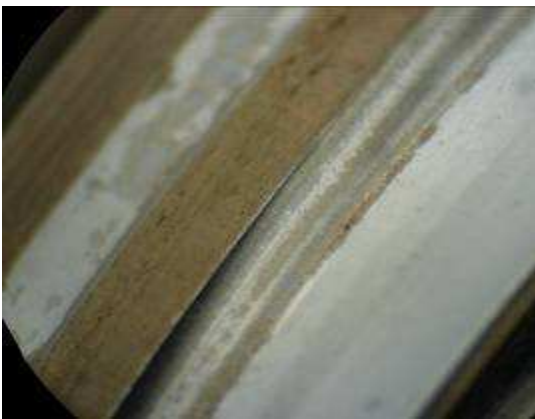
Figure 3: Inner Raceways

The inner raceways were dull, 'pitted' and this extended to the dams. Contact marks from cage riding were seen on the land. One raceway track was uneven due to axial loading.

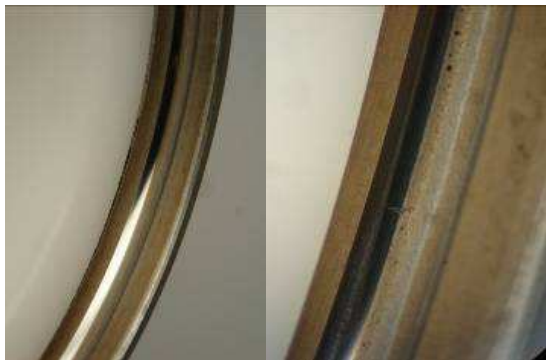
Figure 4: Outer Raceways

There was also some noticeable 'damage' in the form of contact marks from cage on the land. There was a change in the circularity of the bearing of about $8\mu\text{m}$ which was due to the applied loads.

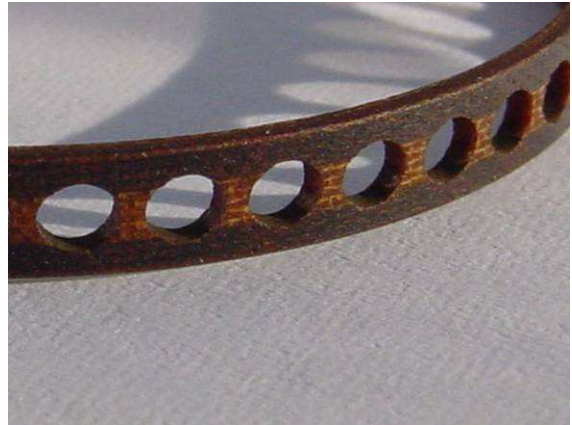
Figure 5: Phenolic Cages

The cage was dry, i.e. no lubrication was present. There were marks on ball pockets and rubbing marks on ID & OD.

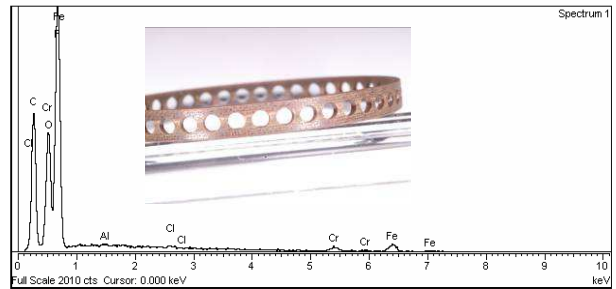
Figure 1 SEM micrograph and corresponding EDX spectrum from cage 1. The purple rectangle identifies the region for EDX analysis.

The results showed no evidence of Soft Iron from the motor (Vacoflux: Fe, Co, V, Ni) at the motor stator interface but there was evidence of the rotor potting material (Stycast epoxy: C, H) within the bearing contamination material and also evidence of the Braycote 601EF grease (C, F, H & PTFE).

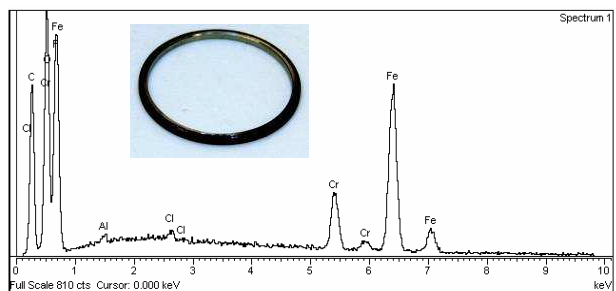
Figure 2 SEM micrograph and corresponding EDX spectrum from ring 1. The purple rectangle identifies the region for EDX analysis.

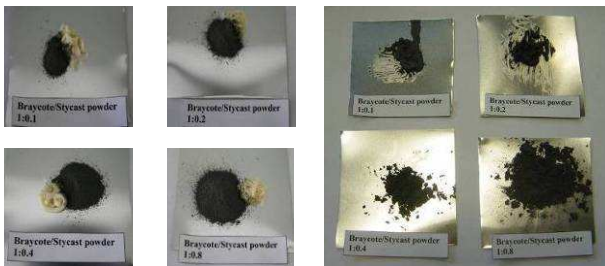
Samples before mixing Samples after mixing
Figure 7: Stycast / Braycote Absorption Test

It was possible to reproduce the initial reaction between the two materials where they form a cake substance (or 'crumbs') but they did not form an emulsion and there was no further reaction between the materials.

Apart from the moisture loss on the bearing, there was no measurable weight loss of the braycote. The braycote was however fully absorbed by the staycast which leads to a loss in the effectiveness of the braycote which may lead to the bearings will tend to wear quicker. It is apparent that a small quantity of stycast can cause increased wear in the bearing when mixed with the braycote.

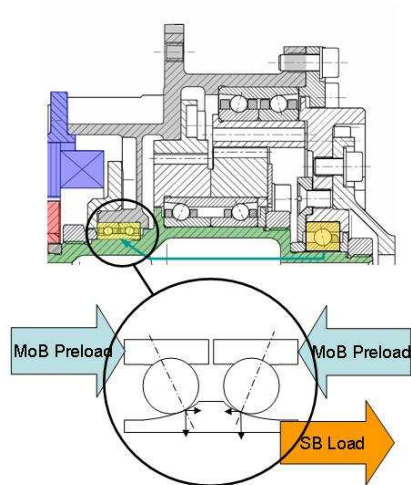
Figure 8: Eccentric Preload on Bearings

From a careful examination of the bearing configuration, it was established that the preloading of the shaft bearing acts as an external load on the motor bearing and affects the applied preload within the bearing. The effect of this is shown on figure 8.

This effect leads to a change in stiffness of the MoB which means that the bearing off loads earlier than anticipated during the vibration testing.

Lesson Learnt 1: It may seem obvious but check for internal design effects that for example may cause a redistribution of the preload in bearings which could in turn lead to a change in bearing stiffness.

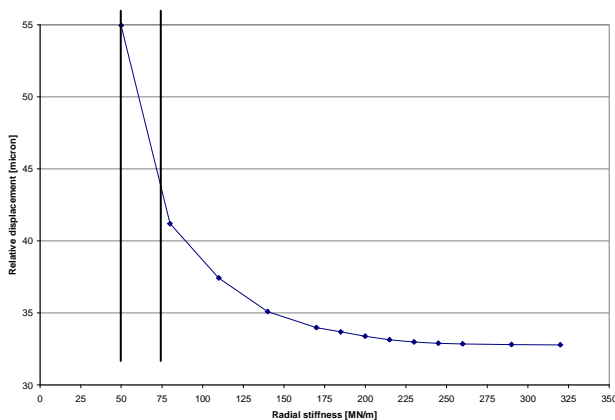
Figure 9: Displacement Increase as Result of Stiffness Variation on Motor Bearing

The displacement on the bearing due to the stiffness variations is shown on figure 9.

Here it can be seen that as the stiffness decreases, the displacement increases significantly.

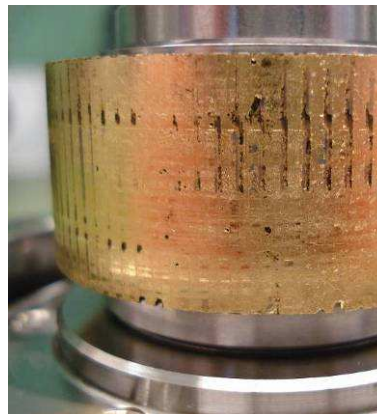
After the test, the mechanism was disassembled to determine whether or not there had been contact between the rotor and stator. Despite the lower vibration levels, marks were seen on the gold coated motor which indicates that the rotor and stator have made contact with each other.

These marks, seen on figure 10, can be differentiated from those that occur during disassembly because these would show as scratches while the contact marks in question are clearly 'imprinted' in the soft layer. The undisturbed surface with the rotor structure shining through can also still be seen.

Figure 10: Gold Coated Rotor showing contact marking

The results from the test verified the assumptions that the bearing stiffness changed during the test causing displacement at the bearing causing the motor to contact.

Lesson Learn 2: Account for the variable bearing stiffness when loaded externally (i.e. Vibration) to

account for bearing deflection and loads. This effect can be significant.

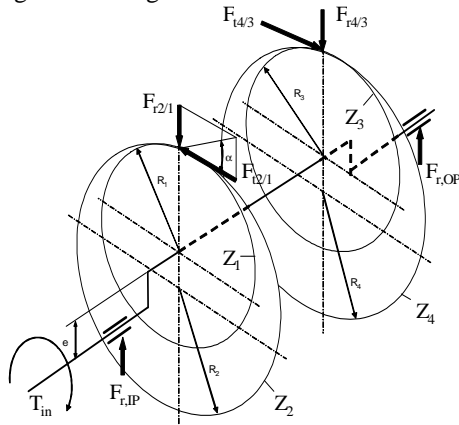
Figure 11: Bearing Forces due to Gear eccentricity

If a load of 20Nm is applied to the output flange of the mechanism, the result is a radial load of 425N acting at the Motor Bearing. During the life test, there was a long phase where the mechanism was driven at 0.5°/s with a large inertia attached to the output flange. This led to a higher than normal load at the output flange but this still only corresponded to a moment at the output shaft of only 1Nm. This results in a load at the motor bearing of only 22.6N which is considered insignificant and therefore has no significant impact on the bearing allowable life. The load issue on the gears is reinforced by the inspection where it was seen that there was no noticeable wear.

Lesson Learnt 5: When using a fixed output inertia to simulate external loads, the speed of operation of the mechanism should be considered as higher speeds to accelerate testing may lead to higher than expected loads on the mechanism.

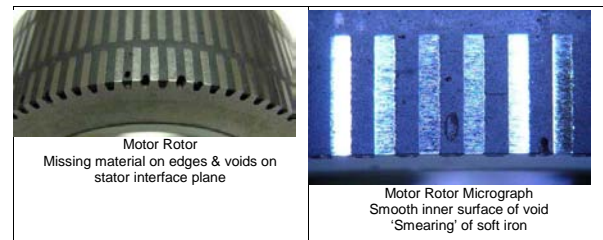
Figure 12: Voids on Motor

From an examination of the rotor surface, it was seen that there were a number of voids in the Stycast. After discussing this issue with the supplier, ETEL SA, it was clear that the voids occurred because the resin was not degassed during preparation. Without degassing of the resin, the machining operation can leave very thin areas over the voids which when placed in vacuum could break off and migrate towards the bearing and then break up into a powder form and react with the Braycote.

Lesson Learn 6: When using resin materials, always ensure that the mixture is degassed before use to remove air bubbles.

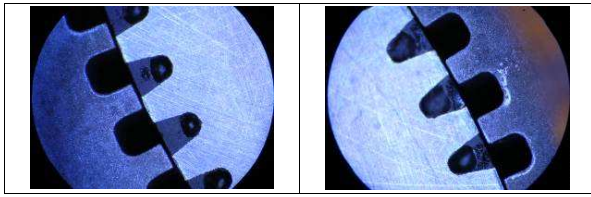
Prior to the retest on the mechanism to demonstrate that contact occurred at the motor, the gap was measured between 54 μm and 58 μm which indicates a good build standard for the unit.

Figure 13: Gap between Rotor (lighter colour) and Stator of SAD-LP Rebuild
