# Review of International Space Station Mechanical System Anomalies

## Abstract

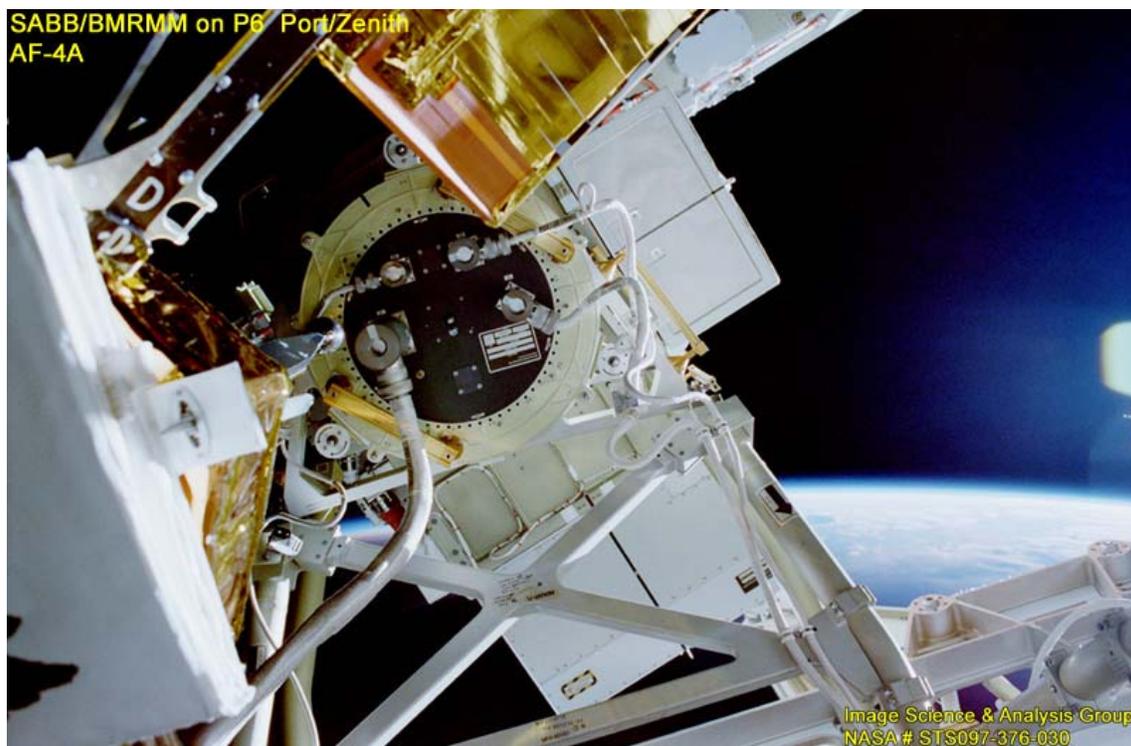
**Figure 4. Photo of BGA and 4-Bar Assembly**

This failure occurred during the deployment of the first solar arrays on the P6 element of ISS. During activation of the element a four bar mechanism is used to rotate the solar array mast canisters and blanket boxes from a launch position to an on-orbit position. Locking features at the base of four bars engage when full rotation is achieved. The deployment force on-orbit was significantly higher than expected and not all locks could be properly engaged. An exhaustive investigation revealed that insufficient control of the manufacturing tolerances allowed binding to occur in the mechanism which increased the required force to deploy and caused the hinge lock to malfunction. Also, a design feature that relied on friction to maintain alignment of critical parts failed when subjected to the binding loads. A redesign was undertaken to correct this on the remaining six solar array four bar mechanisms along with tighter control of the assembly process and functional checks to verify deployment forces.

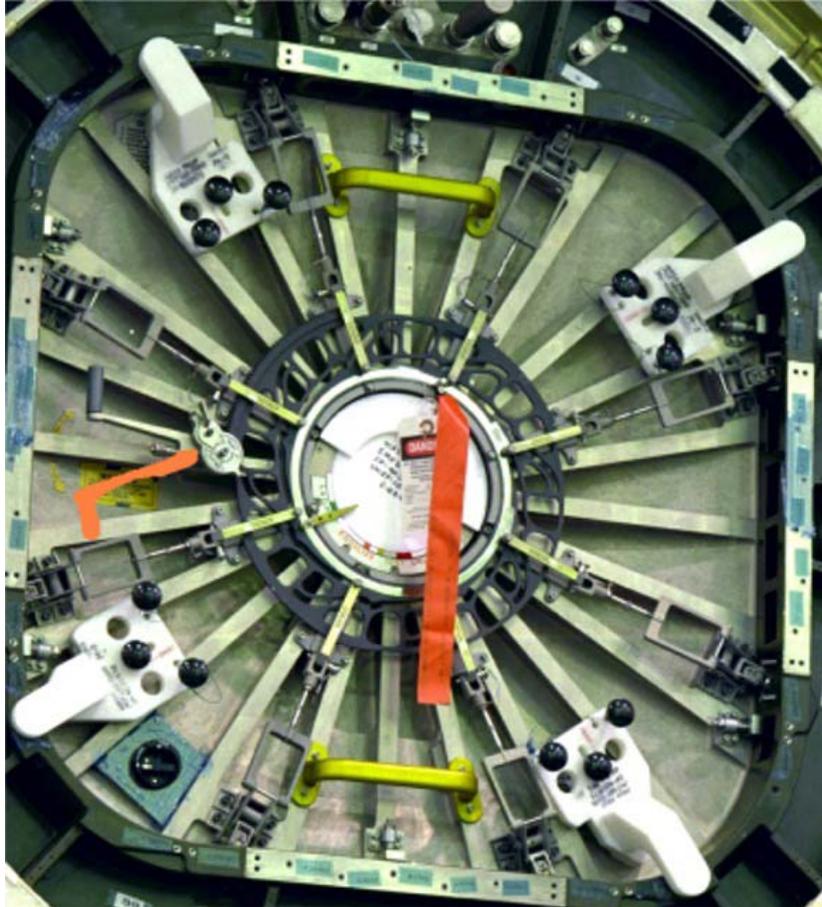
The handle on the ISS common hatch is used to operate the latches on the hatch. After use, the handle is stowed in a position so that it does not interfere with the mechanism. The stowage procedure relies on crew training to assure that this is performed properly. As was the case on orbit, an improperly stowed hatch handle almost caused the loss of access to the airlock. A non-standard work around luckily allowed access to be regained and new procedures are in place to assure the condition does not happen again. In review of the failure it was determined that the design does not adequately protect against the miss stow of the handle. Adequate design features to prevent the miss operation of the hardware were not provided. Anytime that operator training is required to prevent what could be catastrophic consequences design solutions should be found to minimize the chance that they could occur. In this case guards are being added to the hatch to preclude improper hatch handle stowage.

**Figure 5. Photo of common hatch. Incorrect handle position in red.**
