# Space Shuttle Orbiter Atlantis Liquid Oxygen Pre-Valve Detent Roller Cracking Investigation

## Abstract

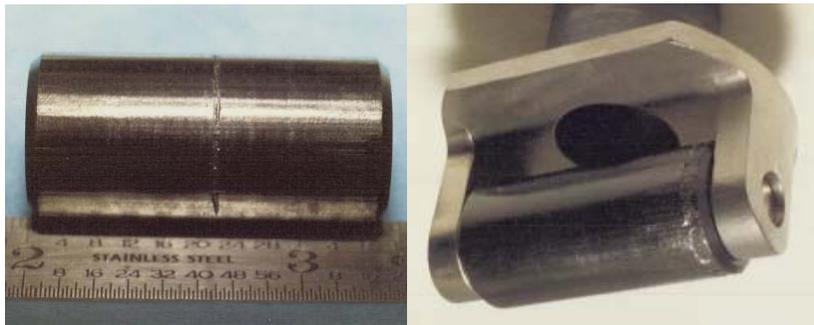
Some rollers within the fleet are specially machined to have a smaller diameter in specific locations. The purpose of this process is to reduce the effect of rough or high spots on that specific valve's visor. During inspections after the initial flights of the OV-103 and OV-104, several rollers in the LH<sub>2</sub> and LO<sub>2</sub> systems were found with rough gouges at specific distances along their lengths. Borescope and visual inspections concluded these instances of damage were due to wear associated with the high spots on each visor. Two rollers showing this type of damage are shown in Figure 6. Examples of specially machined rollers with gaps to avoid a high spot on a discrepant visor are shown in Figure 7.

**Figure 6: Rollers Exhibiting Wear due to High or Rough Spots on the Visor**

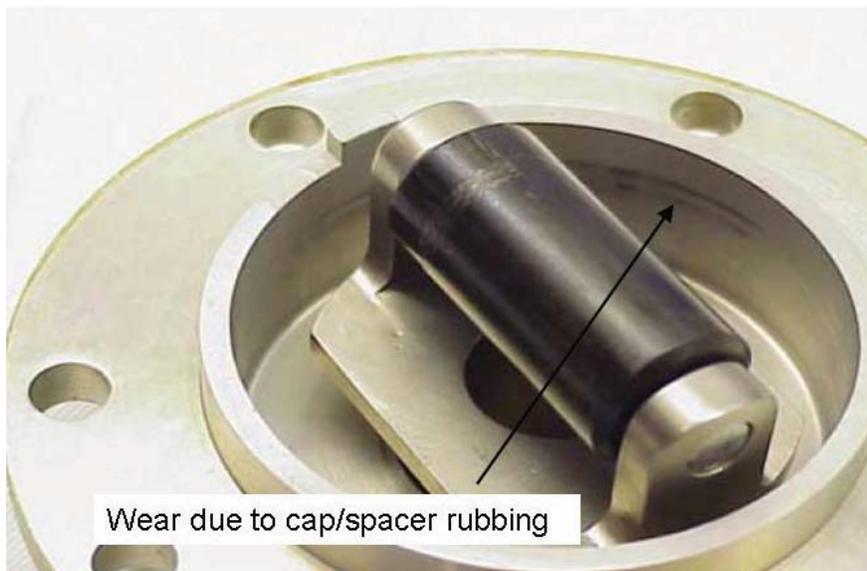
In addition to roller wear, the retainers also show signs of wear due to contact from the side of the follower. Deposits of the retainer material have been found on the pin and follower, which further supports the theory that the retainer is being damaged by these components. The cap also shows signs of wear due to the sliding contact of the four spring spacers. Example of nominal wear associated with spacer travel in the cap can be seen in Figure 8. All parts of the assembly are inspected thoroughly and replaced if the wear is considered significant. Minor wear to metal parts may be treated with Chem-film which is an acceptable practice for Shuttle LO<sub>2</sub> and LH<sub>2</sub> systems.

**Figure 8: Cap showing signs of nominal wear due to spacer rubbing**

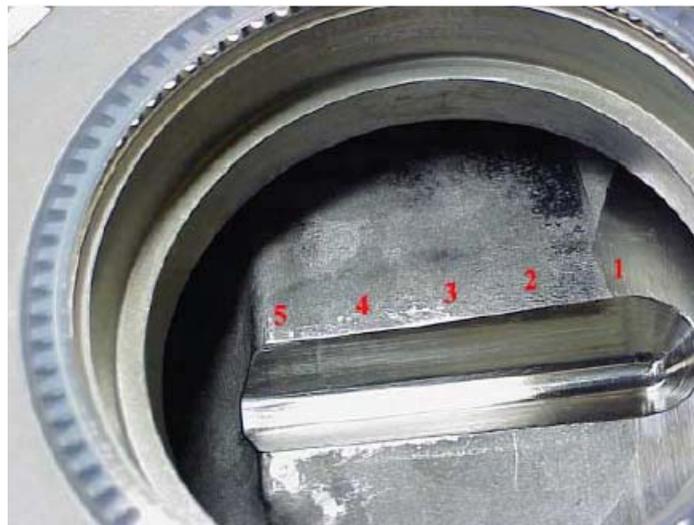
Molds of the visor detent groove were made so that measurements of the key dimensions of the visor could be taken. It was determined that the radius of the lip of the leading edge of the detent groove was sharper for this particular valve visor than drawings for the part allowed. The edge radius underwent a grinding and polishing process with the valve installed on the vehicle. Prior to machining, the radius was found to vary between 0.13 to 0.51 mm (0.005 to 0.020 inch) at various points along the length of the detent groove. The drawing requirement for this radius was 0.38 to 0.76 mm (0.015 to 0.030 inch). After the procedure, the sharpest dimension found along the length of the detent leading edge was 0.48 mm (0.019 inch). The polishing process was performed between the second and third rollers.

It was also noted from the mold impressions that the one end (labeled as "5" in Figure 9) of the leading edge was slightly higher than the other. This resulted in an unparallelism between the roller and visor interface. This unparallelism resulted in one side of the leading edge being approximately 0.64 mm (0.025 inch) higher than the other. This meant that one end, the horseshoe shaped end, compressed the detent roller more than the open end. All three cracks initiated on the end corresponding to the higher compression.

**Figure 9: Pre-valve Visor Detent Groove**

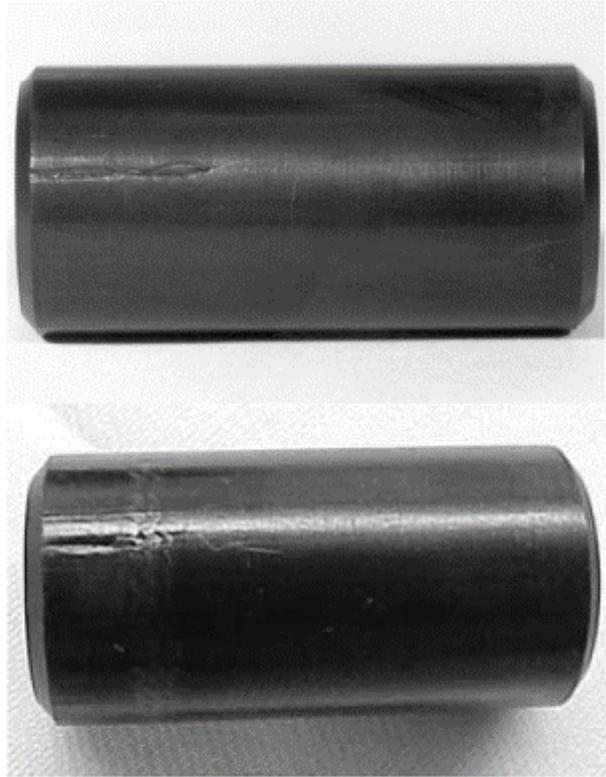
To date, three cracked rollers have been found through inspection. All 3 rollers were in the OV-104 Engine 3 LO<sub>2</sub> pre-valve. The first cracked roller was found after the second flight of OV-104, which led to the inspections discussed above. During OMDP for OV-104 after Flight 26, the second cracked roller was discovered. Following this investigation, every-flight inspections were instituted for the specific Engine 3 LO<sub>2</sub> pre-valve. During these inspections, the third cracked roller was discovered. Unlike the prior two cracked rollers, this roller cracked after only one flight. This raised concerns that a cracked roller that remains in service may degrade further and cause a serious failure in the LO<sub>2</sub> system.

Rationale to fly after finding the second cracked roller was based primarily on the conclusion that the sharp leading edge of the detent groove was the root cause of the cracking. However, after the detent groove leading edge was returned to print, the third roller cracked after only one flight. The second and third cracked rollers can be seen in Figure 10. In each case, the crack was observed to run through the LO<sub>2</sub> compatibility testing mark and completely through the thickness of the roller. This can be seen in Figure 11.

**Figure 10: The second and third cracked rollers**

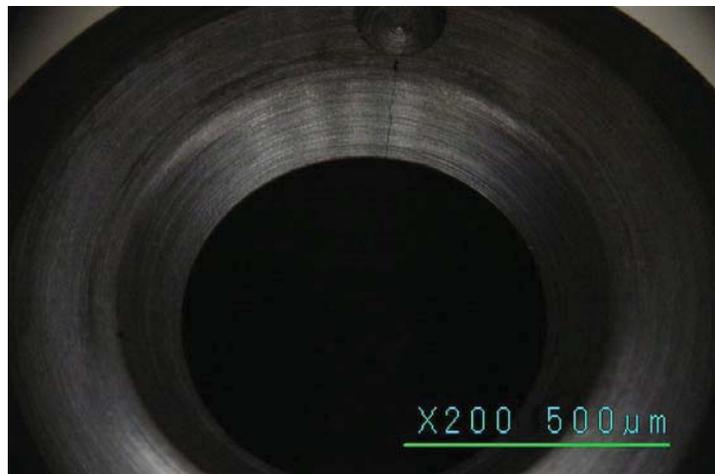
After the second failure was discovered, two likely causes were identified: roller material LO<sub>2</sub> compatibility testing marks, and detent groove leading edge sharpness. Before a soft good or non-metallic material is used in Space Shuttle LO<sub>2</sub> systems, each batch of the material must be compatibility tested. The Vespel SP21 used for the roller requires this testing. To ensure that rollers that aren't batch tested are not installed in the vehicle, a small dimple is machined into the end of the roller to indicate that the material successfully completed the required testing. The depth and diameter of the dimple are drawing controlled. The mark is to be no more than 0.76-mm (0.030-inch) deep and 1.57 mm (0.062 inch) in diameter. It was noted that the crack observed on the second and third cracked rollers initiated at the dimple and propagated through the thickness of the roller. The dimple was identified as a stress riser and a contributor to the cracked rollers. However, it was also noted that the first cracked roller did not have a dimple, so there is likely an additional cause.

**Figure 11: Crack can be seen through the compatibility testing mark and from the inner to outer diameters**

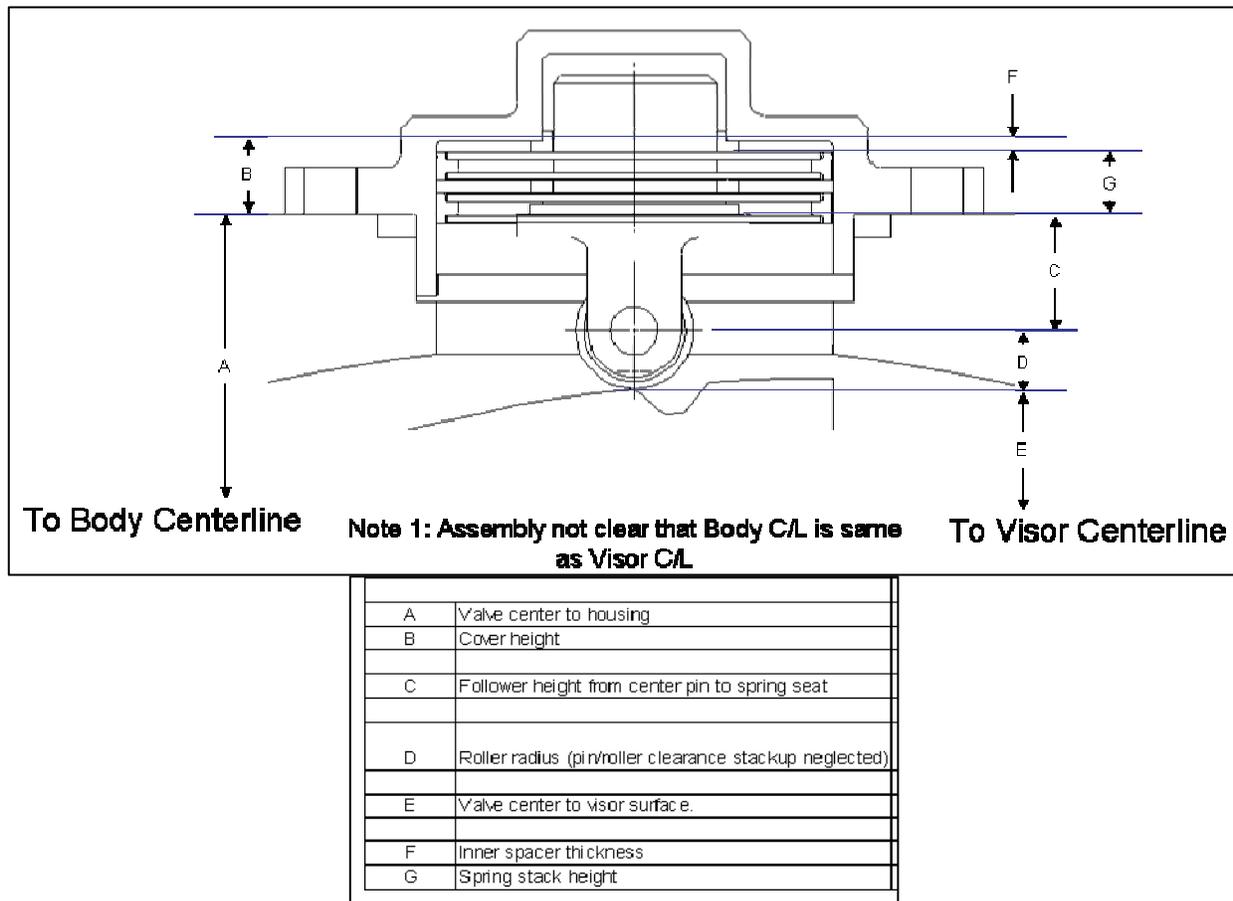
During further examination of all available data it was noted that the visor to valve body height, recorded during the visor mold impression and grinding work, was out of family. This information kicked off a tolerance stack up analysis. The third cracked roller kicked-off an effort for a more in-depth investigation of alternate causes. Because the first two causes that were examined, the dimple and the sharp edge, did not preclude another cracked roller, it was necessary to look for a less obvious cause. Because the third failure was after only one flight, resources and attention not previously available were given to the problem.

The out-of-specification measurement of the visor height prompted the tolerance stack-up investigation. The measured distance of the visor from the valve body was used as a basis for a tolerance stack-up analysis. Actual measurements of the installed detent mechanism components were used, including a force-deflection curve of the Belleville spring stack set-up. The stack up of the individual components was subtracted from the visor height to determine if interference was possible. Interference would result in the spring stack reaching its solid height and imparting unexpected high loads on the roller. It was determined that combinations of nominal piece parts tolerances could result in deflections that caused the Belleville spring stack to go flat and introduce the high loads onto the roller. An illustration of the mechanism and the measurements used in the analysis are shown in Figure 12. As a solution, piece parts were carefully selected to produce an acceptable assembly on the low side of the tolerance band. This should preclude the spring stack from reaching a solid deflection height. Further mitigation was to machine an angle in the retainer surface that contacts the follower. The surface was angled to 2 degrees based on the marks left by the roller on the retainer. These marks indicated the angle at which the roller was moving when in contact with the visor. The modified retainer allows additional movement of the follower and prevents binding at the follower-retainer interface. This reduction in binding also reduces the load being applied to roller.

Figure 12: Detent Mechanism Tolerance Stackup
