The Mars Climate Sounder In-Flight Positioning Anomaly

Bruno M. Jau* and David Kass*

Abstract

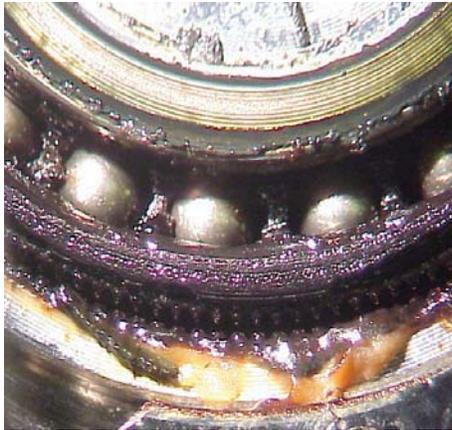
Figure 7: Close up View of Mechanical Components after the Life Test

Figure 7 shows a close up picture of the harmonic drive, taken after the life test: No mechanical wear could be detected at any mechanical parts, nor was there any graceful degradation evident, which would have expressed itself, for instance, by substantial increases in backlash. But the lube's color had changed from brown to black in the engagement zones between gear teeth and in the bearings. Chemical analyses, however, revealed that lube samples taken from inside the engagement zone had retained their lubricating capabilities. The joint thus maintains its full capabilities.

The overall conclusion based on life test results (for life test conditions), is that the joint demonstrated its capability to survive the required mission error free, pointing away from a mechanical cause for the anomaly: The life test joint is still being used on occasion today, proving its mechanical integrity and the lube's lubrication capabilities time and time again. It runs error free, provided it receives the proper electrical input signal and current.

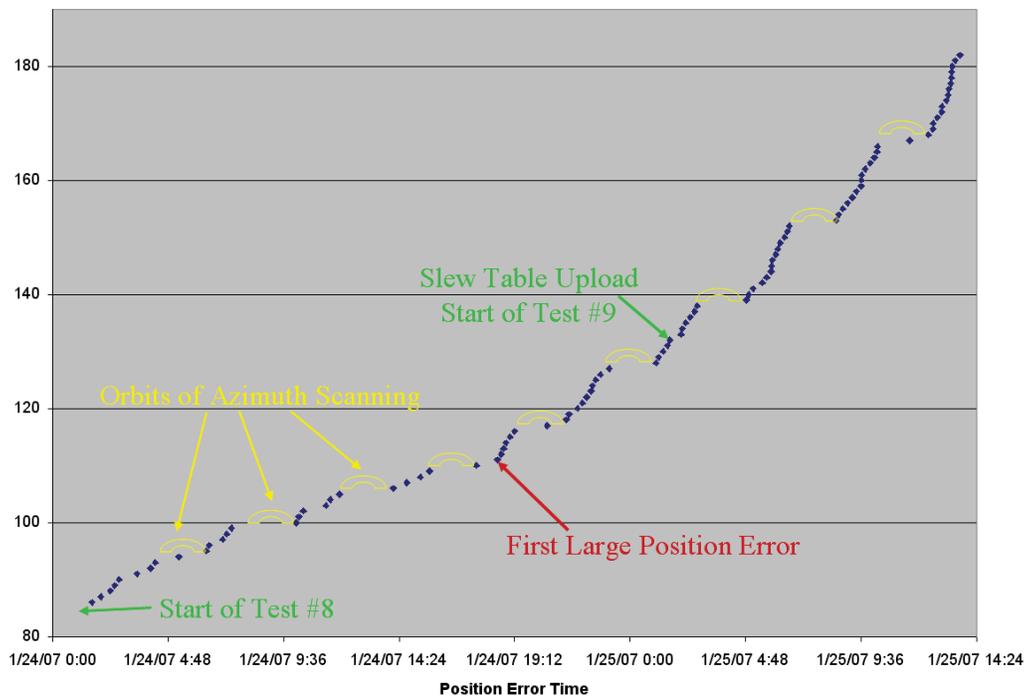
Figure 10: Error Rate in Late January Testing

The results are shown in Fig. 10, plotting the time of the error versus error number. The yellow crescents are the orbits with azimuth scanning. All of the errors during the azimuth orbits are associated with elevation scans. Part way through, it was decided to proceed with the next test (test #9) and remove the last difference between the two actuators by overwriting the elevation slew table with the azimuth table.

One interpretation of the two tests (in addition to eliminating a large number of systems from the fault tree) was that the elevation actuator was rapidly degrading and would soon be inoperable. The final error rate was also significantly degrading the ability to perform good science observations. And the large pointing errors introduced a sun safety issue. This led to the formation of an anomaly tiger team. At this time, Starsys [7] was actively brought into the investigation.

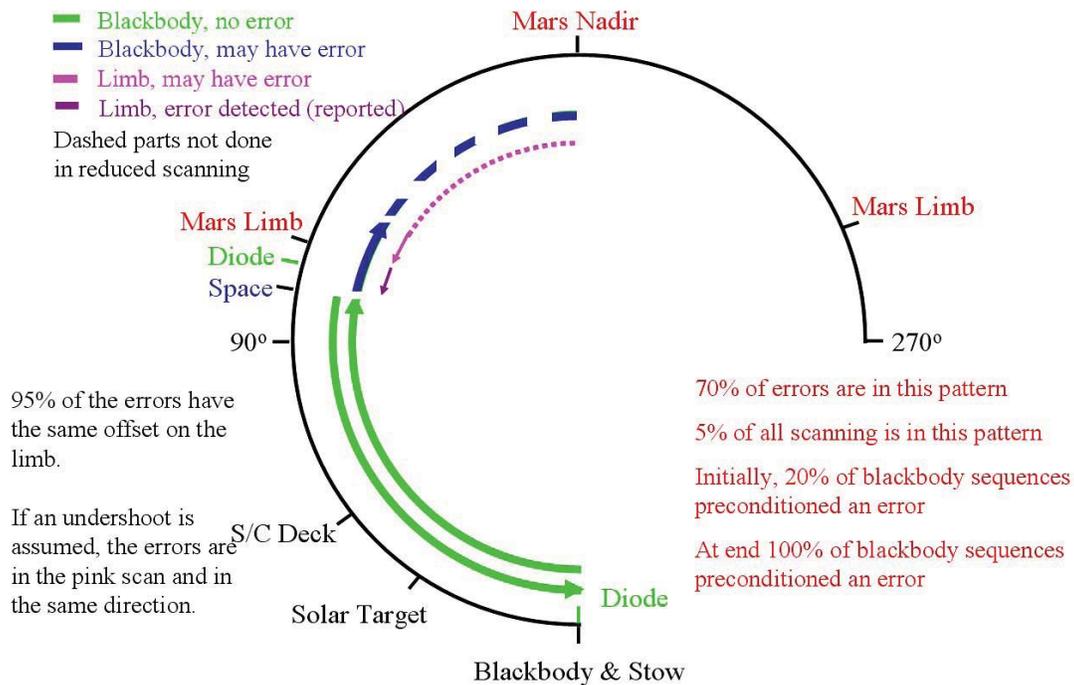
Figure 11: Blackbody then Limb Error Pattern

The cause of this preconditioning is not understood. Initially, 20% of the black body sequences preconditioned an error. When the errors were the most frequent, all black body sequences preconditioned a position error. Extensive analysis of the MCS software, electronics and mechanical assembly, has failed to point out any reason for such a preconditioning to occur.

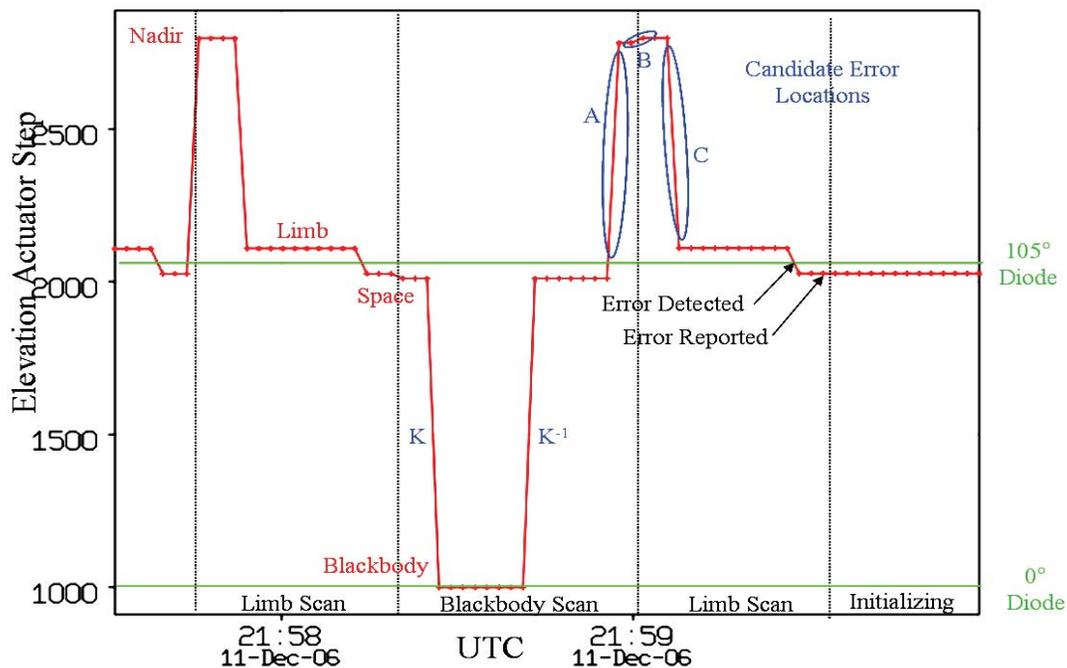
Figure 12: Slews Implicated in a Typical Position Error

There is currently no identified root cause for the position errors. All conceived investigations with EM hardware, life test actuator, or in-flight evaluations have failed to shed further light on the issue. Likewise, design reviews and theoretical studies have been exhausted without identifying an obvious root cause.

While four potential root causes have not been completely eliminated, none appear to be the answer. None of them matches all observed or anticipated behavior of the hardware. All have major issues that would be sufficient to eliminate them from consideration.
