Space Station Control Moment Gyroscope Lessons Learned

Abstract

This paper describes the configuration of the ISS CMGs, their operations, a description of CMG1's "hard" bearing failure after approximately 1.3 years of operation. Included also are the findings for CMG3's "soft failure" that led to its removal from service and the corresponding most probable causes and lessons learned.

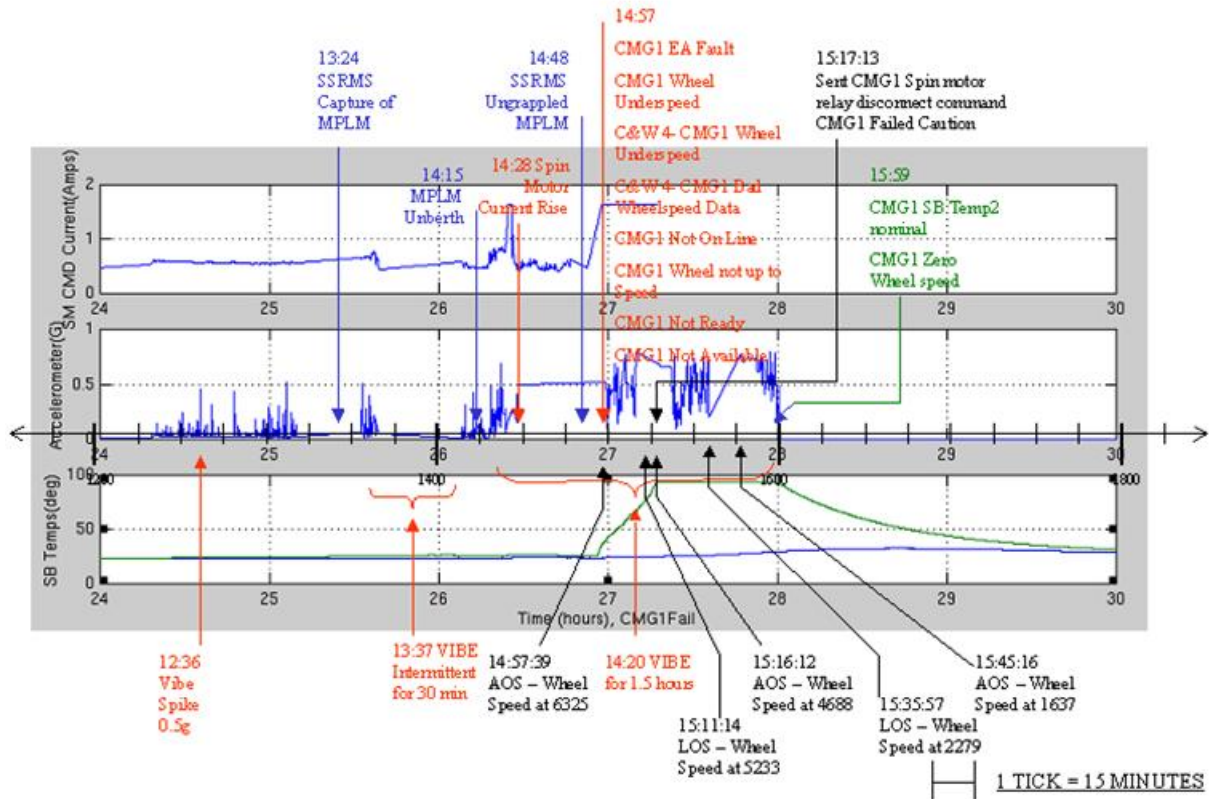
Figure 7. Hard Failure and Shutdown GMT 159/2002/12:00-18:00

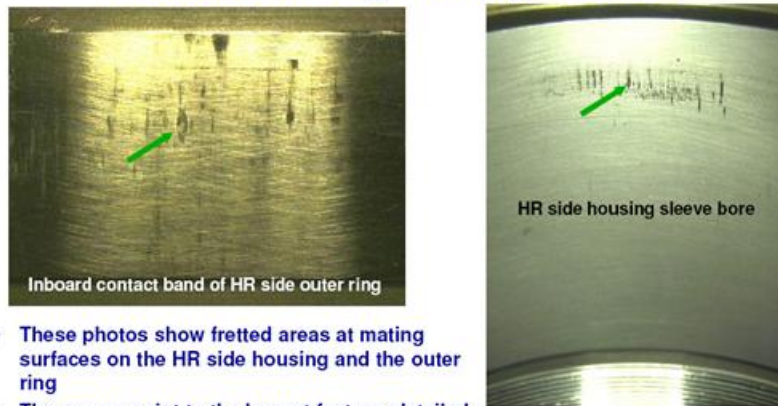
HR Side Outer Ring / Housing Interface

1. Similar “fretting” type marks were observed on the steel sleeve of the bearing cartridge steel sleeves (Figure 11). The fretting marks were near 180 degrees apart from the area on inboard section to the area on the outboard section, an indication of bearing bore misalignment. If these conditions occurred before the failure, either during on earth acceptance testing or during operation, this misalignment would have affected the preload system.

- These photos show fretted areas at mating surfaces on the HR side housing and the outer ring
- The arrows point to the largest feature, detailed on the next chart
- There were generally fewer frets here than on CMG1 and ADP
- There was some evidence of wear marks 180 degrees apart from these on the outboard end of the bore, but this was not as distinct as in CMG1 and qual unit

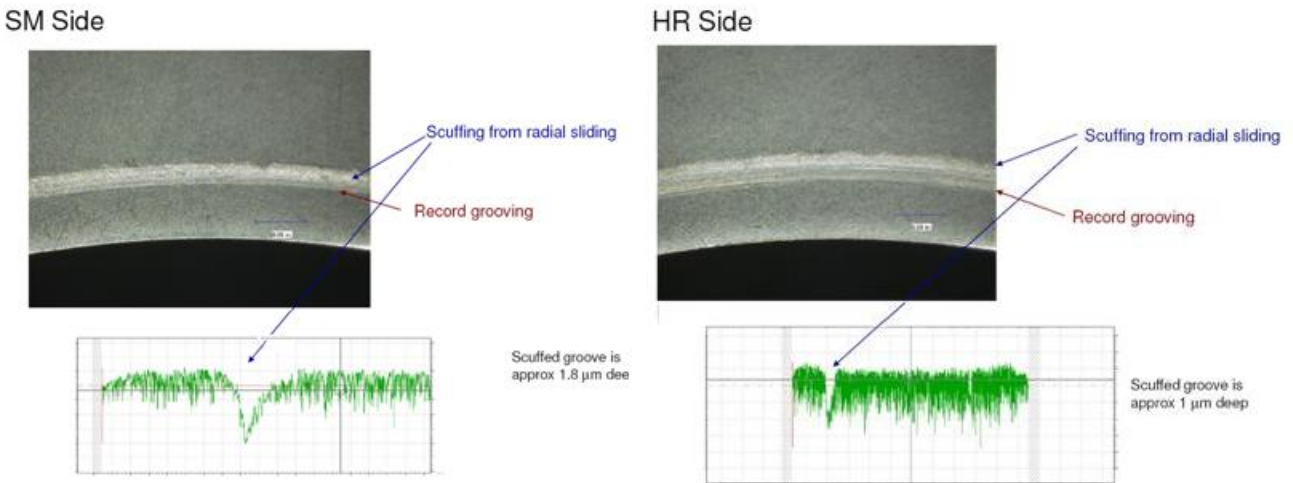
- Some scoring (record grooving) on both the Spin Motor and Hall Resolver side preload nuts has been observed (Figure 12). This condition inhibited the spring action to react properly during the load and release cycle during axial motion of the flywheel. Preload was reduced to cause low preload and ball skid.

Figure 12. Typical Preload Nut Record Grooving
