International Space Station Powered Bolt Nut Anomaly and Failure Analysis Summary

Daniel E. Sievers* and Harry K. Warden*

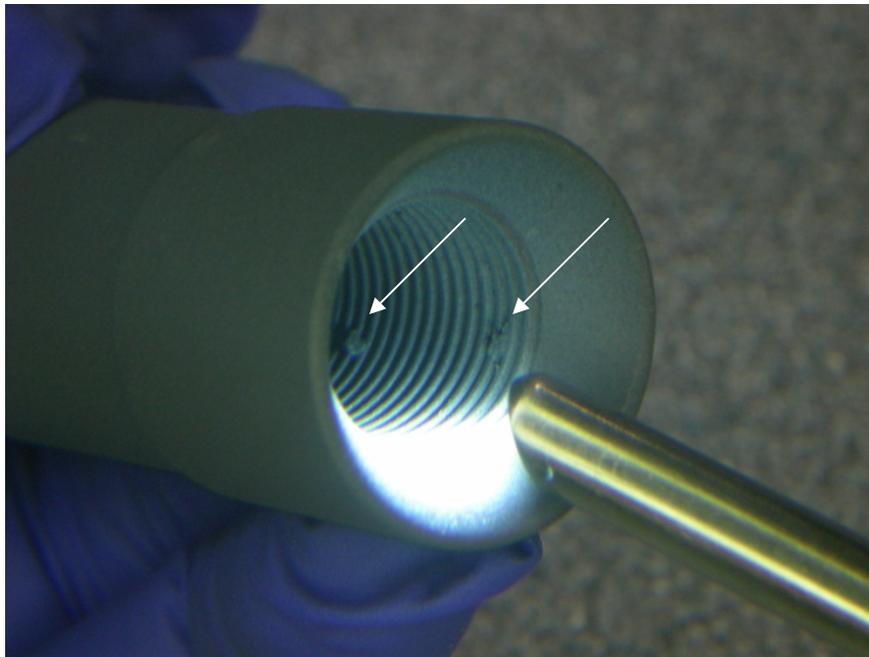
Dry film lubricant, which is applied to internal threads using common practices, has an unpredictable thickness. Thickness is almost impossible and usually too expensive to measure in an indestructible manner. If the lubricant is too thick, this will cause high torque limits during acceptance testing leading to failure of the nuts. Thickness of the PBN lubricant was also a reason for failure for some of the previously built PBNs. A way to defer from dry film lubricant being too thick is to use a thread cutting tap. On previously built PBNs, a roll forming tap or a specially manufactured forming tap was used. Both the roll forming tap and specially manufactured forming tap were not sufficient enough to cut through the cured ceramic base coat of the lubricant; this problem will be similar for most ceramic-based dry film lubricants. During this process, the roll forming tap became stuck in the nut barrel on various PBNs and had to be cycled multiple times into the nut. Much force had to be applied to the tap to smooth and cut out lubricant. This process increases the risk of damaging the lubricant or the threads of the PBN. A thread cutting tap should only be used on the fully cured ceramic base coat of the lubricant. Dry film lubricants may be applied in multiple coats and a thread cutting tap should not be used on the top coat. The thread cutting tap will strip the top coat off the base coat and the lubrication properties of the top coat and the lubrication system will be lost.

Figure 5: Agglomerations of base coat ceramic of Dry Film Lubricant

When deciding on a thread cutting tap, the end thickness of the lube must be taken into consideration. Adding the end thickness of the lubricant and subtracting the top coat not yet applied to the nut pitch diameter will ensure the thread cutting tap only clears out the unneeded base coat of the lubricant and leaves an even and smooth base coat on the threads. Figure 5 is an agglomeration of ceramic particles after curing of the lubricant and before using the thread cutting tap. Another benefit of using a thread cutting tap is cutting out debris which may come loose later during acceptance testing. This loose debris gets caught between the threads and causes torque spike anomalies in acceptance test data. This debris can also lead to false failures. Spraying the top coat of lubricant over a loose base coat will cause a loss of both top coat and base coat as debris during testing. Losing the top coat and base coat in areas will cause the lubrication system to function improperly, leading to higher torque readings and possibly galling. For each PBN, the thread cutting tap was used only one time to mitigate cutting into too much lubricant or causing damage to the lubricant. Using a thread cutting tap on dry film lubricant is not an easy process and difficult to do by hand. The PBNs were placed in a vice while a hand tool was used to gain

cutting torque in order to cut through the cured ceramic base coat. After the correct thickness of the base coat was obtained through proper tapping of the nut, the top coat of the lubricant system was applied. The variables stated earlier in this section are now controlled to ensure a consistent uniform lubrication throughout production.
