# Failure Analysis and Recovery of a 50-mm Highly Elastic Intermetallic NiTi Ball Bearing for an ISS Application

Christopher DellaCorte\*, S. Adam Howard\* and Lewis E. Moore III†

## Abstract

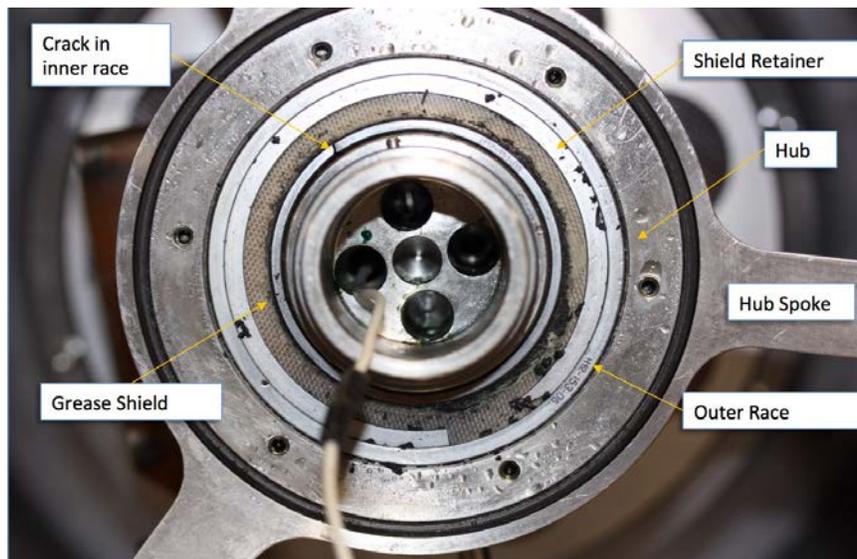
Based upon this image alone, one plausible preliminary failure scenario is that the inner race fractured and caused more generalized damage and wear as the test continued. A close up image of the inner race fracture, shown in Figure 3, offers additional clues to the behavior of the 60NiTi.

**Figure 2. Hub-side view of failed ISS Distillation Assembly centrifuge bearing. Note cracked inner race and ejected wear debris**

The inner race appears to have sprung radially outward from the DA shaft to the left side of the crack and a significant gap has opened between the faces of the crack. This behavior suggests that the inner ring had been under considerable residual stresses and these may have been a factor in the bearing failure.

Indeed, the bearing manufacturing process for 60NiTi includes a rapid water quench step following heat treatment at 1000 °C [9]. This rapid cooling results in the rise of residual thermal stresses. Unlike steels and other metals in which such residual stresses can be relieved by soaking the parts at elevated temperatures, NiTi has no mechanism for internal atomic level slip. The residual stresses that remain after the quenching step cannot be relieved through additional thermal treatments and these stresses may be a factor in undesirable effects like ring cracks [10, 11].

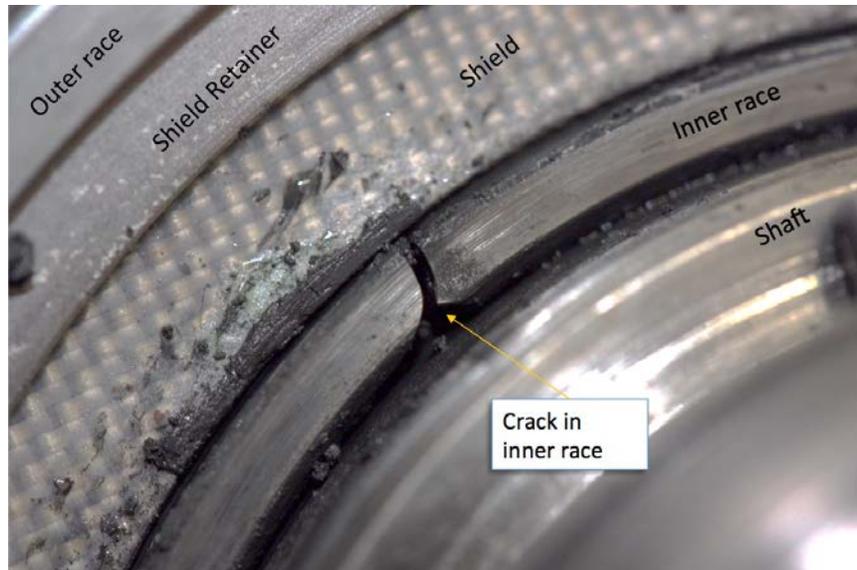
**Figure 3. Close-up view of cracked inner race**

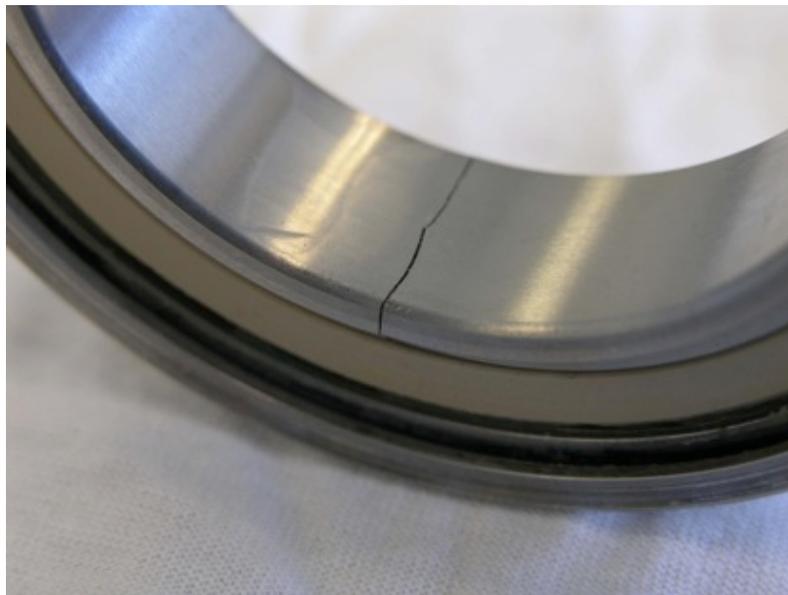
A similar bearing ring crack was observed during prototype bearing development. A bearing had been successfully tested, removed from the test rig and inspected. The bearing was in as-new condition and was placed in storage. Several weeks later, the inner ring developed a crack similar to the one observed in the present case. Figure 4 shows that inner ring crack.

**Figure 4. Photo of an early prototype bearing that developed an inner race crack during post-test storage**

In this instance, forensic analyses showed that the early prototype 60NiTi material used in this bearing contained significant non-metallic inclusions and other internal flaws that could have triggered the crack. In addition, the bearing was damaged during final machining of the inside surface of the inner ring. Adjacent to the fracture location, a low spot and a deep gouge are observed. This damage was a

manufacturing flaw that resulted from the inner ring becoming loose in the machining fixture. Thus this post-test ring crack was attributed to the known material and machining flaws [11].

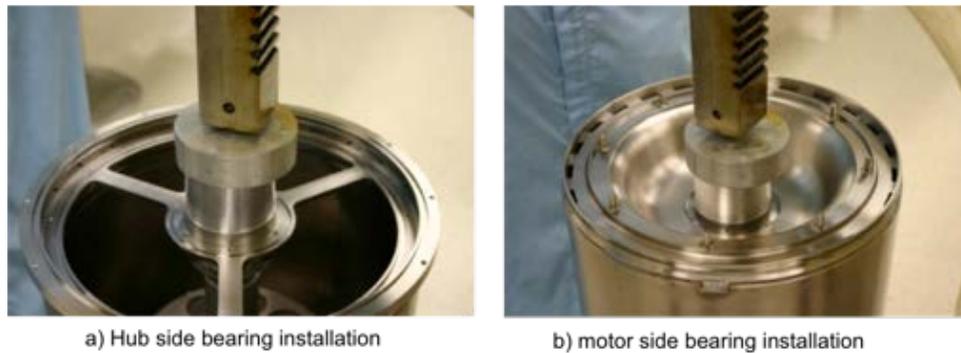
Aside from the differing levels of interference fits, the most obvious difference between the motor and hub-side bearing locations is the structural design of the housings. As shown in Figures 1 and 5, the motor-side bearing housing has an axial symmetric bowl shape while the hub-side bearing housing is comprised of a shallow cylinder supported by a three-spoke flat plate. The spoke design provides ready physical access to the central portion of the drum to enable the installation of piping and other internal elements. Figure 5(c), for example, shows a close-up view of the hub-side of the drum where a fluid pick-up tube is visible. To determine whether the differences between the hub and motor side housing structures were a contributing factor in the bearing failure, a finite element based analysis was undertaken.

**Figure 5. End views of DA drum shown during bearing installation. Hub side bearing housing structure (a) differs significantly from motor side (b).**

For the hub-side bearing the situation is more nuanced. The known interference fit is larger, 0.0011 in (28  $\mu\text{m}$ ). This level of press fit into a circumferentially symmetric and relatively rigid housing would be expected to reduce the bearing diameter by about 0.0009 in (23  $\mu\text{m}$ ). This level is greater than the known bearing internal clearance (0.0008 in (20  $\mu\text{m}$ )) resulting in the bearing having no internal clearance and indeed the balls and the inner race would be under a preload by the outer race. This in itself is an undesirable condition that may factor into the hub-side bearing failure. However, the circumferentially non-uniform spoke structure supporting the hub-side bearing housing may cause additional problems in that the installed bearing outer race may not be compressed uniformly.

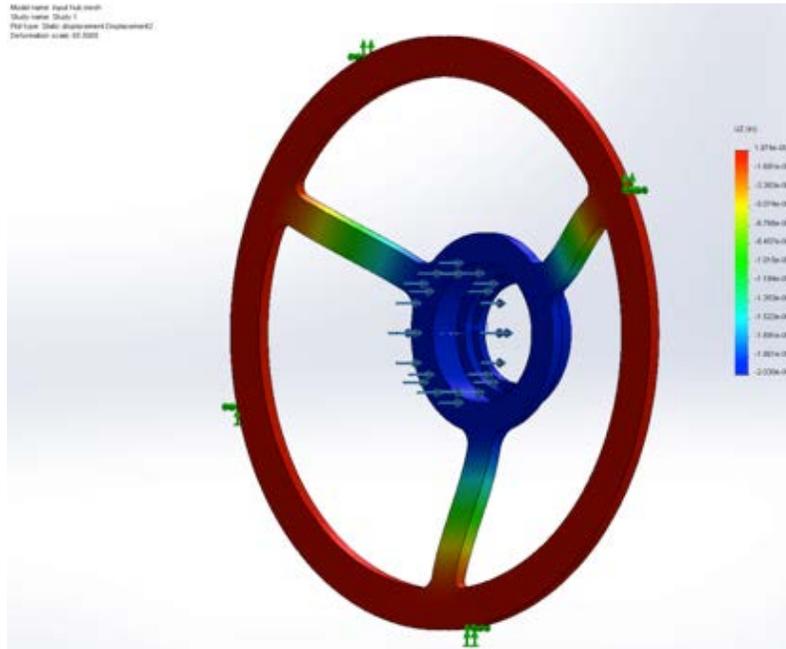
To estimate the magnitude of the deformations of the hub-side bearing outer race, a finite element model was developed. Figure 6 displays the model result for the axial deformation of the hub-side three-spoke structure under a greater than normal 200-lb (890-N) axial load. The normal axial load for the DA is only 40 lb (178 N). The 200-lb (890-N) case was run to determine whether axial deformation arising from the spring preload could possibly distort the hub-housing geometry. The result was clear. Even under exacerbated axial load the housing shape remains round. It was noted, however, that significant axial deformation of the spokes occurs even under the 40-lb (178-N) design load. This deformation effectively reduces the axial preload through reduction of the distance between the outer races of the hub and

motor-side bearings. Thus if the wave spring height reduction is used to set preload, it is likely that the installed preload will be lower than expected by about 10%.

**Figure 6. Finite element deformation of the DA hub side structure in response to a large (200-lb (890-N)) axial load. Note that the hub bore remains round**

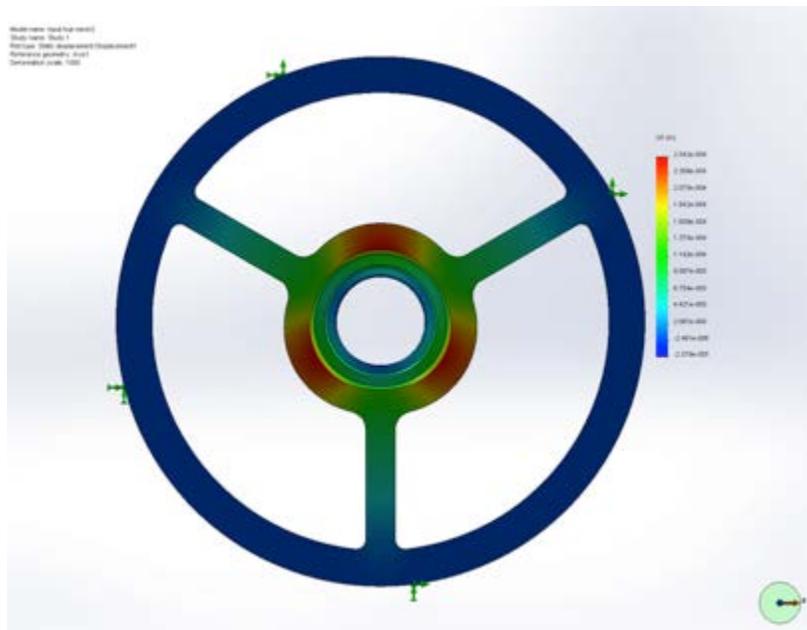
**Figure 7. Finite element deformation of the DA hub side structure into which a bearing is installed with a heavy (0.0011 in/28  $\mu$ m) press fit. Note that the three spoke locations provide high rigidity leading to an irregular bore shape**

The second case examined was for a heavy interference press fit (0.0011 in (28  $\mu\text{m}$ ) diameter difference) of a round bearing into the circular hub-side housing bore. Figure 7 shows the result.

At the spoke locations, the bearing outer race diameter is reduced by approximately the same magnitude as the bearing clearance and the less rigid housing sections between the spokes allows the bearing housing to take on a tri-lobe shape with radial variation of approximately 0.0002 in (5  $\mu\text{m}$ ). Such roundness variation combined with the loss of internal clearance could be responsible for the rapid bearing failure. To corroborate such a root cause theory, however, requires experimental verification.

Selective fitting of the bearings, especially in the hub-side DA housing, should be done to seek a fit in which the bearing outside diameter and the hub bore diameter are as closely matched as possible. The design calls for a range of 0.0001 in (2.5  $\mu\text{m}$ ) clearance to 0.0006 in (15  $\mu\text{m}$ ) interference. Another approach is to manufacture bearings with varying diameters to accommodate future DA machines with less or no interference thus avoiding the deleterious effects of outer race distortion and loss of internal clearance. Furthermore, bearings with larger internal clearances can be used so that any outer race press fit will not result in a significant or even complete loss of internal ball-to-race clearance. Conversely, bearing designs less sensitive to internal clearance variations, such as angular contact bearings, could be considered.

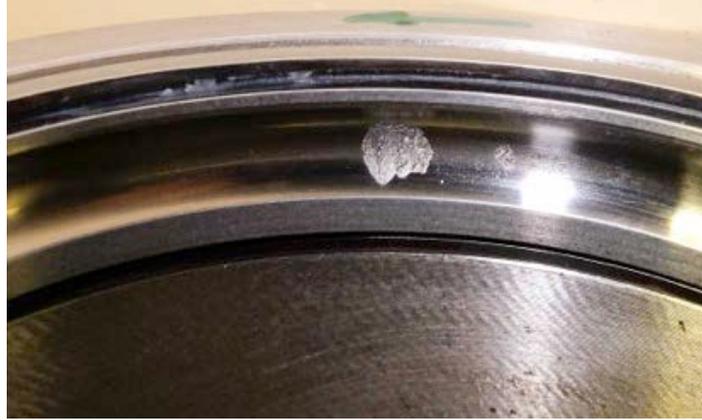
After 150 hr of test time the bearings continued to turn smoothly. At 157 hr an audible noise was noted and the torque sensor indicated a measurable torque ripple. The test was stopped and the bearings were removed, disassembled and inspected. The shimmed bearing had suffered from fatigue damage. The grease was discolored and wear debris was observed. The fatigue damage resulted in deep raceway pits and spall craters. These were located in the regions that overlapped the shims. The other test bearing that was not shimmed showed no signs of damage. Figure 10 is a close up photograph of the raceway surface of the shimmed outer race after test. Significant surface pitting and spall regions are present. The inner race also showed signs of surface distress (small pits) but it was uniformly distributed around the raceway and less severe.

**Figure 10. Raceway pit developed during shimmed bearing test after 157 hr of run-time**

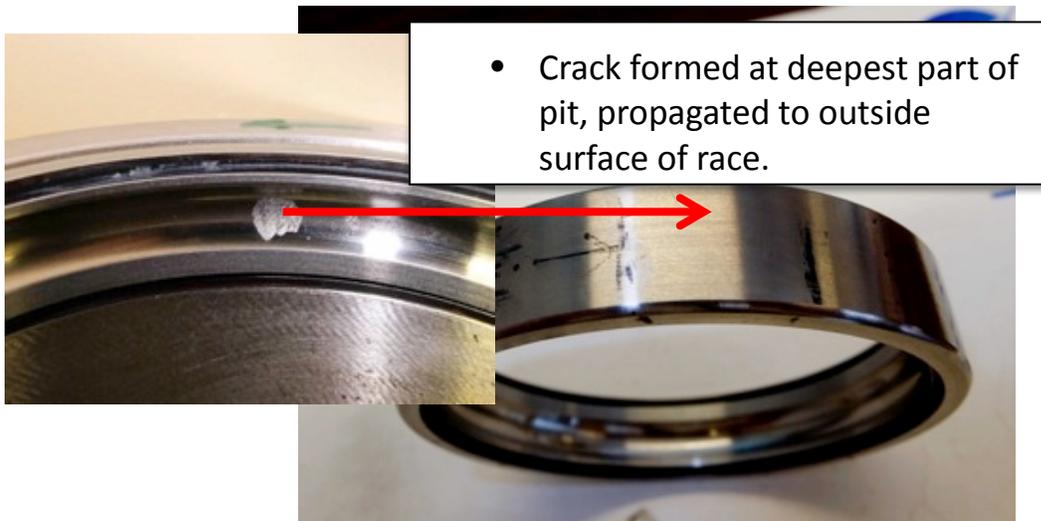
In the largest spall crater, approximately 4 mm in diameter, cross-race cracks had developed. In some places these cracks had propagated to the outer surface of the race as shown in Figure 11.

**Figure 11. Crack originating in the fatigue spall on raceway has propagated to the outer surface of the race after 157 hr of run-time**

If this test been allowed to run longer it is reasonable to expect the damage to progress possibly until the race cracked through completely. Upon reflection, it is possible that the failure path for the DA bearing was surface fatigue followed by pit growth, crack formation and propagation and finally, race fracture. At the onset of the investigation, one theory was that the raceway residual stresses had led to ring fracture and subsequent bearing wear and debris generation. Based upon the shimmed bearing experiment, it appears that ring fracture may have been the final step, not the initiation step.

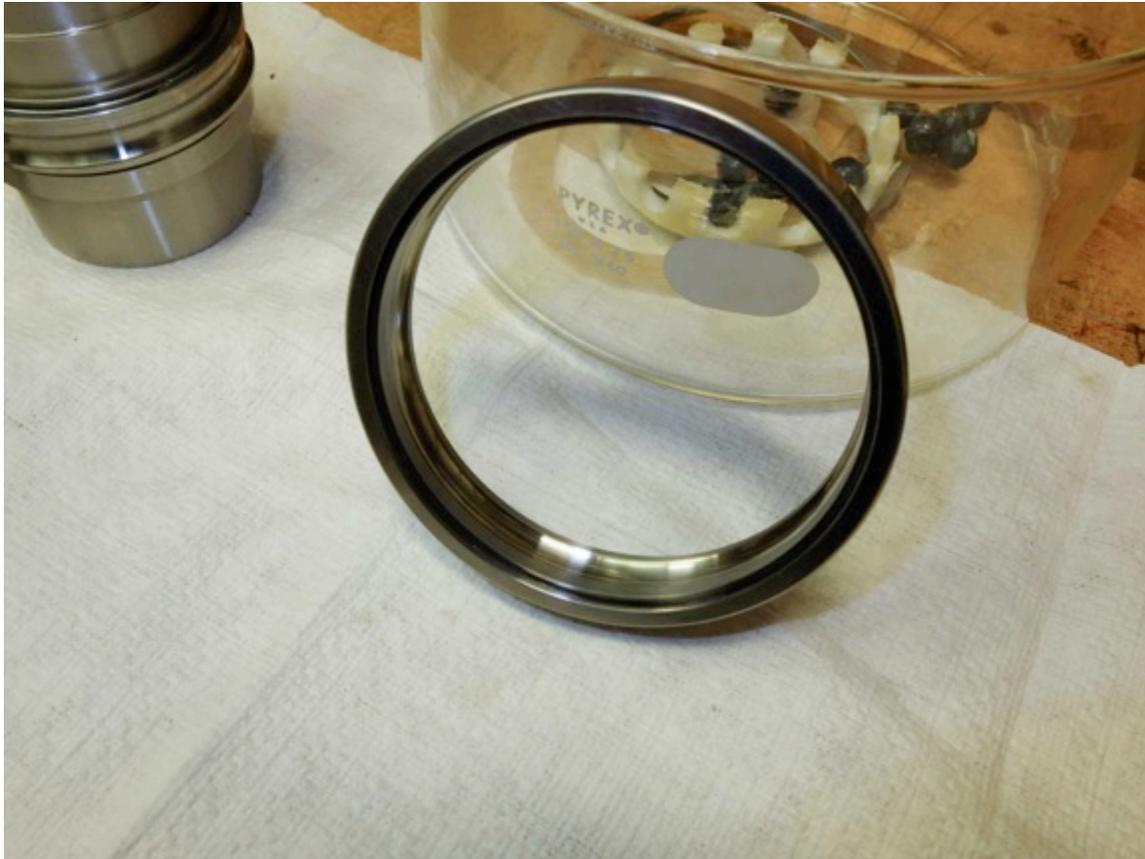
During the inspection the races were examined under 10x optical magnification and appeared to be in excellent condition. They exhibited no surface pits, scratches or wear tracks. Also, the retainer was unworn and the grease color and consistency was the same as the beginning-of-test. Following the inspection, the bearings were solvent cleaned, re-greased and installed back into the test rig. After a few hours of operation the torque ripple subsided leaving a vibration spectra that resembled one from before the inspection.

**Figure 13. Photograph of the test bearing during an interim inspection at 1075 hr. Overall condition of the bearing races, balls and retainer was unchanged from beginning of test. The grease consistency and color was also unchanged**
