Lubricant Degradation in High-Load, High-Cycle Actuator Test Using Heritage Harmonic Drives for the Multi-Angle Imager for Aerosols Instrument

M. Michelle Easter*

Abstract

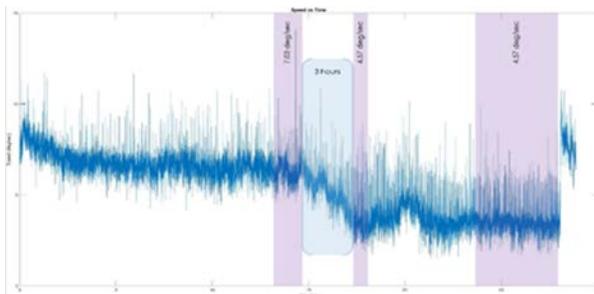
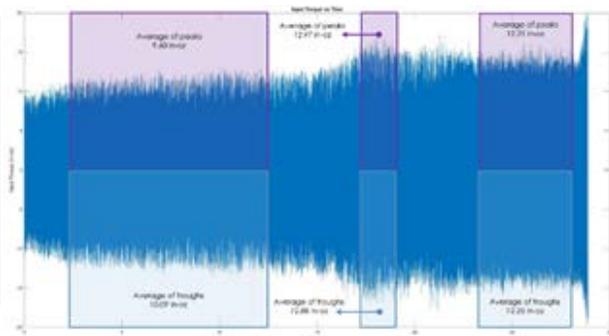
Figure 6. Output Speed Degradation in the Final 6.5 Second Dither Time Test Event

Figure 7. Input Torque Increase in the Final 6.5 Second Dither Time Test Event

This time, when the speed was increased to the desired value, the system faught harder than before. Input torque climbed quickly, exceeding previous test maximums, as seen in the far right of Figures 6 & 7. In

addition to the behavior was a simultaneous temperature spike of 10°C on the test article housing in under a half hour, with no change to the ambient environment. When the data for both lives was concatenated, as shown in Figure 8, it was clear that this final 6.5 second dither time test event showed unacceptable performance. The test was halted for further assessment.

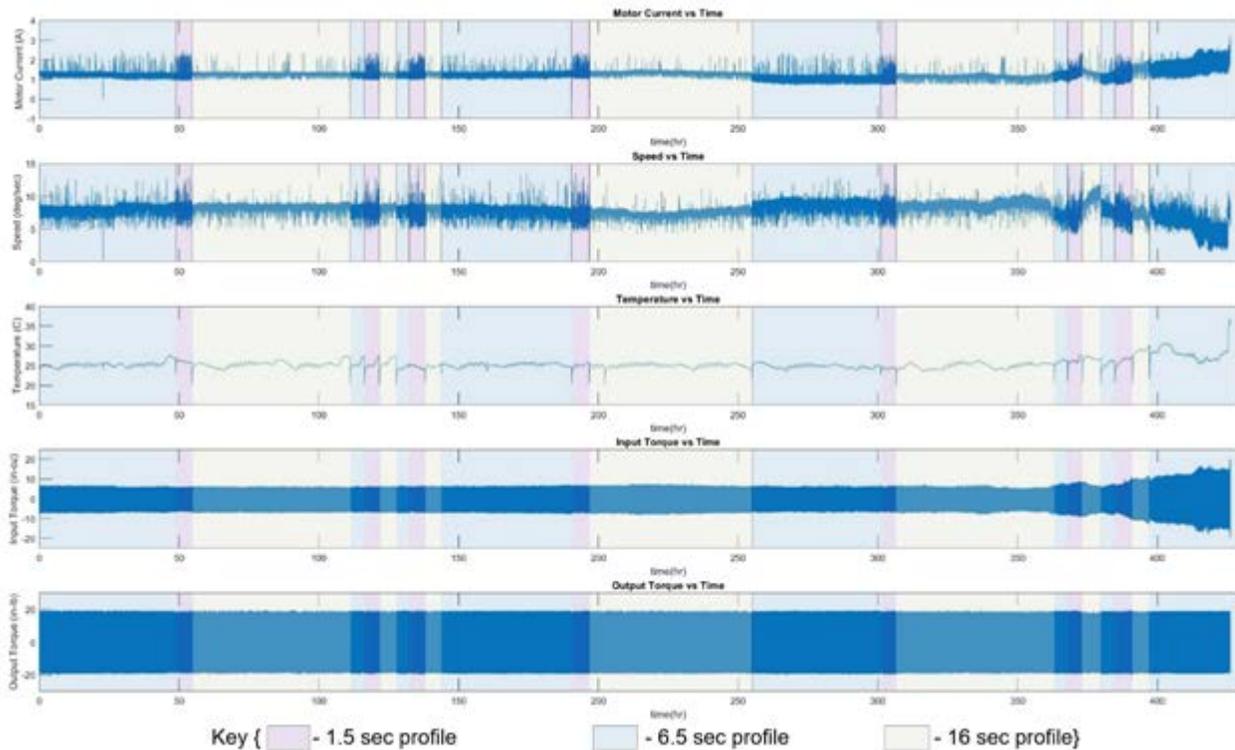
Figure 8. From Top to Bottom, Measured Motor Current, Speed, Housing Temperature, Input Torque and Output Torque from the Endurance Test, Through the Final 6.5 Second Dither Time Test Event

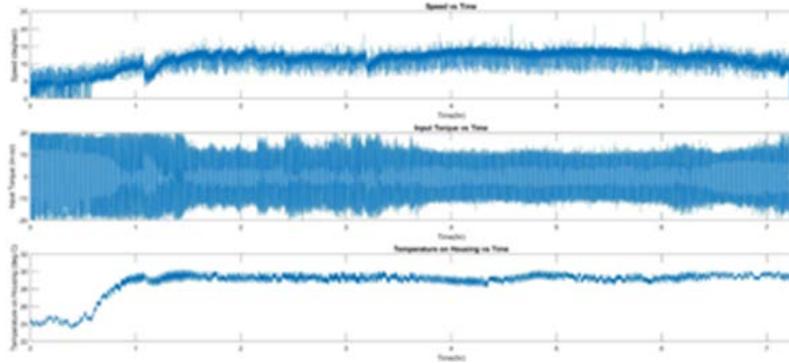
Then, the system turned a strange corner. The input torque dropped, about 40 minutes before which the titanium housing temperature climbed 5 degrees Celsius in about 20 minutes. The output speed experienced a major noise reduction at the onset of this temperature increase, and proceeded to exceed 10 deg/s, the highest value observed yet. A few blips followed, before the input torque necked down to 77.7 mNm (11 in-oz). See Figure 9. After seven hours, the rollercoaster ride ended, as the motor began to stall. See Figure 10 for the full test dataset. The time had definitely come for disassembly. Beforehand, the start-up torque and no-ratchet torque tests were conducted. The no-ratchet torque was successful again, and the start-up torque test pushed the acceptable limits, with a peak measured value of 24.7 mNm (3.5 in-oz).

Figure 9. From Top to Bottom, Speed, Input Torque, and Temperature up to Termination of the Final 16 Second Dither Time Test Event

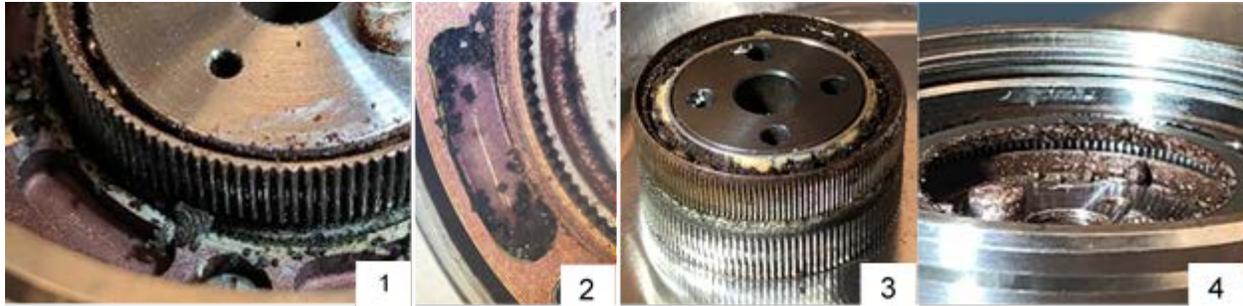
Removal of a single piece part revealed severely degraded lubricant in the Drive Output subassembly. The grease within the Wave Generator bearings looked like copper colored glitter, and felt like the glitter was mixed with dried glue. The material surrounding the tooth interface of the Flexspline and the Circular Splines was black in color and crumbly, with a texture similar to clay mixed with brown sugar. Refer to Figure 11, panels 1 and 2 show the blackened sample within the gear mesh, and panels 3 and 4 show the glittery Wave Generator bearing samples. Each sample was sent to the analytical chemistry lab for analysis, and the HD assembly was ultrasonically cleaned using Vertrel XF, then sent for Scanning Electron Microscope (SEM) imaging and Energy Dispersive X-Ray (EDX) analysis.

Figure 11. Panel 1: Drive Output Subassembly After Removal of Dynamic Spline, Showing Output Teeth of Flexspline, and Static Spline. Panel 2: Dark, Crumbly Material Gathered in the Static Spline Feature During Disassembly. Panel 3: Wave Generator Subassembly with Flexspline Installed. Panel 4: Opened Drive Output Subassembly Before Disturbance of HD Components

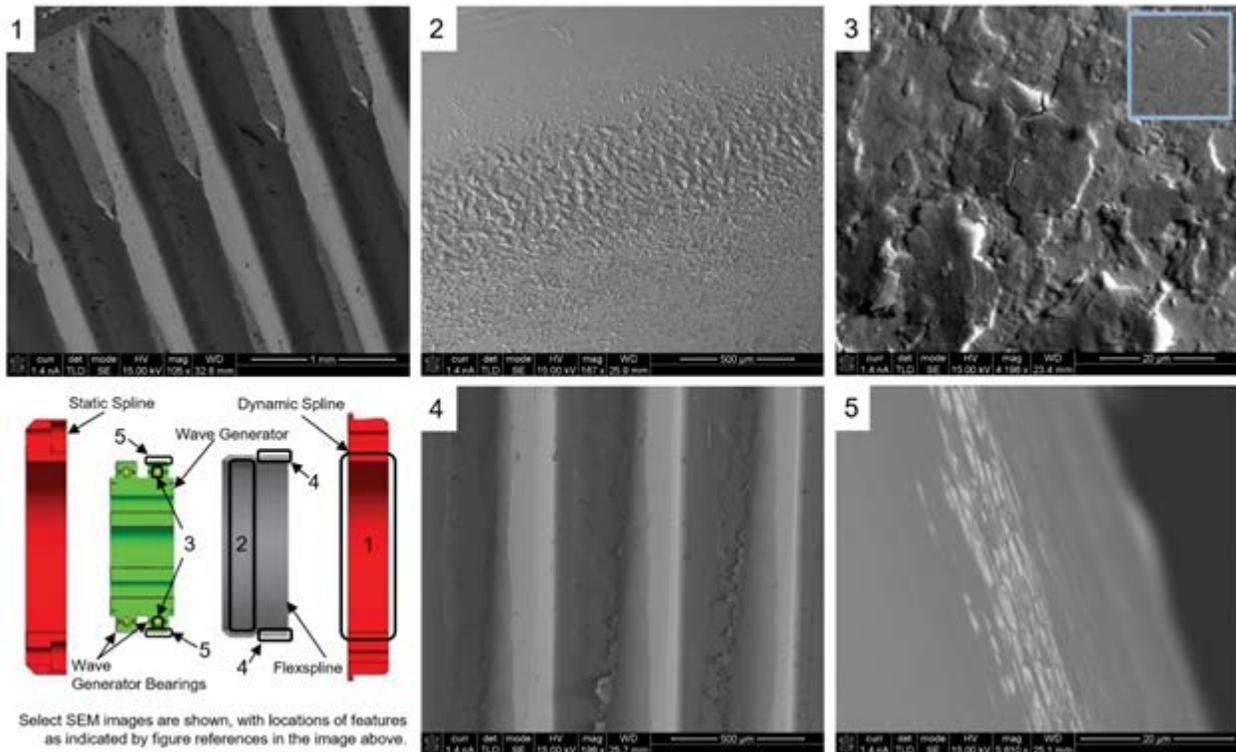
The HD showed wear on all teeth, biased with the worst damage on the dynamic spline tooth interface, and on most Wave Generator bearing surfaces. Damage on the teeth and bearing races was aligned with the line of action of the bearings. SEM revealed wear to the Flexspline teeth, shown in Panel 4 of Figure 12, which corresponded with Dynamic Circular Spline tooth wear, shown in Panel 1 of Figure 12. The Flexspline had been slipping on the wave generator bearing outer races, with polymerized grease product in between, and as a result, damage was seen on the inner diameter of the Flexspline (shown in Panel 2 of Figure 12) and the outer diameters of the bearing outer races (shown in Panel 5 of Figure 12). Flexspline material was removed at that interface, combined with the bearing grease product, and redeposited onto the Wave Generator bearing balls (see Panel 3 of Figure 12) and ball tracks.

Figure 12. Panel 1: Dynamic Spline tooth wear. Panel 2: Damaged Flexspline, input side inner diameter damage pattern reflects ball track load path. Panel 3: Flexspline material adhesion onto bearing ball (increased chromium & nickel seen as dark patches via EDX). Inset shows representative "normal" ball surface at similar scale. Panel 4: Flexspline output side tooth wear. Panel 5: Damaged bearing outer race- pattern reflects ball track load path.

Raman spectroscopy of the samples revealed the coppery hue to be due to iron oxide, and EDX SEM results showed increased concentrations of oxygen on the bearing races and ball surfaces. Both results indicated the presence of corrosion. X-Ray Fluorescence (XRF) detected the presence of iron, chromium, nickel, and copper in both grease samples. Iron, the Circular Spline material, and chromium and nickel, constituent materials of the Flexspline, corresponded with the worn teeth observed on both via the SEM inspection. The presence of copper was an unexpected discovery.

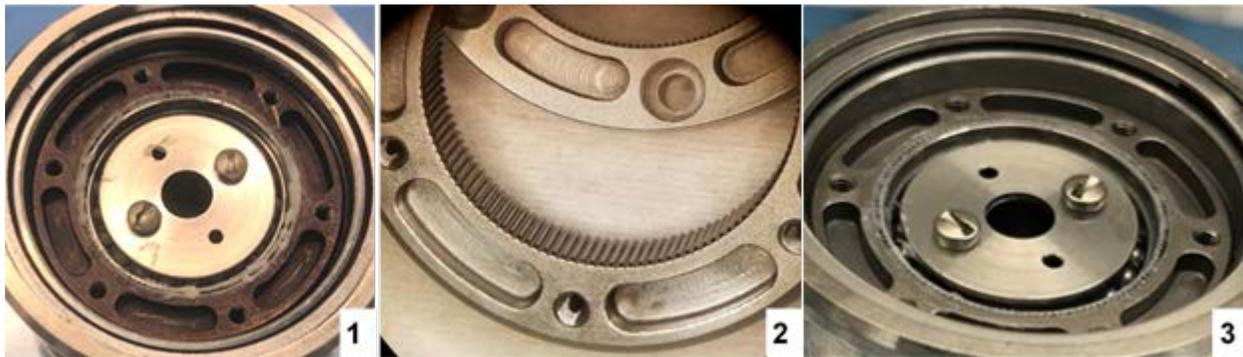
All the while, a simultaneous deeper inspection of the Circular Splines revealed that their black oxide coatings did not demonstrate the expected physical properties. Namely, it seemed unnaturally thick for a hot black oxide conversion coating, and instead could be scraped off with a dental pick, turning to powder in the process and revealing a bare surface. It appeared to be a room-temperature, or cold, black oxide application, which is a deposited layer of copper selenium as opposed to a conversion coating, which is not included in the MIL-C-13924 specification as an acceptable black oxide application process.

This understanding of the black oxide type provided the clue to the rogue copper discovered in the previous XRF grease analysis results. The cold temperature black oxide coating had been slowly scraped into the grease by the sliding tooth action during the Endurance Test, and, in addition to generating debris in the tooth mesh grease, it was certainly not performing as a corrosion inhibitor for the Circular Splines, as it was intended.

Figure 15. Panel 1: Harmonic Drive with Room Temperature Black Oxide on Circular Splines, Dynamic Spline Shown, Installed into Drive Output Subassembly, with Braycote 601EF at Tooth Interface. Panel 2: Clean Circular Splines with Black Oxide Removed. Panel 3: Clean Harmonic Drive Circular Spline, Dynamic Spline shown, Installed into Drive Output Subassembly, with Rheolube 2000 at Tooth Interface.

This meant the Circular Splines had to be abraded as well, to remove all of the undesirable black oxide coating. After this was completed, the units were re-cleaned with Heptane, re-grease plated, and slurry filled as before. This time, when the completely renovated HD was reassembled into the Drive Output subassembly, rotation was smooth, and lubricant was clean. See Figure 15 for Circular Spline images before, during, and after cleaning and re-assembly.
