Thermal Vacuum Testing Lessons Learned for Small Stepper Motors and a CubeSat Translation Mechanism

Alex Few*, Lynn Albritton* and Don McQueen*

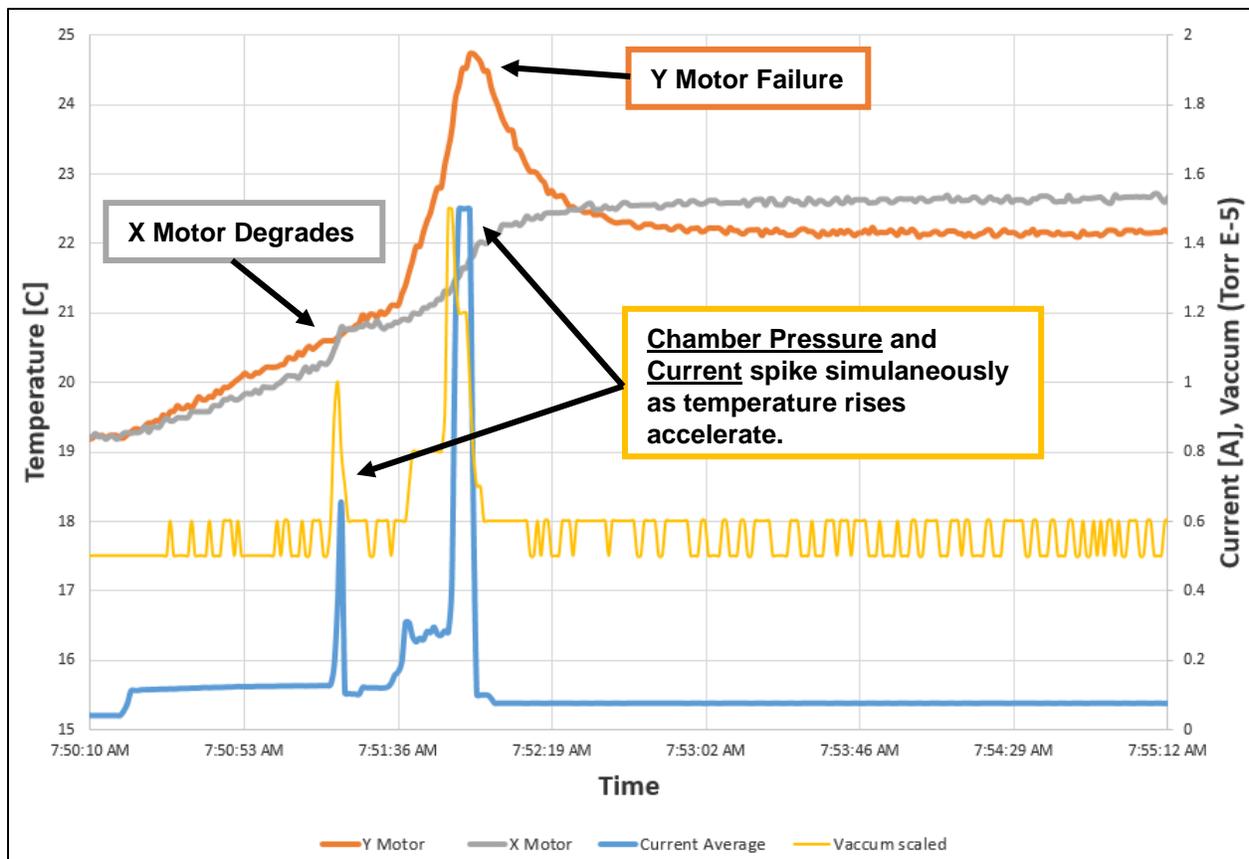
Following a functional test verifying the electrical, mechanical and test chamber set up, the TVAC chamber was controlled to 25°C, given time to dwell and depressurized to <math><1.0E-5</math> Torr. The AMT motors were powered to begin the first functional test at ambient temperature (25°C). About a minute later, the team noted temperature spikes from TCs mounted near the motor housings. After pausing the operation and reading the motor coil impedances, it was clear that the motors had begun the process of a cascading short failure. Given the previous TVAC tests for the EDU, the team had a natural inclination to suspect

overheating of the motor coils, but the root cause was unsure. Previously, it had been a poor thermal conductive path, which had been addressed for this mechanism. The next 13 weeks would revisit and uncover a few new contributors that were not discovered during the EDU tests.

Figure 3. NEA Scout AMT Ambient Failure Temperature, Current and Pressure Data

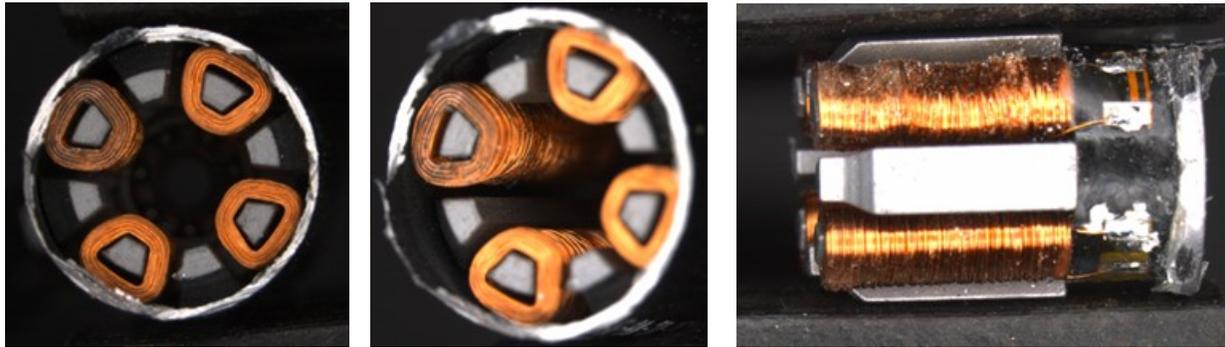
NASA MSFC has a team and facility devoted to failure investigation and these resources were vital to the stepper motor destructive evaluation process. Figure 4 shows some of the sample images of the failed stepper motor. These motors, which are about 6 mm in diameter, showed clear signs of overheating at first glance. The discolored (reference the coil at 10 o'clock in the right image of Figure 4) and deformed (same coil shown in the right image at the top) exhibited tell-tale signs of the coils overheating. The overheating was a two-fold failure. First, the lacquer break down emitted material causing the noticeable pressure spikes. Second, the rapid temperature rise causes the copper wire to lengthen, creating the wavy, deformed coil.

Electrical testing would also show that the deformed coil was indeed the coil that failed, rendering the motor useless. The motor vendor, which was gracious to participate in these efforts, agreed to these conclusions.

Figure 4. Motor Coil Images post Destructive investigation. Note waviness to coil in 3rd image, top coil

Though the symptom of the failure was obviously coil overtemp, the investigation team was unsure why these motors would fail at 25°C in a minute when motors of identical design were used on the EDU and lasted for up to an hour at 60°C without issue. Unfortunately, due to scheduling constraints, the program required the rebuild the AMT before the fundamental cause could be determined. The team chose to protect the motors from future failure by creating a “duty cycle” for the motors at 25°C and above. This duty cycle would be determined by the rebuilt hardware in the TVAC facility at vacuum. A sequence of increasingly long run times followed by coil impedance measurements would determine when the coils would reach a maximum allowable temperature. The impedance would then be monitored until it returned to a near-ambient temperature, allowing for the motor to be cycled again. Each motor coil was monitored, and the performance ranges between coils and motors were larger than expected. The first lot of duty cycle discovery gave a maximum of 40 seconds on, 25 seconds off. This duty cycle would keep the motors from reaching a “red line” test limit of 110°C maximum coil temperature. The team chose to use the duty cycle operation at the 25°C and 45°C functional tests.

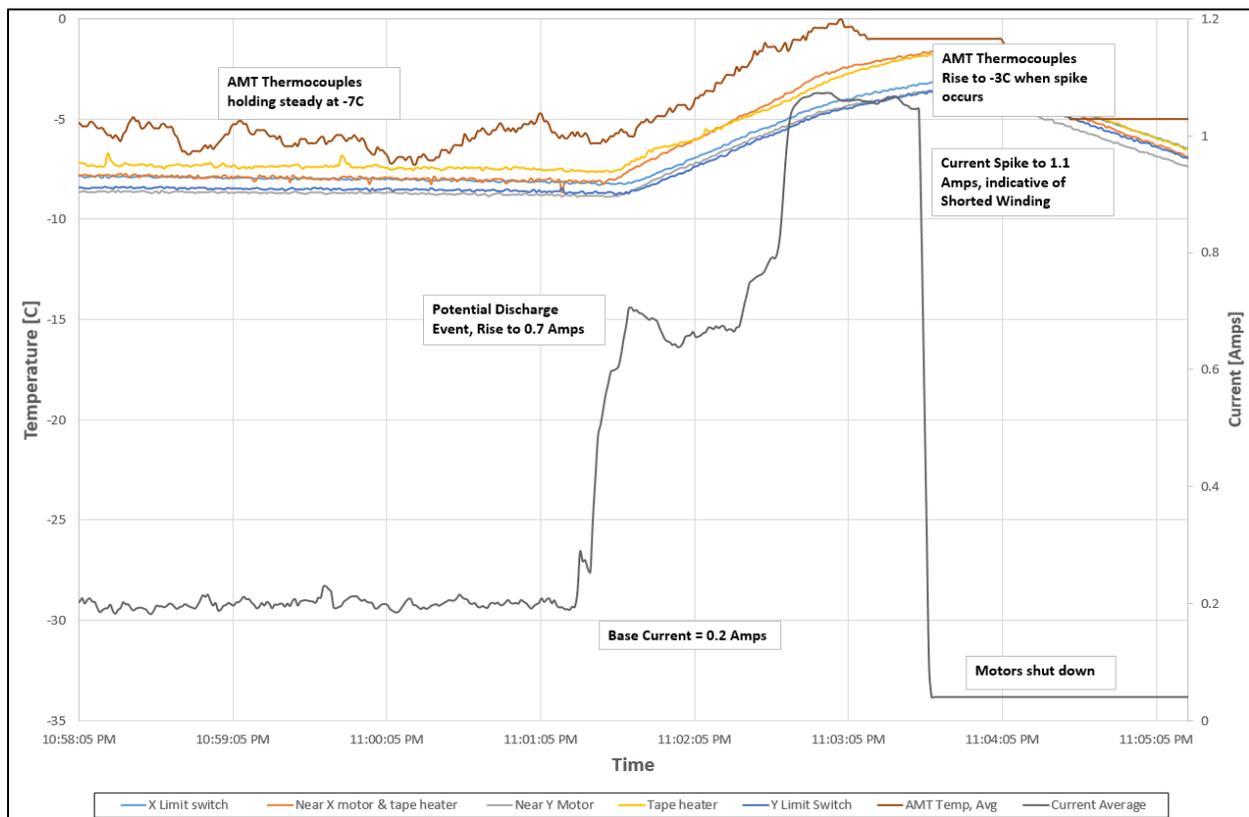
Since the first failure, the test plan was updated to use a data logging power supply to monitor current and voltage levels across the motor driver circuits. Analyzing these log files, the team found some peculiar current behavior which resembled a motor failure on the Tethered Satellite mission. (The motor on the TSS mission was determined to have failed due to a phenomenon called Paschen Discharge.) This current behavior is shown in Figure 5. Since the failure occurred at such a low temperature, the team—believing the causes of failure may have been different than before—spent weeks investigating Paschen Discharge. This effort was never fully realized due to schedule constraints, but the team could never rule out the possibility completely. The concluded hypothesis was that the heated coils offgassed small amounts of lacquer which filled the small cavity inside the motor. The motor vent paths, sealed by kapton tape and/or indium, disallowed any free molecules to escape and possibly raised the pressure into the critical 10^{-4} to 10^{-3} Torr range. This pressure, coupled with the local magnetic field may have provided a “sweet spot” for the discharge to occur across particular lengths of winding. This hypothetical event could have caused the current to rise to 0.7 amp, hold for a moment, and once winding temperatures exceeded a failure temperature, create a short.

Figure 5. Potential current rise and pause could be Paschen Discharge

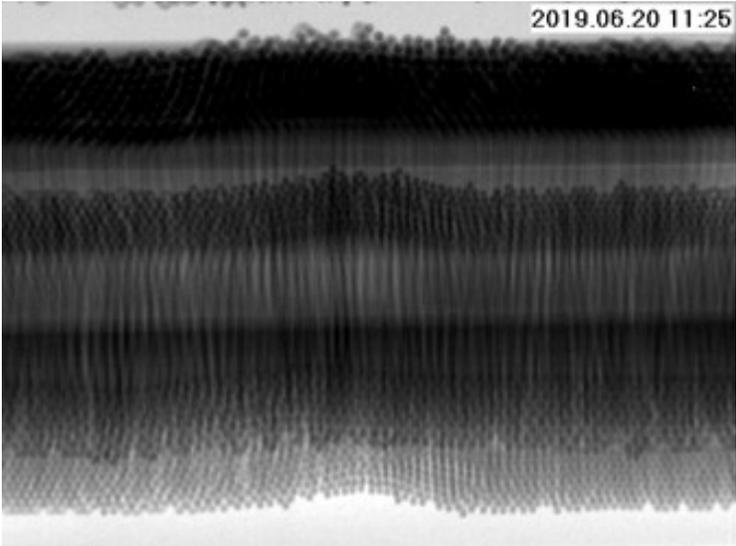
The failed motors from the second TVAC test were also taken to the MSFC failure analysis team. This second investigation yielded some helpful data in regards to the manufacturing variations in the motors, coils, magnet wire and potting. The motors underwent a typical round of X-ray imaging, which plainly showed deformed coils, as shown in Figure 6. The destructive evaluation showed a few new irregularities. One of which showed that the ball bearings inside the motor were single shielded and were installed with no regard to the shield direction. The next irregularity was with the laquer. A special instrument allowing metals and polymers to be clearly distinguished under microscope showed that the laquer was producing

Figure 6. Deformed Stepper Motor Coil under X-ray

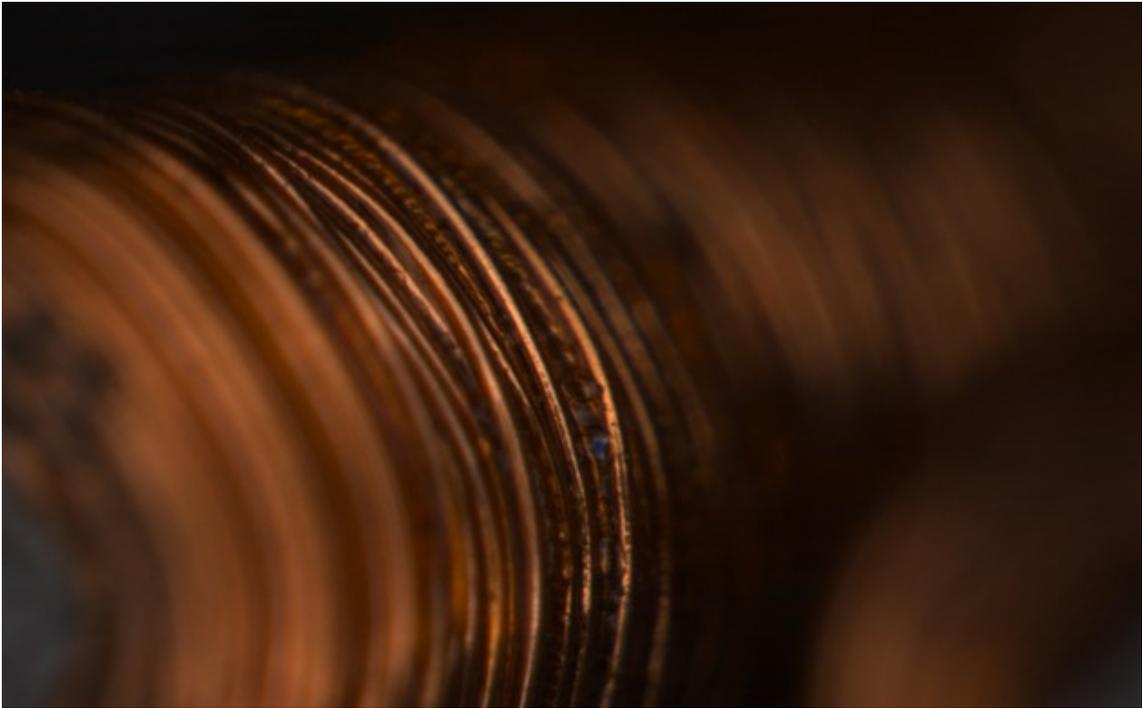
very large bubbles/voids in random areas. Figure 7 shows an image of a few bubbles or voids formed in the lacquer, either due to testing or remnant of manufacturing processes. This image, amongst others collected, also gave insight that the coil/stator design was not suitable for sustained use in vacuum. The most prominent detail noticed at this investigation was with the potting and mounting of the coils to the stator. The team assumed the coils were potted to the stator, but a coil was accidentally damaged and became detached from the stator. Upon further analysis, it became clear that each coil was potted to the stator in a single location, with a single dab of adhesive which was not especially thermally conductive. An example of this potting location is shown in Figure 8.

Figure 7. Coils under high magnification showing some evidence of voids in insulation

The potting underdesign and presence of voids in wire insulation were clear signs that these motors were not well suited for a vacuum environment operation. The conductive paths from the windings to the motor casing were undersized, and the magnet wire had thin insulation. These findings paired with the manufacturing variance of the potting and insulation thickness made it clear that the motors would have to complete a more enhanced thermal acceptance testing to choose the more robust motors from a particular lot. Only after completing these tests could the motors be integrated into the flight hardware for an AMT subsystem TVAC test. The details of the acceptance and burn-in testing will be covered in the next section.

1. Motors intended for vacuum use should use coilwire with thicker vacuum compatible insulation. Some vendors will twice or thrice dip their products for vacuum application.

2. Magnet wire defects such as thin insulation and voids/bubbles can be susceptible to first time-wide temperature swings (such as a first time run in vacuum).

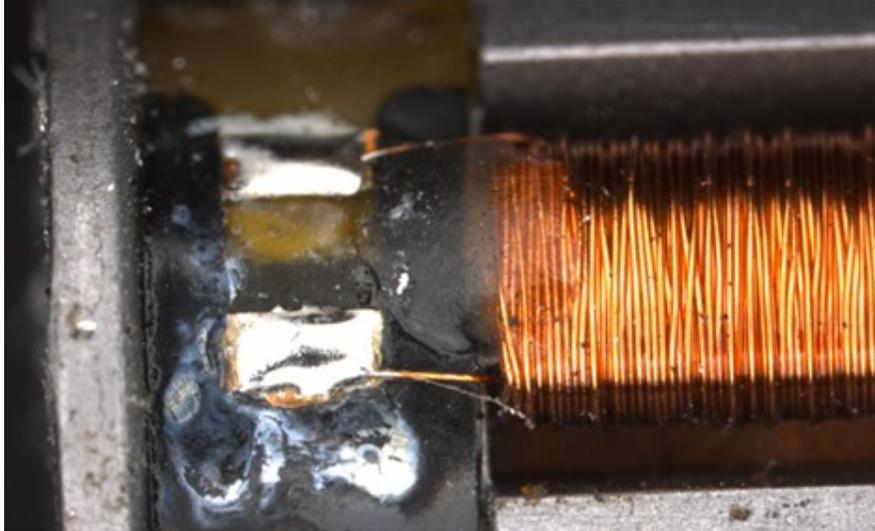
Figure 8. Potting location for coil to stator

3. Motor coils should be potted on all available surfaces to maximize thermal conduction. These motors, though advertised as vacuum rated, were contacting the stator in a single, potted location. This potting was analyzed and had little to no thermal conductive properties. The team's thermal analyst would have assumed these coils to be relying on radiative cooling alone.
