Remote Diagnosis and Operational Response to an In-Flight Failure of the Drill Feed Mechanism Onboard the Mars Science Laboratory Rover

Ryan Kinnett*, Thomas Green*, Douglas Klein* and Megan Richardson Lin*

Abstract

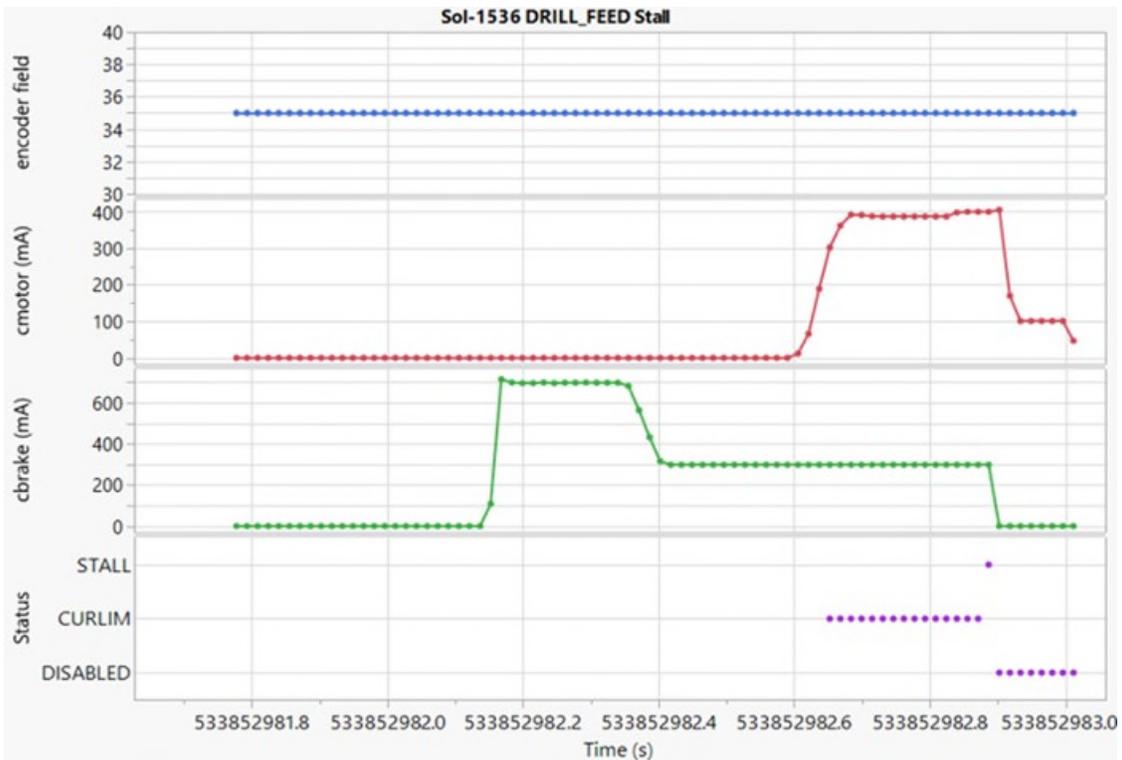
Within the Sol 1536 high-rate motor telemetry, downlink engineers observed that the feed motor encoder indicated no change whatsoever in the motor shaft position. The closed-loop rate controller ramped up current through the motor in an effort to recover nominal rate, but quickly reached the motor's current limit without any indication of motor shaft motion from the encoder, thus triggering the stall declaration.

Figure 4. Sol 1536 drill feed stall motor telemetry. From top to bottom: encoder field number (between 0 and 144 DN); sensed motor current, brake current; control state. Brake current tracked the standard profile which started with a 0.2-second “pull-in” period then reduced to 300 mA during motor commutation. The closed-loop rate controller began commutating at time 533852982.6. Sensing no change in motor shaft position, the controller ramped up motor current, reached current limit, and declared stall.

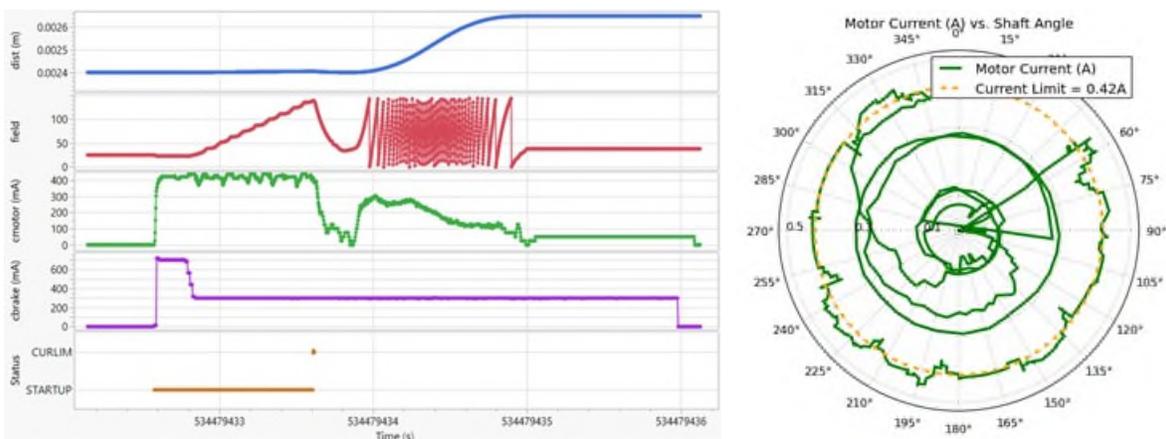
The Sol 1543 diagnostic sequence then enabled both the primary and redundant brakes simultaneously, effectively doubling the force used to disengage the brake. The anomaly response team was pleasantly surprised to find that this worked. After reading a home pulse on the encoder, the motor controller exited the blind commutation mode (denoted as STARTUP status in Figure 5), and the feed motor appeared to operate nominally with no obvious signs of physical resistance or other anomalous behavior.

Figure 5. Sol 1543 drill feed diagnostic motion with primary and redundant brake solenoids energized. Brake current (per-coil “cbrake”, violet) tracked the standard 2-step profile. Motor control started in blind commutation (“STARTUP”) mode, then transitioned to normal closed-loop rate control just before time 534479434. Motor current (“cmotor”, green) appeared normal. Right: motor current vs shaft angle.

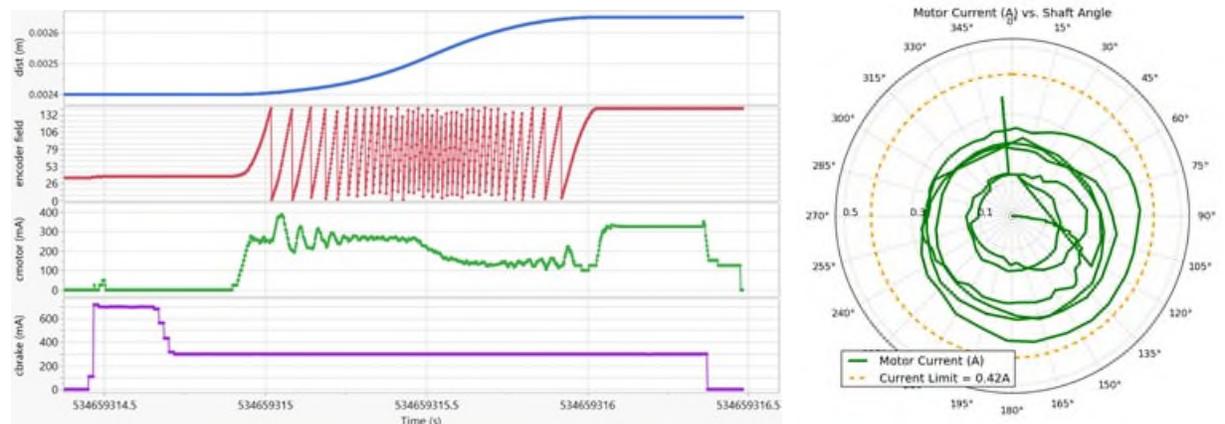
A sample processing activity on Sol 1545 utilized CHIMRA vibration and was followed by the drill feed diagnostic sequence containing commands to drive the feed a short distance forward and then back. In this experiment, the feed motor stalled after nearly reaching its goal. Telemetry inspection revealed a new signature and new insight into the behavior inside the feed actuator. Distinct, repeating current spikes were observed with frequency equal to the rotation rate of the motor (one spike per motor revolution).

Figure 6. Sol 1545 drill feed diagnostic motion following turret vibration from a sample processing operation. Left: Oscillations in motor current (“cmotor”, green) correlate to encoder-indicated motor shaft angle (red), indicating presence of a clocking-dependent disturbance. Right: motor current plotted versus motor shaft angle indicating asymmetric torque disturbance.

Motor current reflects the closed-loop rate controller’s reaction to sensed torque disturbances. Plotting motor current vs shaft angle (as shown in Figure 6) provides a rough indication of mechanical resistance within the motor assembly, correlating to shaft position. Nominally, motor current should not significantly vary with motor shaft position during steady state control, in which case the motor current polar plot should appear roughly axially symmetric, as exemplified on Sol 1543 in Figure 5. Asymmetric skew depicted in Figure 6 indicates higher mechanical resistance within a limited fraction of the motor shaft’s range of motion. This method of polar plotting motor current vs shaft angle proved invaluable throughout this investigation for tracking the evolution of an apparent “high friction zone”.

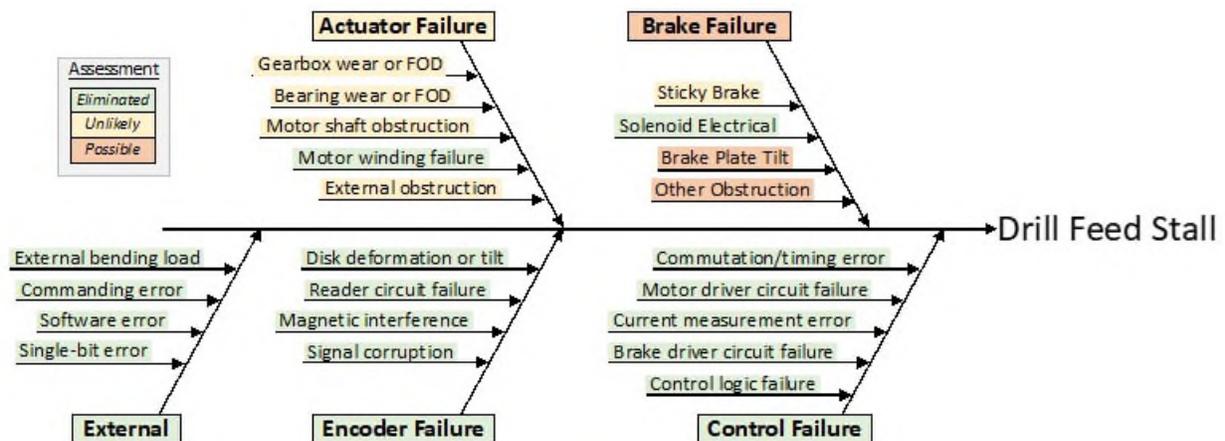
The anomaly response team divided and managed tasks to maintain steady progress toward understanding the nature of the persistent drill feed stall anomaly through flight diagnostic activities while also pursuing other lines of investigation. The team generated a fishbone failure diagram to organize hypotheses and evidence for and against each, shown in Figure 7.

Figure 7. High-level anomaly fishbone failure diagram based on initial flight diagnostics

Telemetry and other observables from the rover were used to rule out whole branches of the fishbone. Once flight diagnostic activities regained motion of the actuator, the team quickly narrowed in on the brake being the most likely branch that caused the anomaly due to the telemetry collected. One key observation ruled out a significant number of potential root causes. Specifically, the impediment to the feed actuating was observed as a “high friction zone” that occurred at a consistent clocking angle with respect to the motor output, and was roughly one third of a motor revolution wide. This meant that obstructions within the gearbox, bearings, or external to the actuator, were highly unlikely. In addition, all other actuator telemetry from the encoder, PRTs, and motor controllers appeared to be otherwise nominal. This telemetry ruled out root cause options related to avionics and control software. Additionally, it was discovered that applying higher brake disengagement force by energizing both brake solenoids simultaneously reduced the magnitude of the drag on the motor through this zone. Repeatedly “clapping” the brake open several dozen times in between motor rotations could achieve a similar effect.

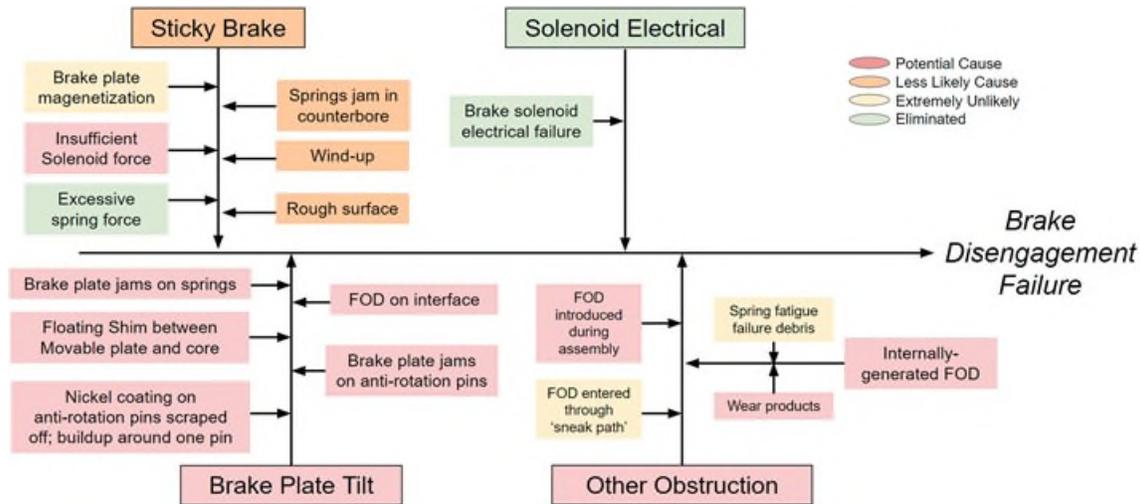
Figure 8. Detailed fishbone failure diagram focusing on potential brake-related problems

The anomaly response team was unable to rule out root causes related to the brake plate failing to disengage creating a high friction zone when the motor turned. Mechanically, this could be explained by the ferrous brake disk not being able to fully retract with a foreign object or piece of debris (FOD) or other obstacle preventing it. This would lead to the ferrous brake disk being tilted with respect to the brake rotor, which is also not perfectly perpendicular to the rotor axis due to assembly tolerances, resulting in a once per motor revolution interference. However, some signatures in the telemetry were not explained by this model. For example, the friction zone appeared to be more difficult to pass through moving in one direction than the other, and would increase in magnitude over time as it was driven through repeatedly, but could be reset by clapping the brake several times. A reduced fishbone diagram focusing on the Brake Failure branch is shown in Figure 8.

At the conclusion of this investigation, the leading theory was that the feed actuator brake was only partially disengaging in a tilted state. This was supported by all telemetry from initial diagnostics conducted on the rover. The sub-branches of the anomaly fishbone detailed in Figure 8 show the family of root causes that could lead to a disengagement failure. The most likely causes were either related to parts within the motor shifting within their tolerances (Brake Plate Tilt), or debris building up behind the brake plate (Other Obstruction), or potentially a combination of these causes. The next sections of this paper summarize investigations that were done in parallel with the flight diagnostics in an attempt to narrow down the root cause further.

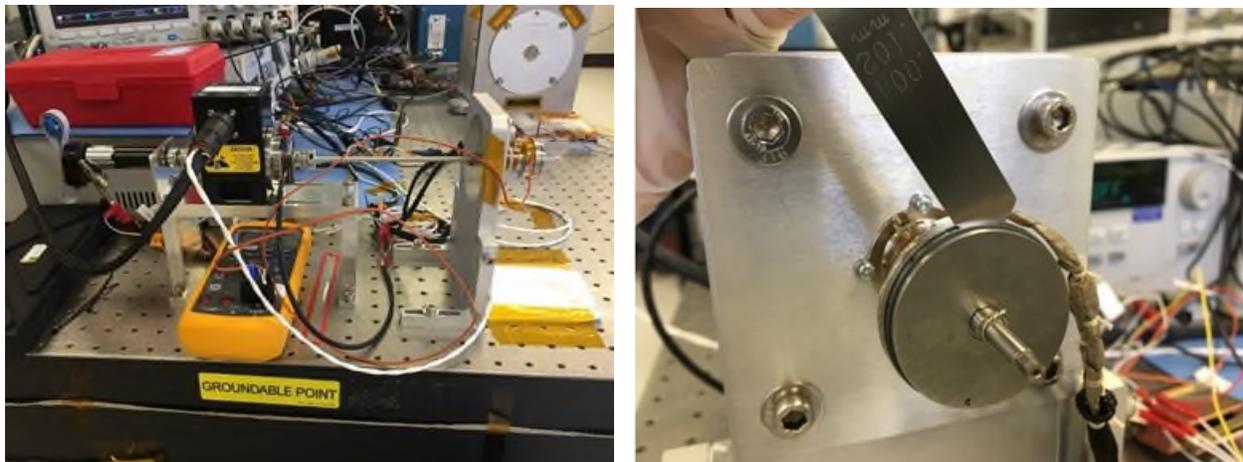
In parallel with the on-going flight diagnostics, additional ground testing was executed to support the anomaly investigation. The objective was to re-create the anomalous behavior using an engineering model actuator to aid in determining potential mitigation steps beyond what had already been discovered. The tests were successful in recreating a once per motor revolution friction zone with approximately the correct torque by using stainless steel shims with different thicknesses, widths, and positions. This confirmed the viability of the brake tilt hypothesis as the probable root cause. It also demonstrated that either “clapping” (repetitively cycling) the brakes open and closed or increasing the brake solenoid current could reduce the drag even with an incompressible steel shim. Lastly, it was discovered that clapping the brake was producing axial displacement of the motor shaft within its slop which potentially explained why the benefit was only temporary.

Figure 9. Test setup for benchtop motor investigation (left) with shim manually inserted behind ferrous brake disk to recreate anomaly conditions (right)

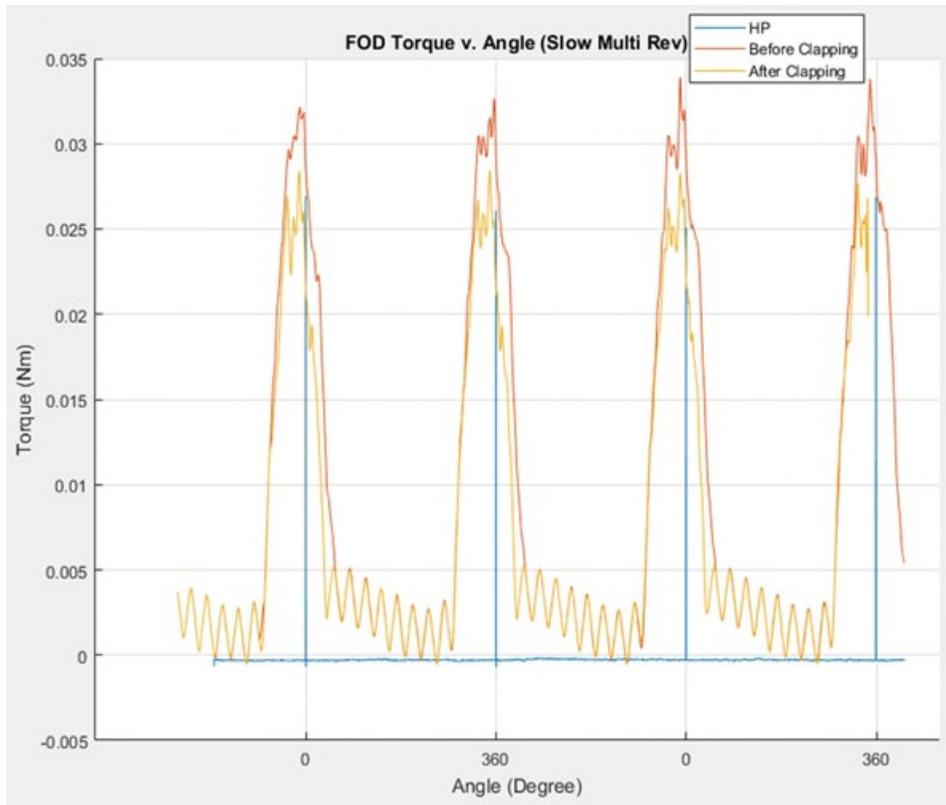
Figure 10. Benchtop motor test sample results. Inserting a shim behind the brake disk to prevent full disengagement yielded a 0.025 N-m torque disturbance spanning approximately one third of a motor revolution, roughly matching flight observations. Furthermore, “clapping” the brake reduced the torque disturbance (yellow).

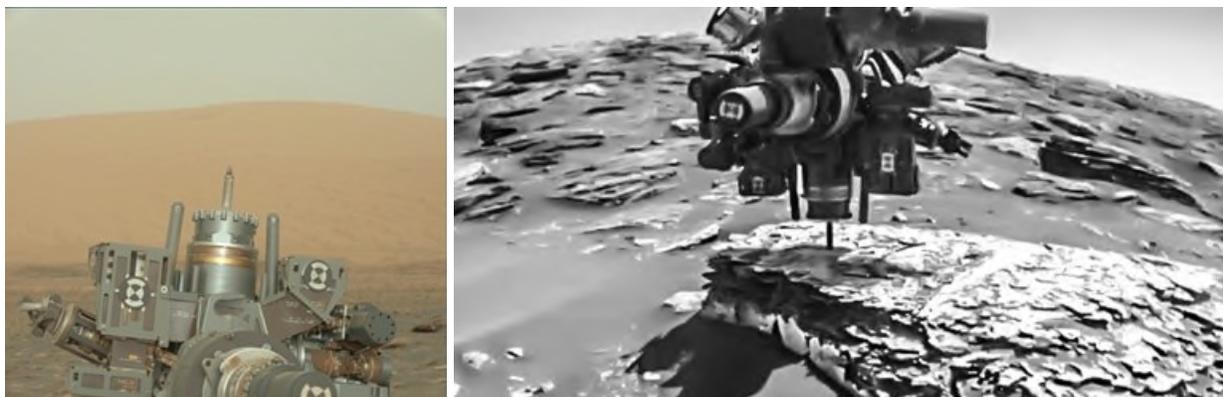
Figure 11. Left: Sol 1780 MastCam verification of the drill feed in its extended position, placing the drill bit beyond the drill stabilizers and preserving the possibility of later development of feed-extended drilling. Right: Sol 2057 drill bit placement at start of first feed-extended drilling operation. (Image Credit: NASA/JPL-Caltech/MSSS)

The process to extend the feed was carefully planned and executed. Long duration and repeated use of the feed motor had been shown to worsen the overall anomaly state. To reduce risk of irreversible binding, motions were conducted using an open-loop commutation mode with moderate brake and motor current limits to ensure that any worsening state of the actuator could be recovered using previously developed mitigation strategies. A thermal watchdog strategy was developed to avoid excessive self-heating due to non-standard, elevated, brake and motor currents that could result in motor heating not easily detectable by conventional thermal fault protection. Brake cycling was inserted after each attempt at extending the feed to reduce the magnitude of the friction zone. The full activity required 4 sols of motion to reach an extension of 58mm, about half way. At that point, Mars and Earth entered solar conjunction, halting communication with the vehicle for several weeks. During this period, the mechanism was placed in what the team believed to be the most beneficial gravity vector with the drill bit pointing up. Following conjunction, the remainder of the activity was performed in a single sol and was successful in moving the feed to its fully extended position of 110 mm. Figure 11 shows the drill bit location at its fully extended position. Without reliable use of the feed mechanism, the team needed to develop a new technique to preload directly on the drill bit and use the robotic arm's 5 degree of freedom capability to safely drill, retract, and deliver samples.
