Failure Analysis of International Space Station Control Moment Gyro

Richard R. Burt* and Richard W. Loffi**

ABSTRACT—The US Attitude Control system of the International Space Station (ISS) includes four Control Moment Gyros (CMGs) that provide a micro-gravity environment for science payloads. On June 8th 2002 a CMG suffered a hard failure after approximately 1.5 yrs in operation. This paper presents an overview of the design, heritage, on-orbit failure, and corresponding root cause analysis of an ISS CMG. A discussion of telemetry data analysis conducted and methods to produce significant results are presented. A description of the suspected modes of failure and corresponding analysis are also given.

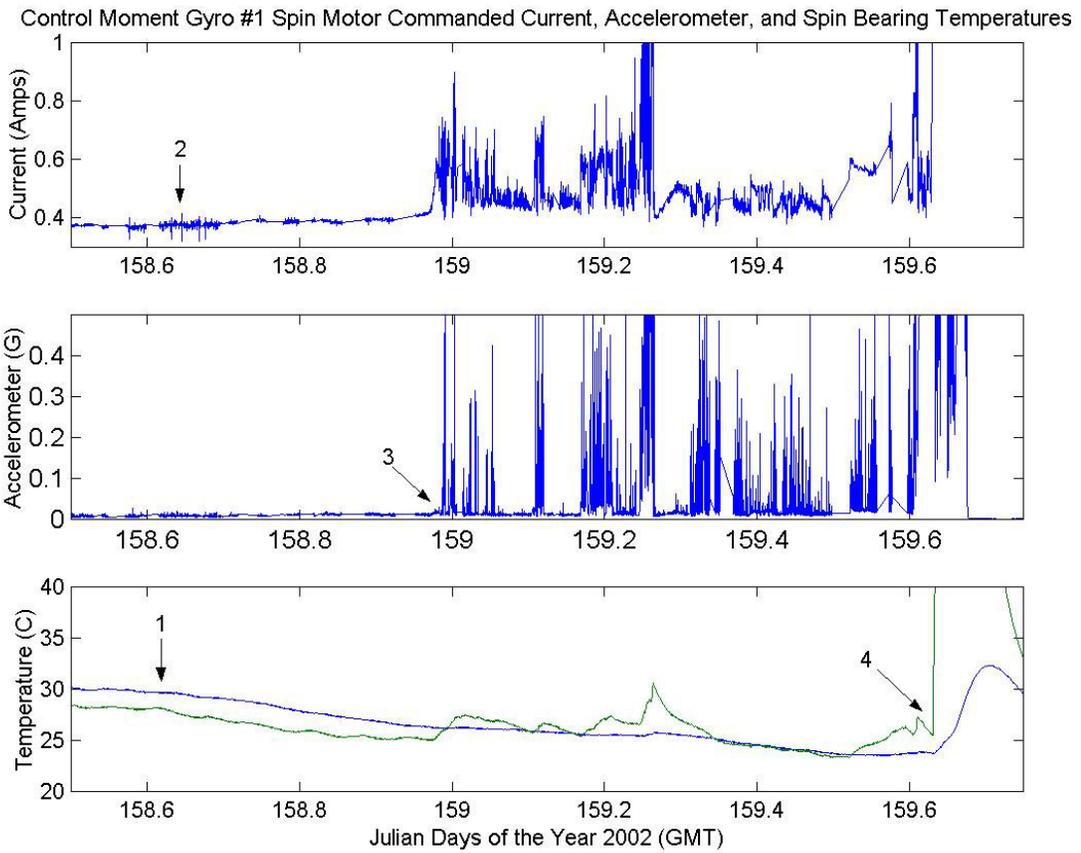
Figure 3: ISS CMG1 Failure Telemetry Data

At the end of May 2002, the ISS was in a high solar beta inertial attitude period where the CMGs experience warmer operations due to more sun exposure. The ISS attitude was transitioned from inertial to Local Vertical Local Horizontal (high solar shade) on June 7th[1], several hours prior to shuttle docking [2]. Several hours after docking, the flight control team noted a flag that indicated the accelerometer on CMG1 had measured 0.5 Gs [3]. The CMG1 SMCC was elevated and one spin bearing temperature was beginning to rise. GN&C personnel determined that the CMG would be monitored but no immediate action would be taken. The event repeated itself twice during the next 16 hours. Then, following a 30-minute period with no ground communication, telemetry showed that the CMG1 SMCC was at its maximum value, 1.6 Amps, and the wheel-speed was decreasing [4]. After several seconds of maximum current and wheel-speed reduction, Fault Detection and Isolation software declared the CMG failed and automatically shutdown the spin motor. Following motor shutdown, normal SB drag would result in the wheel speed decaying to 0 rpm in about 12 hours. During this event, the wheel stopped 72 minutes after spin motor shutdown. Data was retrieved from the on-board data recorders to fill in the missing telemetry for analysis purposes. Astronauts aboard the station and orbiter reported hearing a sound similar to an unbalanced washing machine while vibrations could be seen in accelerometers throughout the 300 tons of mated vehicles. Telemetry data from the failure period is shown in Figure 3 with events described previously annotated.

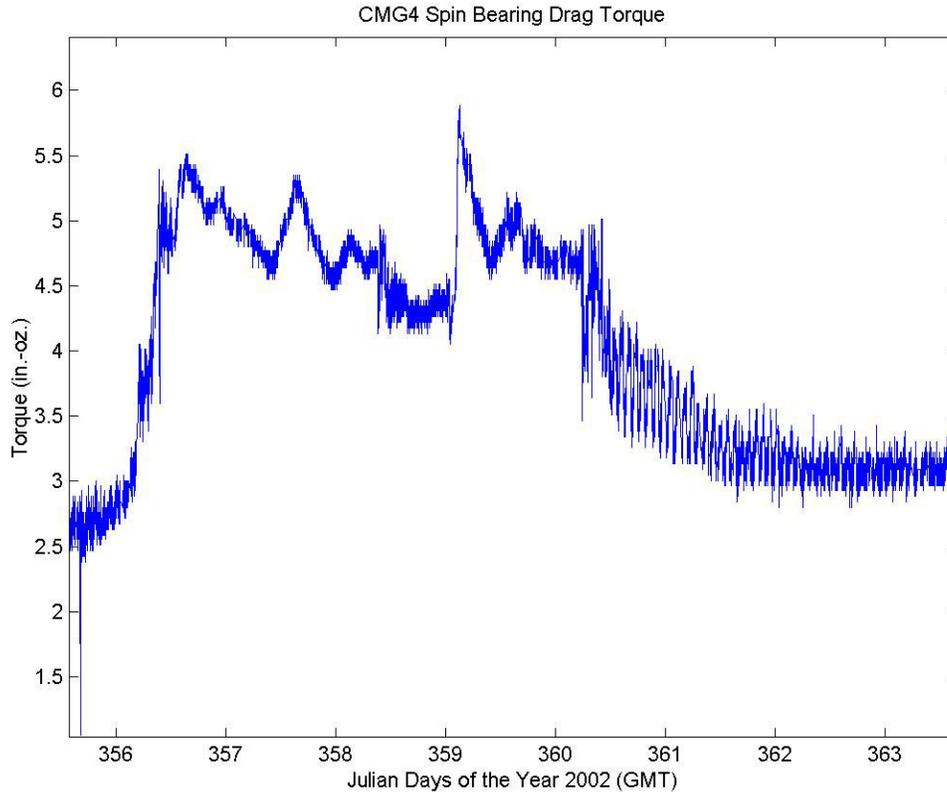
Figure 4: CMG4 Wet Retainer Instability Event

step change in drag torque with a slow first order decay as illustrated below in Figure 4 which shows a period of wet instability experienced by CMG4.

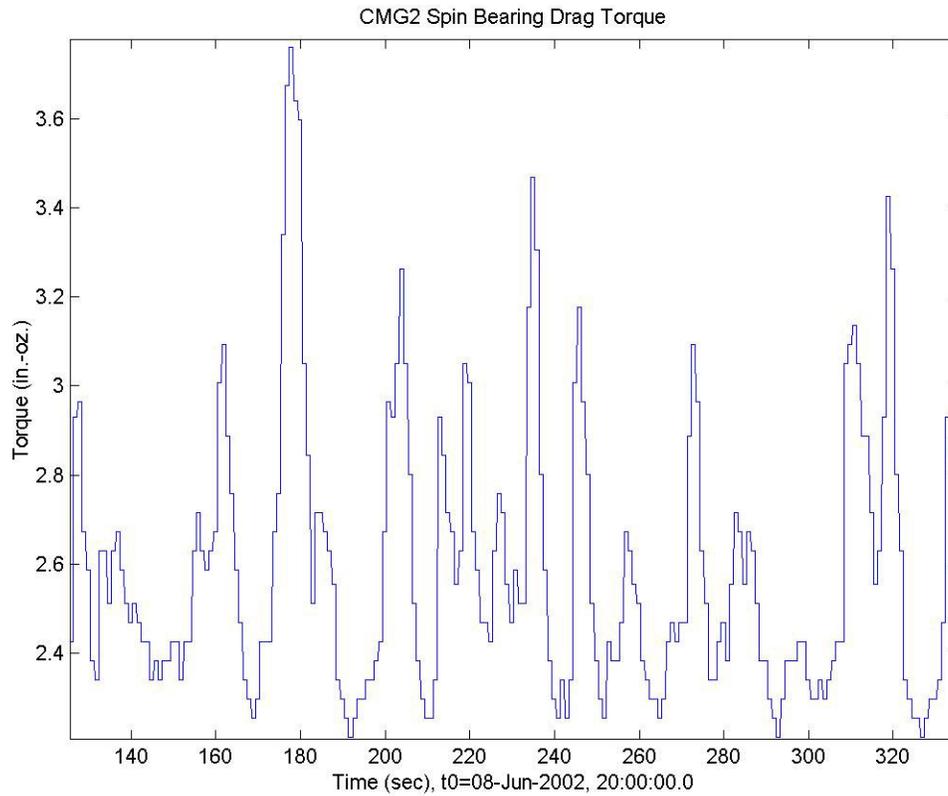
Figure 4: CMG2 Possible Ball Skid Event

rotation as their single row configuration does not allow beat frequencies to exist between the pair. Anomalies have been seen on ISS CMGs which corresponds to the amplitude and frequency described above. Figure 4 shows a period of CMG2 SMCC in which ball skid is believed to be occurring.⁴ Figure 5 shows CMG1 SMCC during the period of anomalous data prior to the hard failure, the similar signature is seen.

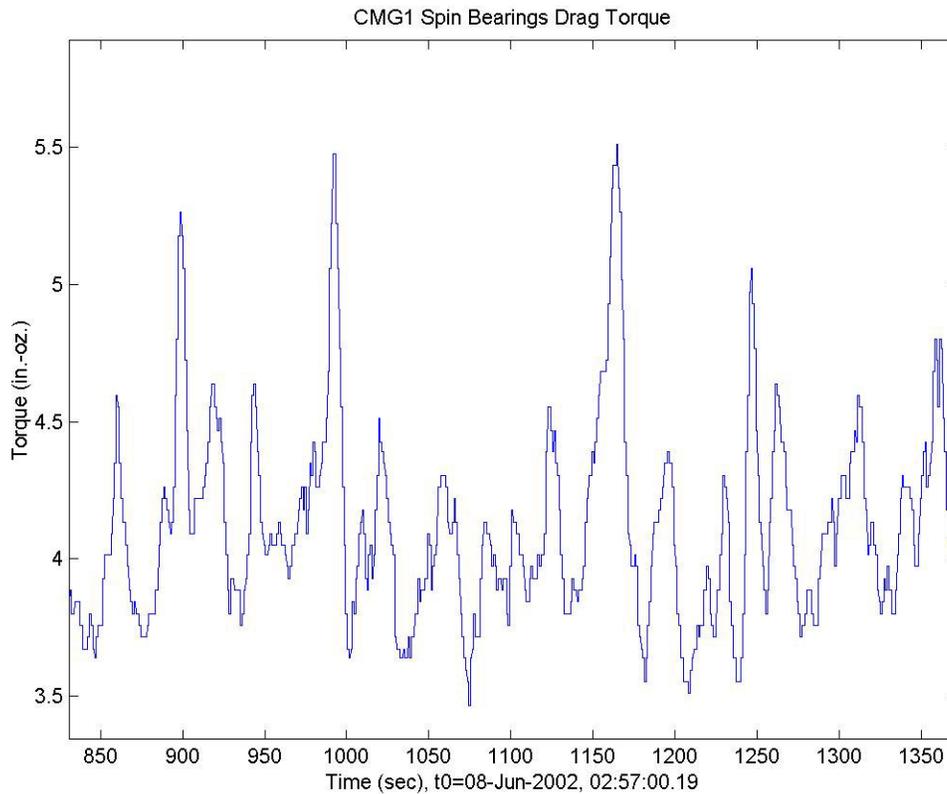
Figure 5: CMG1 Possible Ball Skid Event During Failure

From the bearing under nominal loading conditions with 55 lbs thrust loading due to the pre-load, the nominal load torque is 0.85 in-oz or 0.0566 in-oz per ball. For a single ball with one pound of skidding load, the load torque would be $(.38/.0566)*1$ -lbs. or approximately 6.7 times as much torque as a ball acting normally with regards to the raceway motion. Each pound of skid load per ball corresponds with a 0.381 in.-oz increase in drag torque. Total drag torque (lube + load) for a ball skidding with between one pound of skid load and the nominal load would be 1.83 in-oz (0.329 Amps) and 5.64 in-oz (0.547 Amps) depending on the number of balls skidding. For a bearing pair with a ball skidding as above in one of the bearings, the total drag torque would be between 3.37 in-oz (0.416 Amps) and 7.15 in-oz (0.633 Amps).
