MSG SCAN DRIVE UNIT – FM5 LESSONS LEARNT

The Scan Drive Unit (SDU) is a linear actuator developed as a subassembly of the SEVIRI (Spinning Enhanced Visible and Infrared Imager) for Meteosat second generation program.

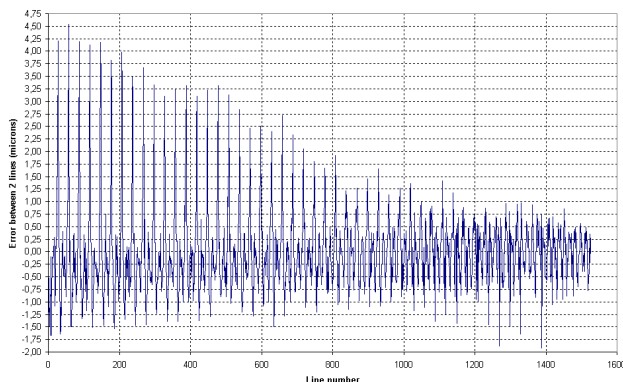
FIGURE 4 : SDU FM5 OPTO-MECHANICAL ABNORMAL PERFORMANCES

The opto-mechanical line to line error signature, Figure 4, has been subjected to a rewarding **NRB** and to a formal complete Root Cause Analysis applying the **ADEQUA process**.

The investigations pointed to a malfunction within the **SDU translation parts** and more precisely to a potential problem at **roller screw device level**.

Review of the acceptance data packages of the 5 roller screws procured and evaluation of the additional tests performed at subcontractor facilities with the SDU QM roller screw resulted into the conclusion that the **EM roller screw signature was singular**, when compared to the other units.

Mechanical analysis has highlighted the observed abnormal phenomenon as **an internal movement within the roller screw device**. In consequence of this finding, it has been agreed to authorize the FM5 dismounting process in order to confirm the root cause assumptions.

During the SDU FM5 dismounting, tests are foreseen to discriminate or incriminate the possible defective elements.
