# DELAYED RELEASES ON ORBIT – ONE SOLVED, ONE NOT SOLVED

Edward A. Boesiger<sup>(1)</sup>, Donald Gibbons<sup>(1)</sup>

## 1.0 ABSTRACT

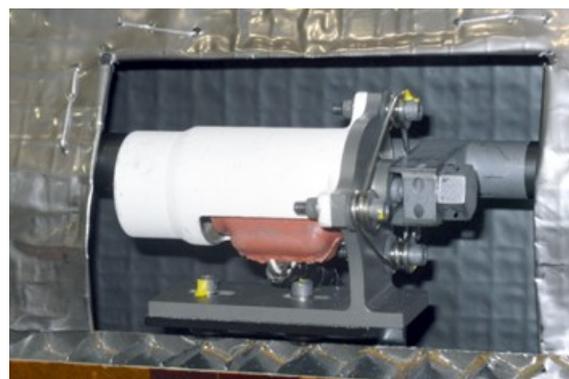
Figure 4. Trim Tab Release Mechanism

The Trim Tab release assembly is shown in Fig. 4, where the sail deploys “into” the page. The notched bolt of the Frangibolt® breaks, allowing the bracket that is attached to the sail crossbeam to slide off and deploy. The kickoff spring initially aids that motion.

In studying the high speed video of the Trim Tab tests, it was noticed that the initial motion of the outboard sail is actually “up” and “right” as well as “into” the page as looking at Fig. 4. This is due to the strut hinges being preloaded slightly in the “down” direction and the Frangibolt® fastener providing energy from fracturing in the “right” direction. The strut hinges when stowed are compliant and provide little resistance to this motion. With that motion, the bracket could conceivably strike one of the fasteners holding the kickoff spring (for instance, the ‘top’ one of Fig. 5).

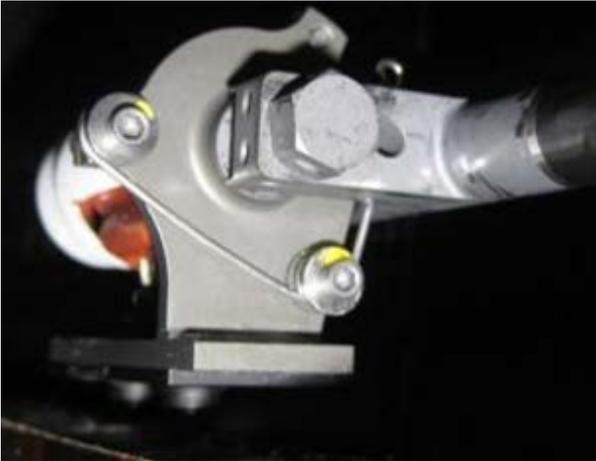
Figure 6. The “Fixed” Kickoff Spring

The shock of the bolt fracture to release imparts energy into the bracket and crossbeam. There is little to no force to generate friction between the crossbeam bracket and the Frangibolt® bracket, and the bumpers (Fig. 2) mitigate any sticking of the sail to the panel. So the requirement for the kickoff spring force is little to none. Thus, the design was changed to remove the possible bolt that could cause interference by taking out half of the kickoff spring (Fig. 6). Problem solved – well, until Flight 3 when once again the Trim Tabs were commanded to deploy and nothing happened.

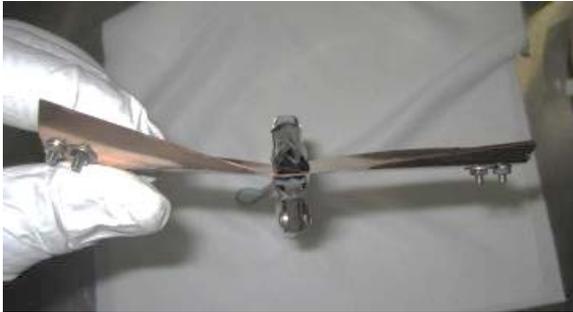
Figure 7. Clamped Strut Hinge Test

**Strut Hinge Cold Welding** – The strut hinge consists of four laminates of beryllium copper in close contact. If this contact in vacuum and vibration made the materials cold weld temporarily, maybe the deployment would be delayed. While some data exists for copper-copper interaction, none could be found for BeCu. A worst case engineering test was done instead. Strut laminates were cleaned and assembled into a stack using screws to clamp

the ends as in flight. The laminate assembly was “stowed” and a vice grips were used to apply clamping force to provide a normal force to generate friction and worst-case cold welding (Fig. 7). The laminate assembly was released and the deployment was normal.

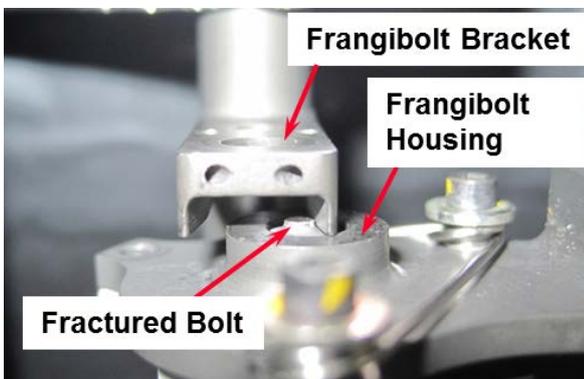
Figure 8. Possible Bolt Snag

Fractured Frangibolt® Snag – The Frangibolt® bolt fractures and of course leaves a rough surface. The actuator expands 0.75 mm (0.030 in) when activated generating a gap at the fracture to preclude interaction. The bolt fracture releases strain energy that drives the two halves apart, but possibly the motion of the sail is not fast enough and the bracket comes back into contact. Nominal dimensional analysis shows that there is an interference fit of 0.1 mm (0.004 in) between the Trim Tab Frangibolt® bracket and the Frangibolt® so it would seemingly want to come back into contact. Forcibly putting the hardware into this configuration is shown in Fig. 8.

Calculating the normal force onto the bolt shows that it is not enough to generate a friction force large enough to stall the hinge. One might imagine that a rough surface could contribute to a higher friction coefficient. Even so, using the measured stiffness with that deflection of 0.1 mm (0.004 inch) results in only 5-mN (0.0012-lb) normal force. With a friction coefficient of 1.0, that is still 100 times less than the deploying force at that point from the strut hinges (0.45 N (0.1 lb)).

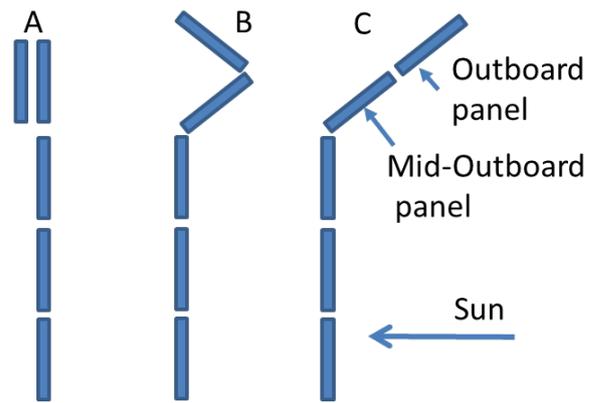
Figure 9. Three Possible Wing Configurations

That last point was the first item that we examined to determine what exactly was stuck. Given only the data that 80% current was generated, the array could be in several configurations. No position sensors are on the hinges. On orbit vehicle and solar panel temperature data, solar cell string data, as well as inertial clues indicated that the first three panels were deployed nominally. The last two panels could be in any of the three configurations shown in Fig. 9. An analysis was done on the deployment dynamics for each of these configurations if they were to release from that point – only Configuration A, the outboard panel not deployed at all, matched the data.

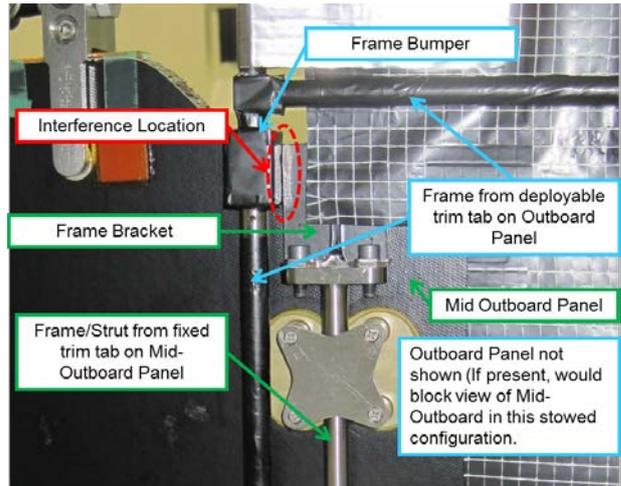
Figure 10. Bumper to Bracket Interference Location

The Trim Tab bumper from the outboard panel lined up the edge of the Trim Tab bracket on the mid-outboard panel (Fig. 10). The bumper is shown in Fig. 2 stowed against the panel. It is a stack of silicone rubber snubber blocks held together with Kapton® tape with a hole such that the sail tube can pass through. These bumpers are not dimensionally measured after the tape was applied; measuring the existing flight hardware still on the ground showed them to average 0.9 mm (0.025) in larger than the drawing requirement.

The theory for how these bumpers could cause the delayed deployment and then release is as follows. The Trim Tab crossbeam (Fig. 2) contracts at cold and causes the bumper to conform around the bracket edge that is 1.5-mm (0.060-in) thick. The bumper becomes more rigid at cold, locking around the bracket edge. As the panels warm, the crossbeam expands and the bumper becomes less rigid, and the panel releases.

The fixed Trim Tab does not have this interference as the bumper in question was only used to restrain the deployable portion of the Trim Tab and therefore the likely cause was eliminated from the design. Even so, the critical clearance checklist was updated for more detailed examination of the solar array panels.

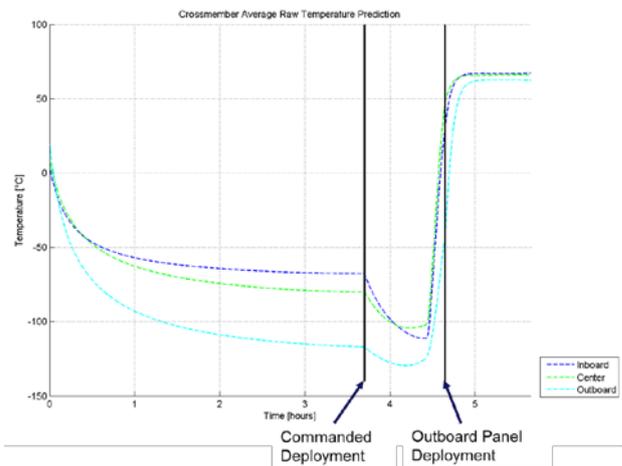
Figure 11. Crossbeam at -120°C when Trying to Deploy

Due to the very cold temperatures of the crossbeam at the time of commanded deployment (Fig. 11) (note the north wing is colder than the south wing on Flights 1 and 3 due to the season they were launched in and the position on the vehicle), the contraction of the titanium crossbeam is 0.94 mm (0.037 in). The result is a 0.23-mm (0.009-in) interference.

Testing of the bumpers at a 0.1-mm (0.004-in) interference indicates that the load to release increases with decreasing temperature. At about  $-70^{\circ}\text{C}$  the bumper material starts to stiffen. Testing indicates that below  $-70^{\circ}\text{C}$  the bumper material at 0.1 mm (0.004-in) interference generates enough force to stall the hingeline. Note on Fig. 11 that the panel released at about  $-50^{\circ}\text{C}$ .

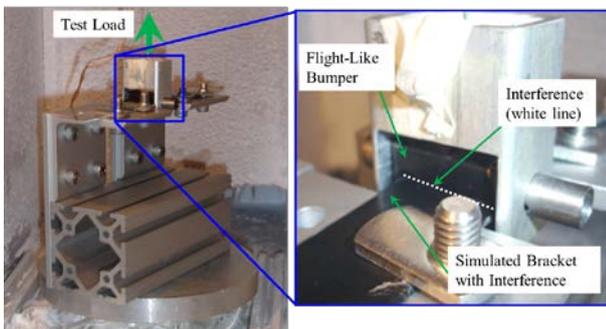
Figure 12. Bumper Interference Test Setup

Testing of the bumpers at room temperature indicates the load to release the bumper from the bracket increases as the interference increases as one would expect. This load increase, while small, is enough to stall the deployment because the interference occurs at the other end of the panel from the hinge torque, thus a small force at a large moment arm will stall the deployment. The test setup shown in Fig. 12 simulated the bumper-to-bracket interference by constraining a flight-like bumper to a known interference with the bracket and then measuring the force to move the bumper.
