ARIEL M2M ACTUATOR DERISKING

This de-risking activity consists in the development of the ARIEL Mirror Mechanism (M2M) cryogenic actuator including its design, manufacturing and qualification testing.

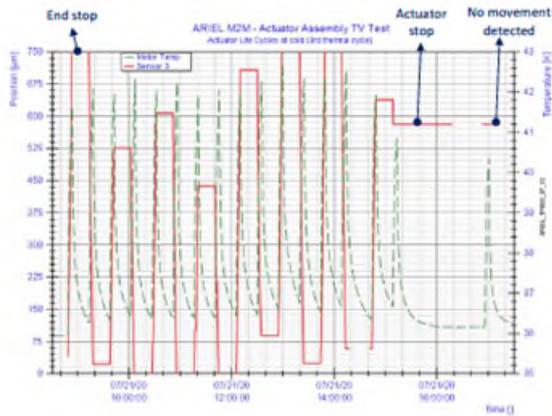
Figure 11 Actuator failure detection

- During life cycling a non-usual behaviour was detected in actuator displacement. In cycle number 50 (motor turn number 750.966) the operational stroke was not completed. After some additional movements, the actuator stopped.

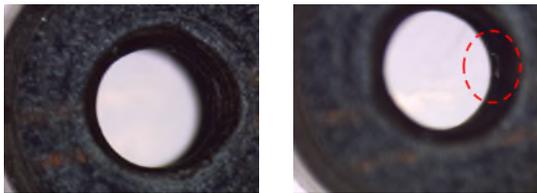
Figure 12 Nut inspection

The motor-reducer spindle and Vespel SP-3 nut were inspected with a microscope. As can be observed in following figures, some small particles of Vespel were found attached to the spindle and Vespel nut.

The Vespel nut wear is considered typical after such amount of cycles, and therefore, it is not the cause of the actuator failure.

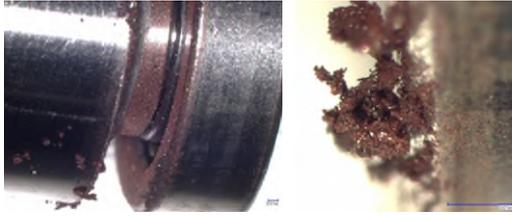
Figure 15 Motor bearings during disassembly

A large amount of brown debris was identified in and around the motor rotor's rear bearing. The debris was also found within the stator bore in the rear bearing's location after it was removed.

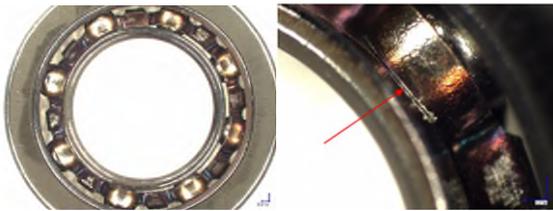
Figure 16 Rear motor bearing

Upon removal of the rotor it was observed that the rear bearing could not spin freely while the front bearing could. During inspection of the bearings showed contact marks on the crest of the ribbon cage from possible interference with the races.

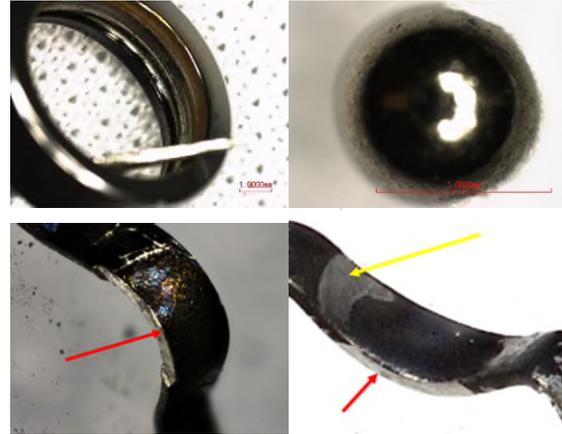
Figure 17 Rear motor bearing ring, ball and cage

The failed bearing was disassembled by firstly removing the cage and pushing the balls together so that the rings could be separated. More force than would normally be required was needed to push the balls together.

- Inner ring and Outer rings – there was no evidence of the MoS₂ lubricant on the raceway and metallic wear was observed.
- Inner ring -Marks consistent with metallic wear due to cage contact were present on both lands.
- Balls – the balls appeared dull and pitted, consistent with metallic wear.
- Cage – the edges of the cage appeared metallic wear with no MoS₂ remaining. Additionally, the MoS₂ was worn at each end of the ball pockets and the substrate exposed, although it should be noted that wear was not even in all ball pockets.

The examination concludes that the reason of the failure was the Rear Motor Rotor Bearing which exhibited heavy steel wear on the raceways and on the cage. Although it was subjected to the same operational conditions, the Front Motor Rotor Bearing still had some lifetime margin. Analysis using EDAX confirmed the presence of O-peaks on areas where the MoS₂ had worn, areas where it was intact and in Fe debris. However, it was not possible to determine if this O originated from moisture or O in the purged environment.

Based upon the information obtained from this analysis, the cause of failure of the Rear Motor Bearing was due to wear of the MoS₂ film lifetime applied to the bearing. Wear of the MoS₂ at the ball pockets and at the contact with the inner ring land eventually led to steel particles being released followed by bearing failure. The variability in the lifetime of this coatings together with the differences in dimensional tolerances between those cages could have led to the failure of the rear bearing much in advance of the front bearing. It is concluded that an MoS₂-coated steel cage is not ideal for long life applications and it is recommended that they should be replaced with PGM-HT cages which have considerable heritage in long-life applications and have also been used in cryogenic mechanism bearings for space. For the last 10 years CDA has used non-metallic retainers, such as PGM-HT, in its dry lube designs. The use of these cages will increase the bearing's life and eliminate the risk of generating metallic debris if the bearing's cages contact their races.

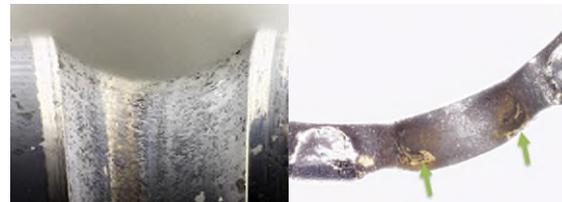
Figure 18 Front motor bearing ring and cage

This bearing was disassembled and examined optically for comparisons with the Rear Motor Rotor Bearing. This bearing was in better condition than the Rear Motor Rotor Bearing.

- Raceways – prior to disassembly the bearing rotated freely. Examination of the raceways revealed that MoS₂ was still present and it was also still present on the lands, although there were marks on the lands where the cage had been in contact.
- Cage – MoS₂ was still present in the ball pockets and light brown marks were evident where the ball had contacted the pockets.

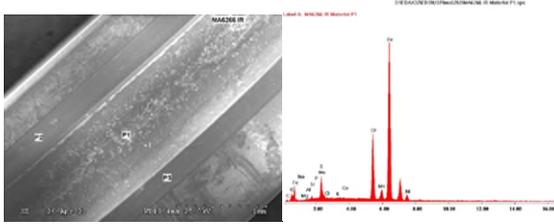
Figure 19 Rear Bearing Ring SEM/EDAX Analysis

Results showed that in addition to the Fe and Cr contained in 440C steel, Ni was also present in small quantities on the lands and a slightly larger peak was observed on the raceway. As Ni is not present in 440C of the bearings tracks, this element is therefore a contaminant and the most likely source is from the 300-series stainless steel cage. Note also, that some MoS₂ was detected and most probably originated from transferred debris or remnants still remaining. From the optical examination, no MoS₂ coating was visible on the raceway or parts of the lands identified by P1 and P2.

In addition, O-peaks were detected upon spectra from worn and unworn areas of the cage, but it was not possible to determine if this O-peak was from moisture or gaseous O combining with either the Fe or MoS₂ on the cage.

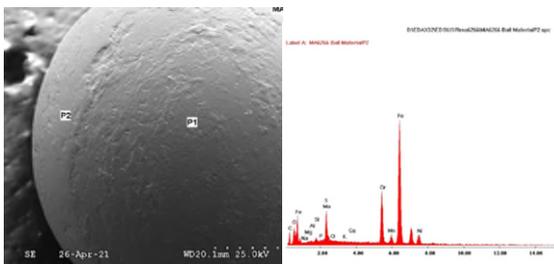
Figure 20 Rear Bearing Ball SEM/EDAX Analysis

Following figure illustrates the surface of a typical ball and the EDAX spectrum confirms Ni present.

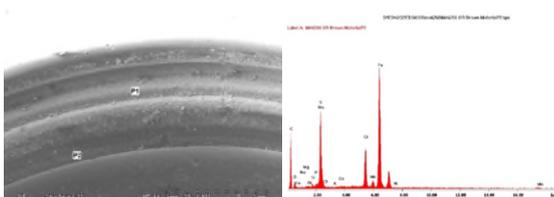
Figure 21 Brown debris from Rear Bearing outer ring

The brown debris on the outer ring was analysed and the results show that Mo, S and O are present in addition to Fe and Cr. Note that there was not any Ni found. These spectra are more likely to indicate that the debris contains MoS₂ and not oxidised cage material.

However, oxidised Fe from the bearings cannot be ruled out. O-peaks were detected upon spectra from the debris, but it was not possible to determine if this O-peak was from moisture or gaseous O combining with either the Fe or MoS₂ on the cage.

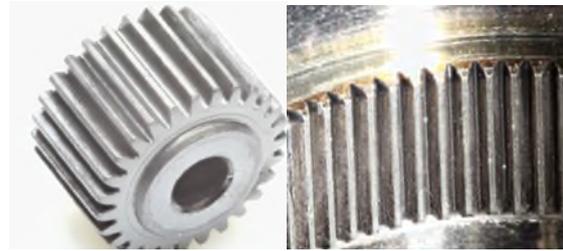
Figure 22 Planet and Housing Gears

In general planet gears and pinions were in good conditions. The MoS₂ film was in good condition with light marks present.

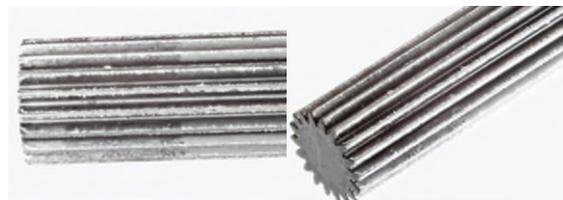
Figure 23 Motor Rotor Pinion

The Motor Rotor was inspected. The MoS₂ film on the teeth appeared intact, although some light marks consistent with contact with the opposing gear were evident.

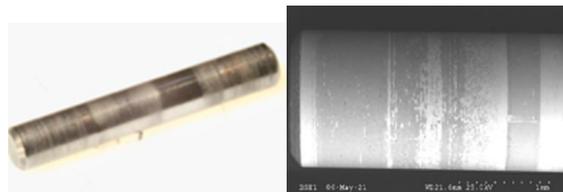
Figure 24 Low Speed Planet Pins

Wear of the MoS₂ is uneven and evident by the circumferential bands observed on all three pins. EDAX spectra exhibit strong Mo/S peak where they are not worn and a smaller peak in worn areas. Note that the pins were manufactured from WC and the presence of W was apparent in the EDAX spectra.

The planetary gear pins exhibited some circumferential marks and wear of the MoS₂. It is clear, however, that the planetary gears and pins still have some life margin, although they are predicted to be the next components which could fail if operation could have been extended.
