Development of an Actuator for Ambient to Cryo Application

Karen Menzel*, Hans Jürgen Jung* and Jörg Schmidt**

Abstract

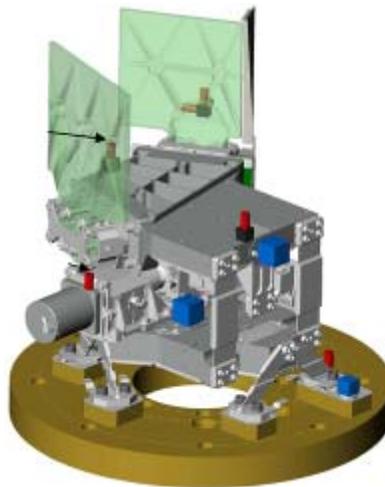
The actuator consists of a three-stage gearbox flanged to a stepper motor. A lever connected to the actuator by an eccentric mechanism moves the upper sled of the Refocusing Mechanism Assembly (RMA), an optical NIRSpec subunit carrying highly sensitive mirrors (see Figure 1).

Figure 1: Refocusing Mechanism Assembly

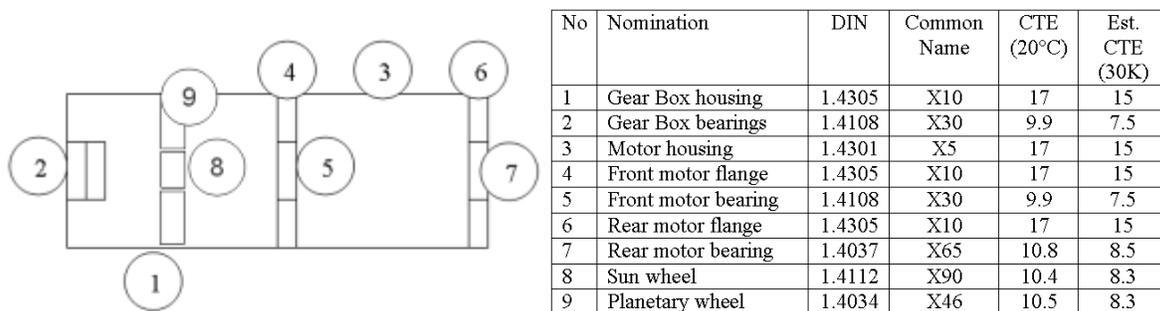
The first RMA actuator consisted of a material mix of six different sorts of steel with an estimated coefficient of thermal expansion (CTE) at 30K varying between 7.5×10^{-6} 1/K (ball bearings) and 15×10^{-6} 1/K (gearbox housing). This design was based on the experiences in gearbox development for usual applications – every single material has its specific strength playing on the individual function. But this cryogenic application cannot be called usual and different strategies have to be pursued.

Figure 2: Material concept of first actuator

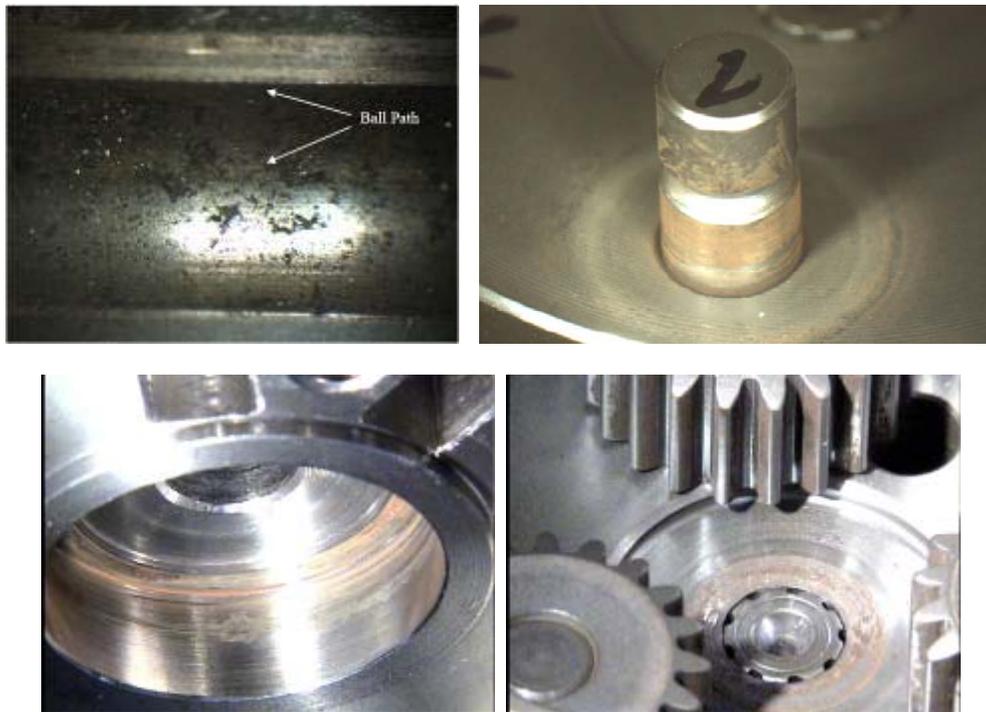
The shrinking at cryo is likely to have caused increased friction and therefore affected the life-time significantly. The lubricant used, Diconite, showed significant signs of abrasion after life test (about 330,000 motor revolutions) resulting in metal-to-metal contact as well as a major increase in necessary current; according to ECSS, a clear failure of life test.

Figure 3: Lubrication failure of first actuator after life test¹

¹ Visible corrosion results from the exposure of the blank metal to air after disassembly of the actuator.

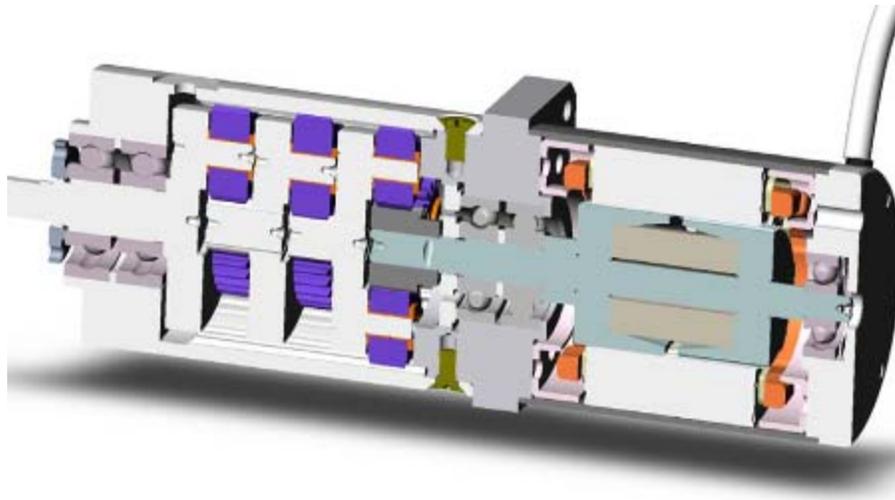
Figure 4 represents the new actuator in cross section, the main design was kept in general but the rear motor bearing was substituted by larger duplex bearings. The rotor axial pre-load spring was moved from the front duplex to the rear bearing. Ideally the front duplex bearings of the motor should have been arranged in 0-orientation to allow a limited rotation of the rotor axis (iso-static support conditions). Due to assembly constraints, an X-arrangement had to be selected in combination with an increased play of the rotor axis rear bearing. The planetary gear with three stages still has a gear ratio of 184:1.

Figure 4: New Design RMA Actuator

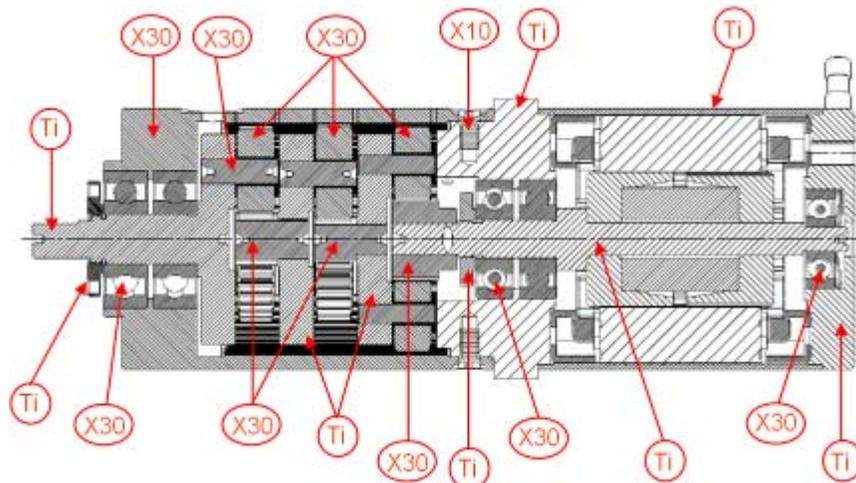
As Figure 5 illustrates, all motor and gearbox parts except the screws are manufactured of either hardened Cronidur® (X30) or titanium, the higher CTE of the screws only results in behavior comparable to extension bolts, and the machining of well known material for these critical functional components minimizes risks.

Figure 5: New Material Concept

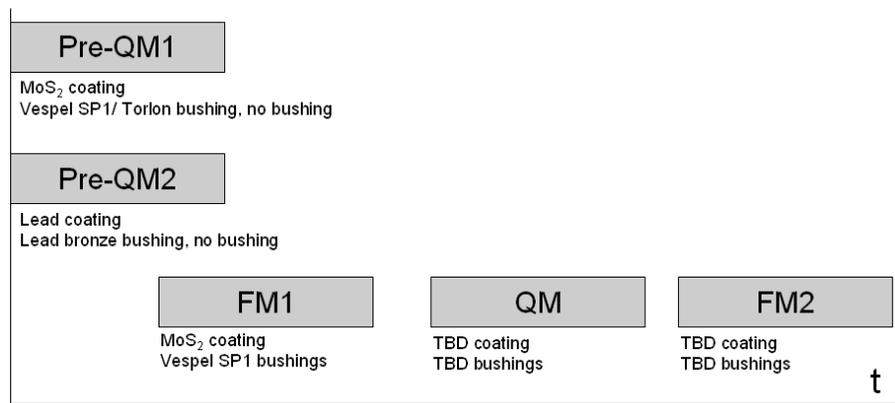
These breadboard models have been manufactured first and the FM1 production has been started during their test campaign as displayed in Figure 8. Indeed the FM1 has been assembled into the subunit at a time the actuator has not been fully qualified – as the Pre-QM1 and FM1 are not assembled completely identical and the Pre-QM life test was in some ways simplified but equivalent at the best.

Figure 8: Development concept and success oriented approach

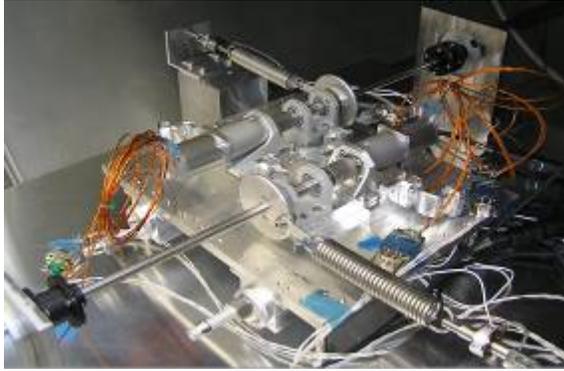
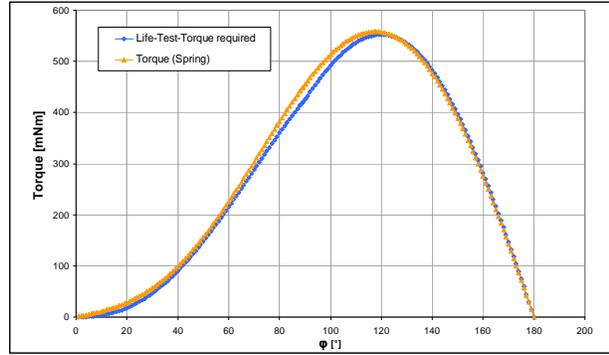
Springs connected to a disc (Figure 9) load the actuators with the torque corresponding to the load the real blades are generating in the RMA mechanism. Figure 9 illustrates that the maximum torque at 120° from launch position and the load represented by the spring set-up is very accurate.

Figure 9: Pre-QM Life Test (left), Load application during life test by spring assembly (right)

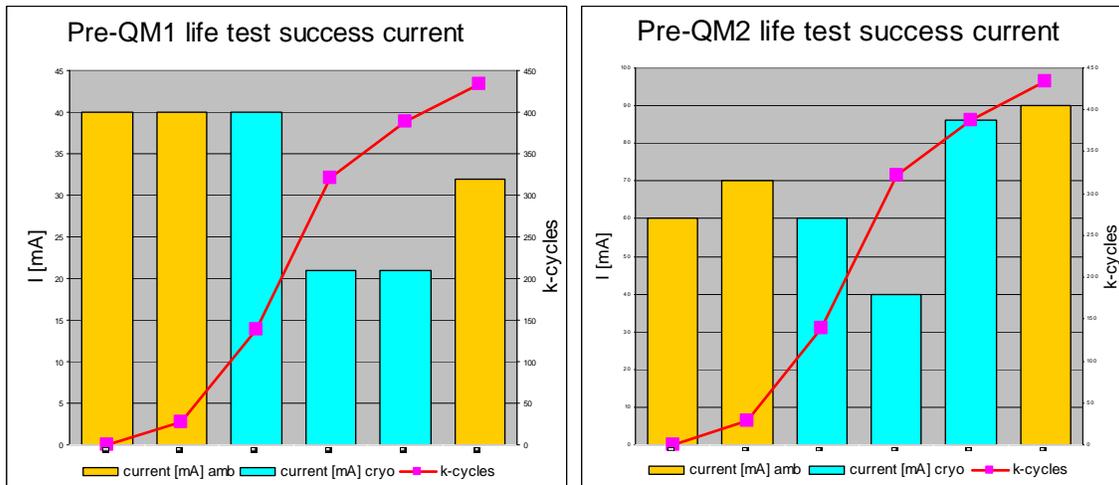
Figure 10: Results of Pre-QM life test

The expected life time of the RMA actuator is about 400,000 motor revolutions including ECSS margins. As Figure 10 illustrates, in the case of Pre-QM1 the so called success current - indicating the friction - does decrease during life time up to the end of life test at about 430,000 motor revolutions. The MoS₂ coating seems to be properly run in at this time. Lead coated Pre-QM2 showed some degradation starting between 320,000 and 380,000 motor revolutions, but is still within the ECSS success criteria at end of

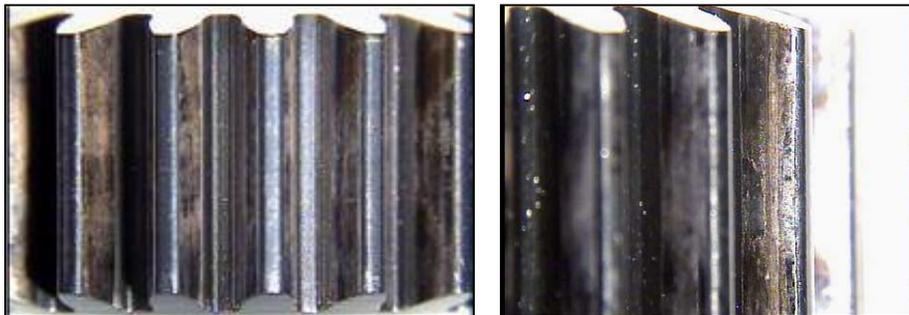
Figure 11: MoS₂ Gearbox inspection after life test

2. When we initially saw those areas of lubrication loss on the gear wheels (see Figure 11) we were sure that this was the end of the story. Thanks to ESTL, who had great confidence in their sputtering process and was confident according to measurements performed to still have sufficient MoS₂ on the teeth to survive the life test, we decided to continue. The life test was a success. Those observed areas increased but the residual MoS₂ layer survived. It is the intention to continue the life test on the pre-QM (see last chapter "Outlook")

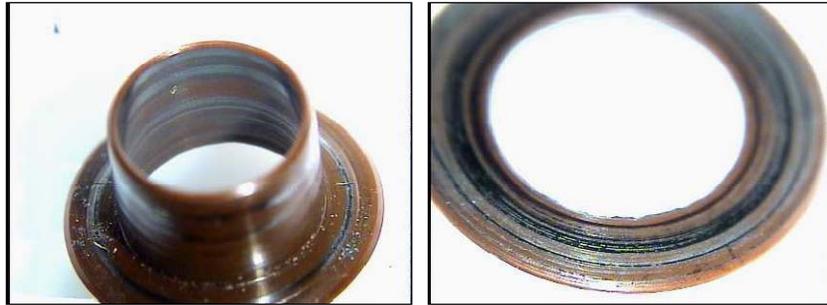
life. The detailed visual inspection of the bushings (Figure 12 and Figure 13) did not show significant differences in abrasion on bushings made of Vespel SP1 and Torlon.

Figure 12: Pre-QM1 Vespel SP1 Bushing and Distance Washer after life test

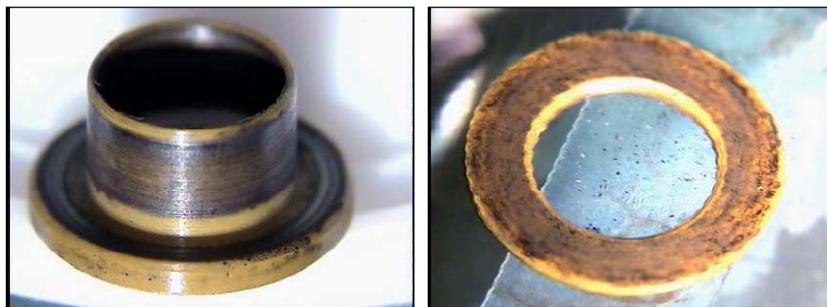
Figure 13: Pre-QM1 Torlon Bushing and Distance Washer after life test

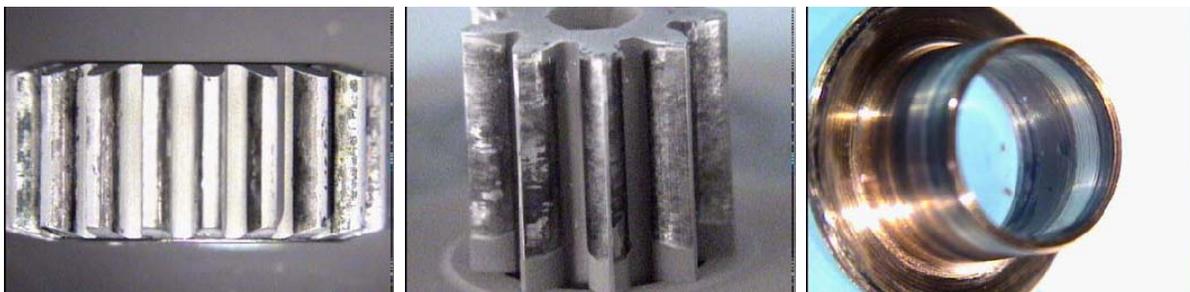
The visual inspection of the lead-coated Pre-QM2 gearbox revealed as well a good condition with no evidence of metallic wear of the steel surfaces. XRF measurements confirmed that lead remained on the gear teeth but that in several areas it was extremely thin. Examination of the thickness values show that in all but one case the minimum thickness was less than $0.1 \mu\text{m}$, being as low as $0.03 \mu\text{m}$ in one case. However, it should be stressed that very little lead is required – particularly on polished steel surfaces - to provide effective lubrication.

Figure 14: Lead-coated gearbox and lead-bronze bushing after life test

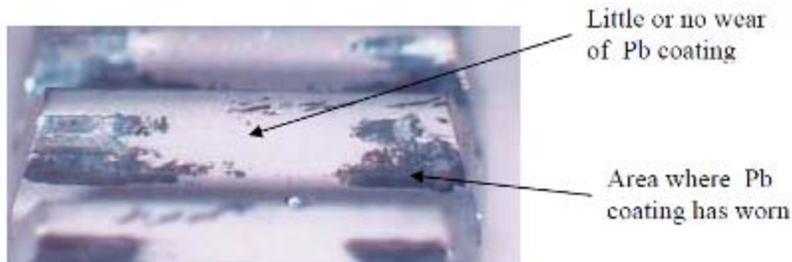
As with the MoS_2 -lubricated gears, the wear of the lead coatings was uneven across the teeth. This is illustrated in Figure 15 for a planetary gear from Stage 3 where it can be seen that the lead coating in the center of the tooth is virtually unworn whereas elsewhere wear of the lubricant has clearly taken place.

Figure 15: Uneven distribution of remaining lead coating on the planet teeth

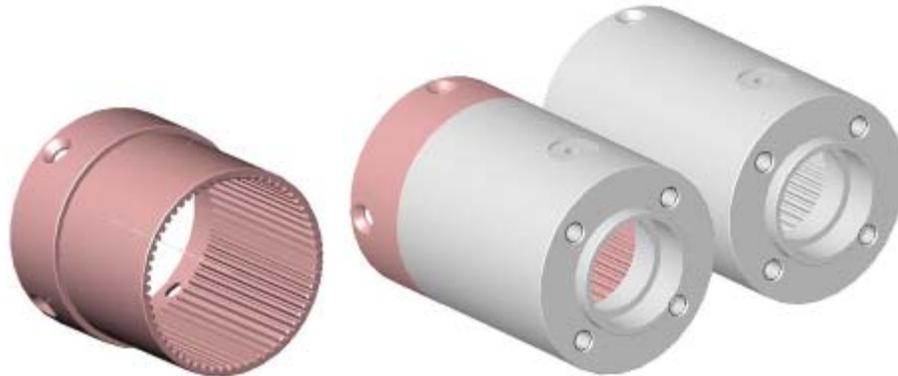
Sticking to the previous concepts still offers two opportunities: harden the entire gearbox housing (Figure 18 right) or manufacture a hollow wheel ring from Cronidur[®] (Figure 18 left), harden it and assemble it in an integrated design to a titanium housing (Figure 18 middle). Both methods have been tested; entire gearbox and hollow wheel ring have been hardened and 3D-measured afterwards with the following result: the hollow wheel was ovalized but the gearbox stayed stable!

Figure 18: Hollow wheel ring and integrated design vs. gearbox housing completely made of Cronidur[®]

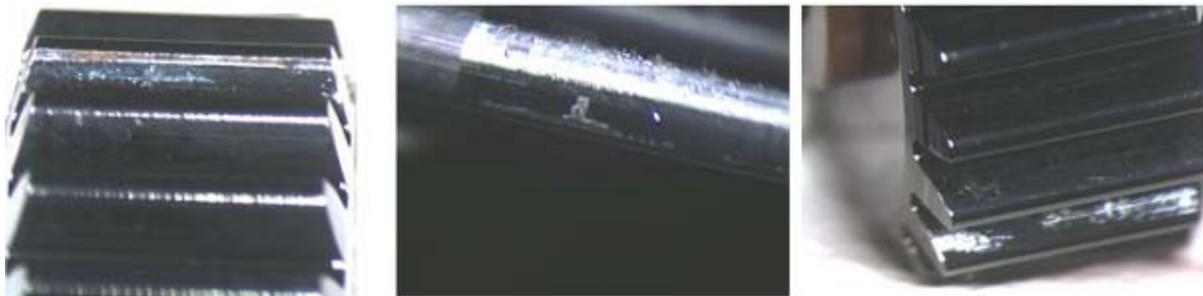
As indicated previously, both Pre-QM1 and FM1 showed signs of coating delamination on the gear teeth of planets, sun wheel and gearbox housing after vibration test, which was detected during subsequent inspection (Figure 19). This finding raised two main questions:

Figure 19: Coating damage after vibration

the gear wheels as observed after vibration testing (see Figure 19) is still not understood and shall be further investigated (see last chapter "Outlook").
