Development of Brushed and Brushless DC Motors for use in the ExoMars Drilling and Sampling Mechanism

Robin Phillips*, Massimo Palladino** and Camille Courtois†

Abstract

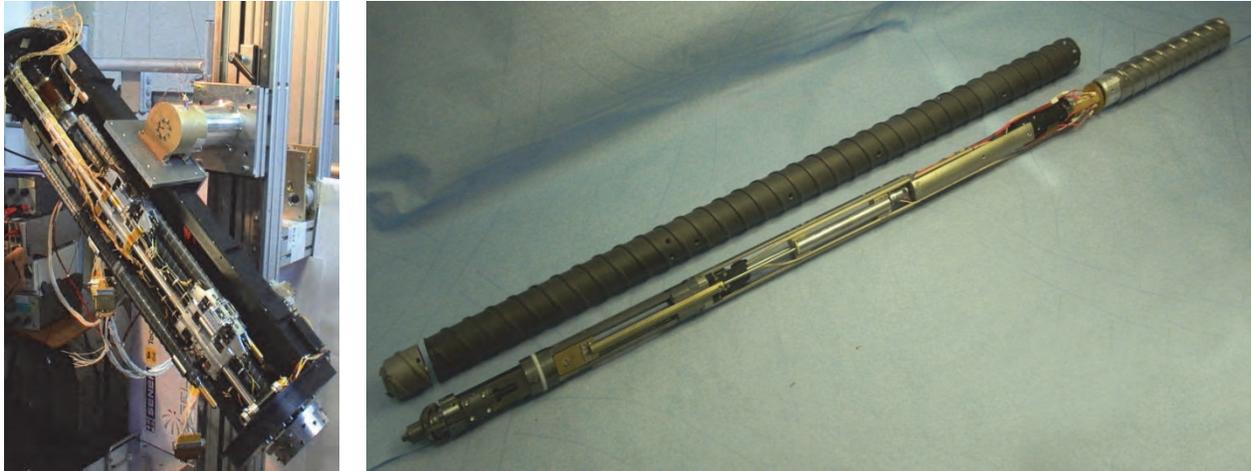
Figure 1: The ExoMars drill box breadboard (left) and drill mandrel EM (right)

The ExoMars program (as originally conceived by ESA) envisaged many motors of numerous types being used for various different functions on the rover, a summary of which is shown in Table 1. For the purposes of the development program being reported on here, the requirements for the Drilling and Sampling mechanism, hereafter “Drill”, were considered. Where possible the RE20 and RE25 brushed motors that were used on the MER missions were used in the original design. However, three applications in the drill required new motor sizes or types. These were the Drill mandrel clamp which has to fit within the diameter of the drill bit (see Figure 1) and hence is limited to Ø13 mm, the main drill drive

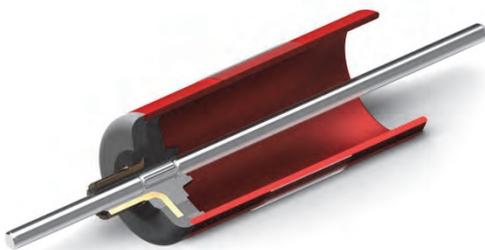
Figure 2: RE13 rotor showing bell shaped winding attached to shaft

For the RE13 motor, there was concern that during shock and vibrations (mainly from launch and landing) there is no contact between the motor winding and the housing. This is particularly of concern since the RE13 motor winding is a cantilever (Figure 2) and the gap between the winding and housing can in the worst case tolerances be only 170 µm, as shown in (Figure 3).
