In-Orbit Performance of the MWRI Scanning Mechanisms

Manfred Schmid*, Miao Jun** and Yu Shuang**

Abstract

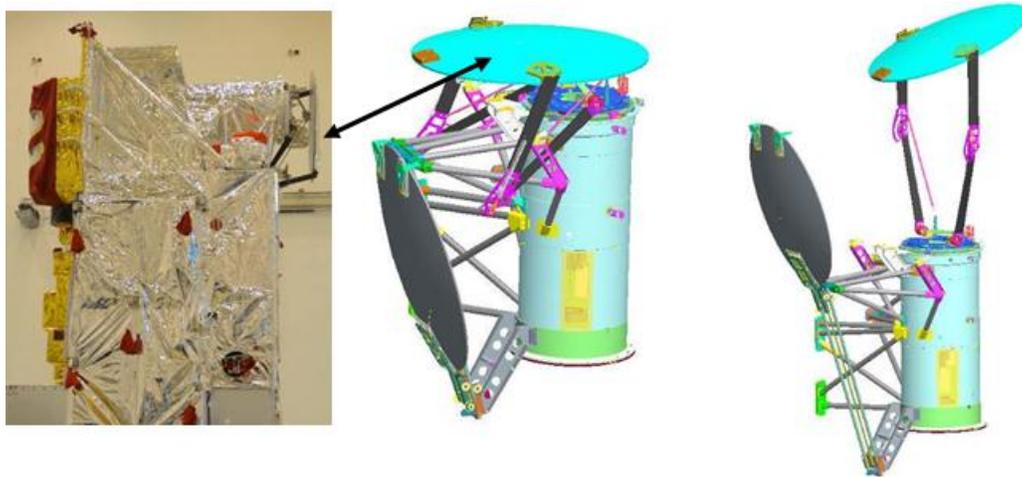
Figure 1. FY3 Spacecraft and Instrument Configuration

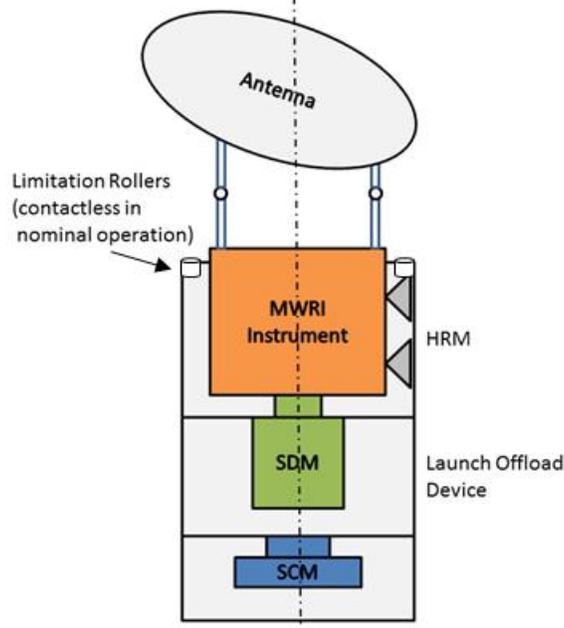
Figure 2 shows the MWRI Instrument block diagram. After launch and HRM release, the antenna dish is deployed to its final configuration by means of a deployable support structure.

Figure 2. MWRI Instrument Block Diagram

The MWRI Instrument is rotated together with the antenna by means of the SDM in order to allow conical ground scanning. The SCM is used for momentum compensation during normal operation (scan rate changes) and during start-up and potential deceleration phases which take 180 s each, performed in a synchronized and controlled mode. MWRI receives data in 10 frequency channels from 10 GHz up to 89 GHz with a ground resolution of 0.25~1 km. A typical output is depicted in Figure 3.

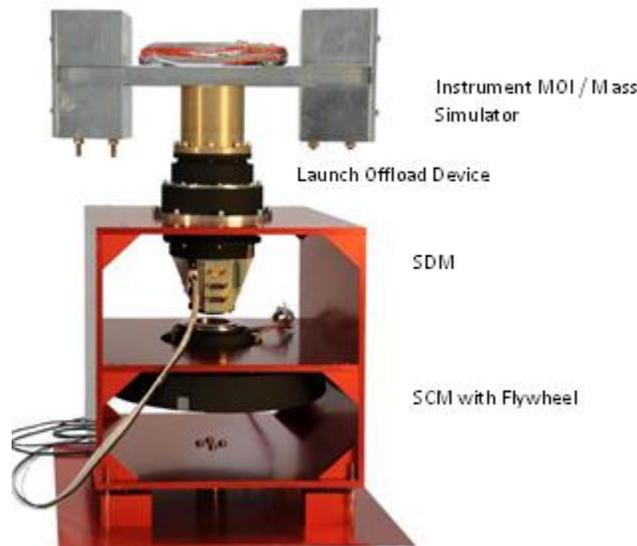
The MWRI Scan Equipment consists of a Scan Drive Mechanism (SDM) including a Launch Offload Device, of a Scan Compensation Mechanism (SCM) and of a closed loop Scan Control Electronics (SCE).

Figure 4. SDM (with Instrument Mol/Mass Simulator) and SCM

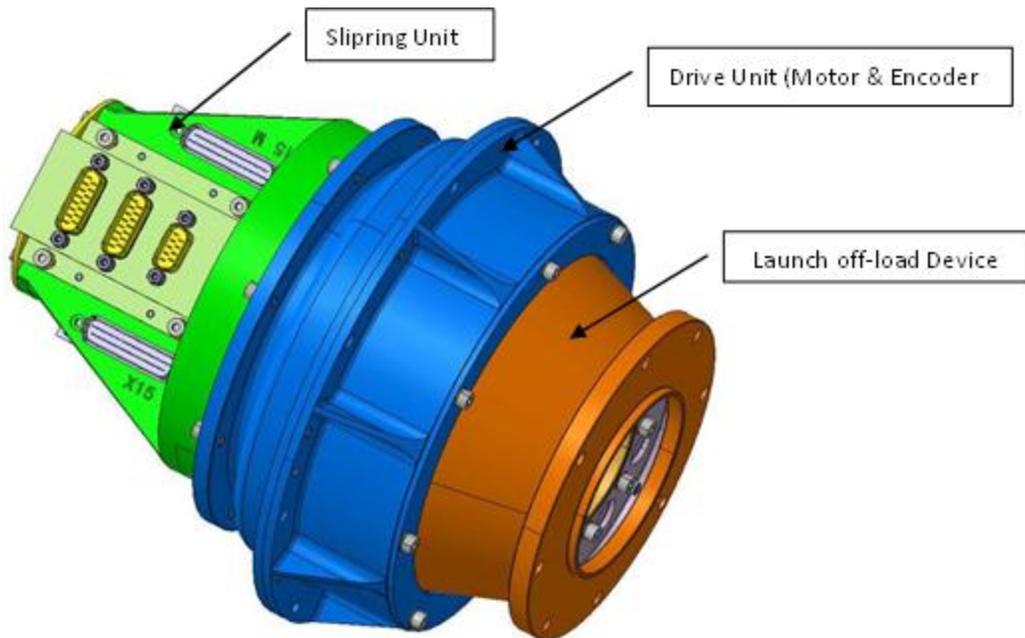
The SDM consists of a drive module using two hard preloaded pairs of ball bearings, a redundant brushless DC motor and a redundant optical encoder for closed-loop velocity control. On the rear end of the drive module, a slip ring unit for power and signal transfer from / to the rotating Radiometer Instrument Package is attached. The Harness is guided through the hollow drive shaft to the slip ring rotor.

The I/F to the rotating instrument mounted on top of the SDM is formed by a launch off-load device. The launch off-load device consists of axially pre-loaded flexible metallic bellows and an accurately shaped conical Interface. The combination of both elements also provides high instrument alignment accuracy and torsional stiffness about the rotation axis during the mission. During launch, the conical I/F is lifted off from the mechanism I/F, so to de-couple the instrument load path from the mechanism. After release of the Instrument HRMs, the instrument is pulled back into its conical I/F and torque transfer from the SDM to the instrument is allowed.

The SDM rotor shaft is mounted via 2 pairs of hard preloaded angular contact ball bearings in face-to-face arrangement into the SDM housing (preload 400N). The bearings are manufactured from Stainless Steel 440C, the cages are manufactured from Phenolic Resin, vacuum impregnated and lubricated with Fomblin Z 25 (changed in the FY3C mission to Nye Oil/ Maplub for commonality reasons with the SCM).

The motor is a brushless DC type with completely cold redundant independent stators. The redundant optical Encoders provide position data with 16-bit resolution.

The slip ring for power and signal transfer to the instrument is composed of 19 solid gold tracks and redundant gold alloy brushes to achieve the expected orbit life of 3 years (3.5 years already achieved, corresponding to 60 million revs, 5 years goal).

Figure 4. SDM Design as flown on FY3-B

The SDM mechanism design as used on the FY3-B Spacecraft is shown in Figure 5.

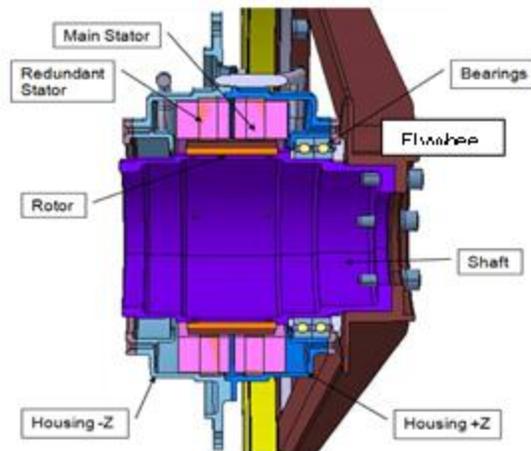
The SCM consists of a drive module using a brushless DC motor with redundant motor stators. The SCM motor is similar to the SDM motor, but optimized for the higher operation speed.

For rotation speed feedback, 3 Hall Sensors are included in each motor stator. A flywheel with trim masses is attached to the motor output shaft.

The SCM is lubricated with Nye Synthetic Oil 2001A and Maplub Grease SH051A. The bearings are identical to the SDM bearings. However, in the SCM only one pair of bearings is used in back-to-back arrangement. The bearing preload is set to 400 N.

Figure 6. SCM Design

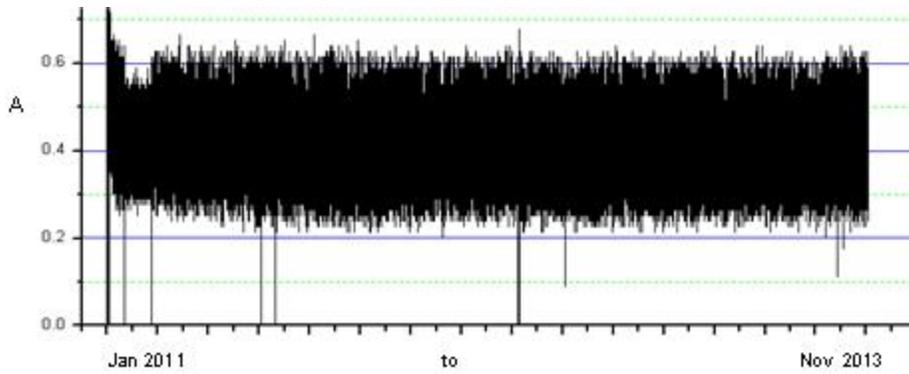
In Figure 7, the SCM current is plotted for the observed mission time frame and we see that the motor current and consequently the mechanism friction looks very stable over all mission phases and it is well within the expected nominal range from the beginning.

Figure 7. Typical SCM Current over 34 Months

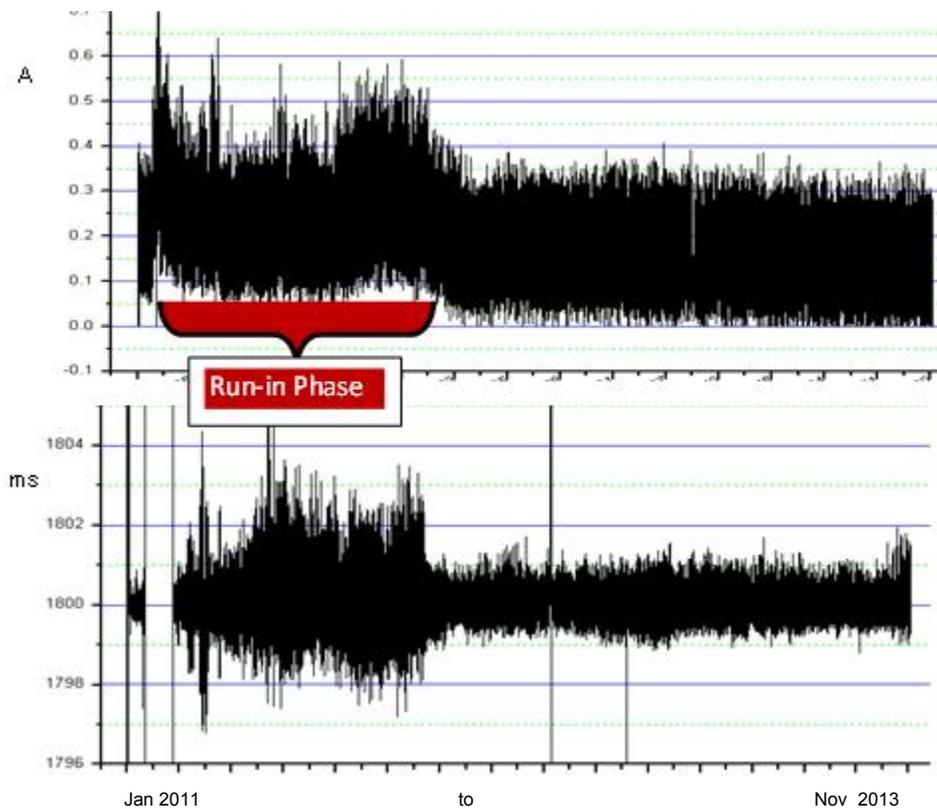
During the instrument's in-orbit commissioning phase it was observed that the SDM current was not stable, but it was randomly varying over time. Nominally the current should have been in the range of slightly above 0.2 A, however, in reality current spikes up to the 1 A range were randomly observed along with long term current variations. From this behavior, the conclusion had to be drawn that the torque needed to operate the SDM together with its MWRI instrument module was varying over time.

It can be seen that after about 16 months of operation, the motor current stabilized back to the expected nominal current values of about 0.2 A and also the scan rate performance improved to nominal values.

In Figure 8, we see the typical current variation as received via Telemetry during the instrument start-up and first operation phase. A direct correlation between the motor current variation and the scan rate stability was observed, and the current variation leads also to a reduced controller performance.

Figure 8. SDM Motor Current Spikes and associated Scan Rate Stability over 34 Months

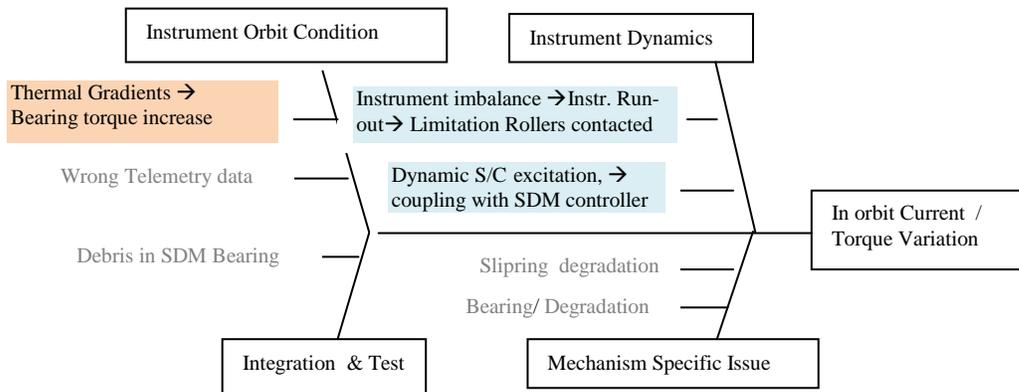
In order to identify the root cause for the current /friction anomaly observed, all potential disturbance sources were identified and investigated in detail. For initial identification of all potential root causes of the observed anomaly, a fish-bone diagram was used (Figure 9).

Figure 9. Fishbone Diagram for Root Cause Investigation

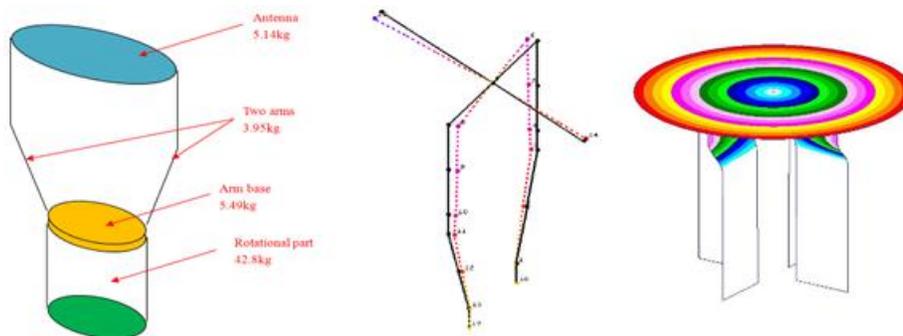
For this purpose the eigen-frequency results from the instrument analysis were used as reference and a spring blade test setup was designed and adjusted to the system reference eigen-frequency by means of a dedicated finite element model (Figure 10). The first rotational system frequency is at about 9 Hz, whereas the first lateral one is at about 5 Hz.

Figure 10. FE Model of the Antenna Deployment Structure and Analogous Model for Test Setup

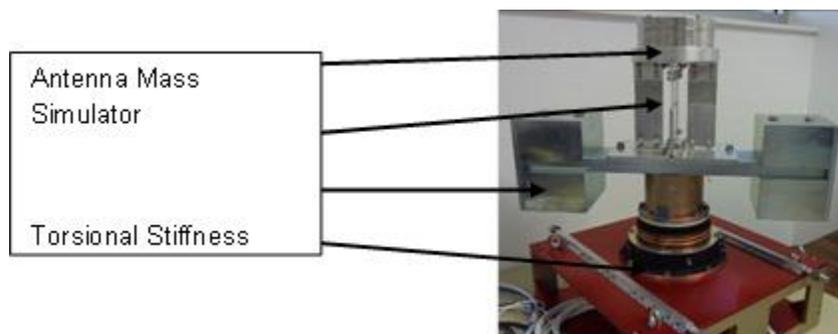
In this configuration, a dynamic test was carried out on the EM Scan Drive Mechanism, with the finding that the influence of the antenna and of its large deployable structure on the mechanism controller, and subsequently on the power consumption, was negligible.

In Figure 11, the H/W of the test setup as derived from the analytical model is depicted. The two masses on the both sides simulate the instrument inertia while the mass on top and the spring blades in between represent the antenna mass and the torsional stiffness of the antenna support structure.

Figure 11. Torsional Stiffness Test Setup

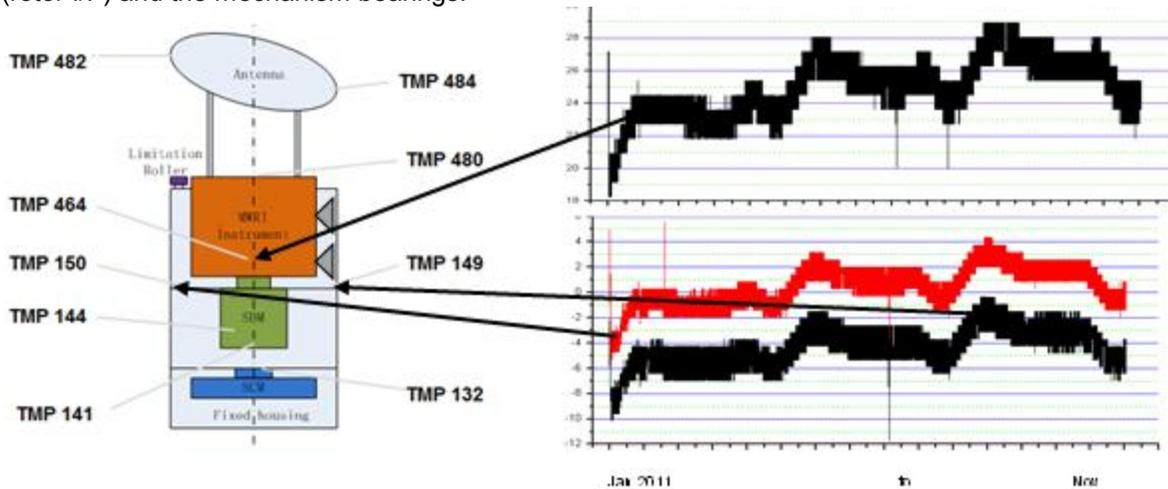
The temperature range in the area of the Thermistors 149 and 150 is in the range of -6 to 0°C (Figure 12). The mechanism temperature (TMP 141/144) and SCM housing temperatures (TMP 132) are also at about 0 deg during operation, with only minor variation. However, the instrument I/F (attached to the mechanism rotor) has a temperature of about 23°C. Therefore, we see a lateral gradient acting through the mechanism mounting I/F to the structure, and also an axial gradient between the Instrument mounting I/F (rotor I/F) and the mechanism bearings.

Figure 52. Relevant Temperature Data (deg C°) of FY3-B over 34 months

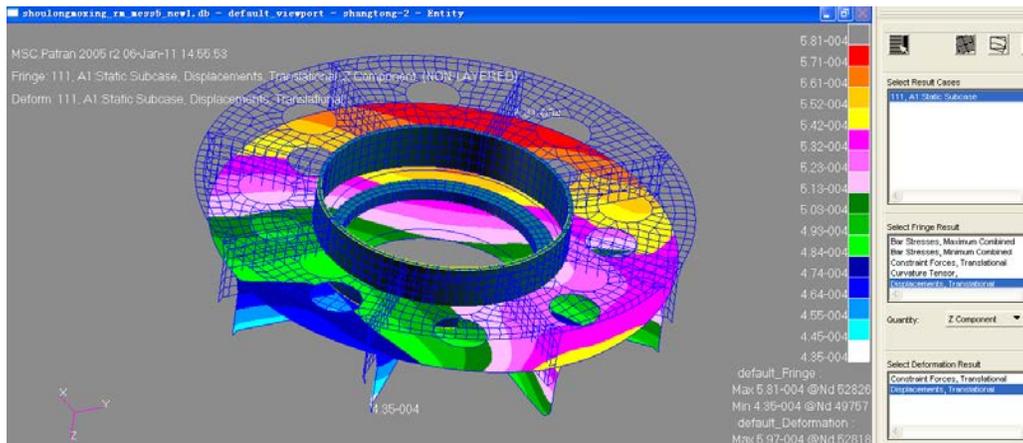
Based on the available orbit temperature data, a thermal deflection analysis was established in order to identify the maximum possible deviation of the mechanism I/F due to thermal gradients in its mounting structure (Figure 13). The analytical result was that the relative displacement of the mounting I/F flange along the mechanism rotation axis due to the gradient influence of the mounting flange is about 65 μm .

Figure 13. Thermal Deflection Model Mechanism I/F to S/C

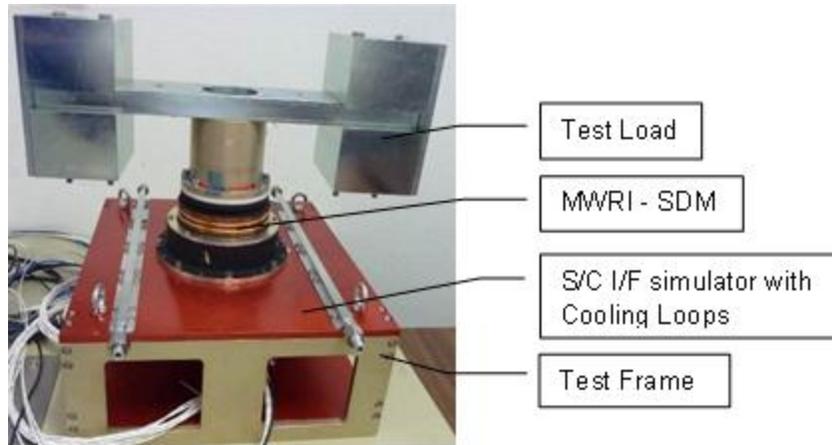
In this test, the baseplate (S/C I/F simulator) was cooled by means of cooling loops to the required low temperature, while the mechanism rotor was controlled to the Instrument I/F temperature (Figure 14). At the start of the test, the mechanism rotor I/F was heated to the orbit I/F temperature, while the S/C I/F temperature was at ambient. During continuous rotation of the mechanism, the S/C I/F temperature was decreased while maintaining the rotor I/F at the warm level. During the test, the rotation rate stability was also measured.

Figure 14. TV Test Setup for Gradient Test

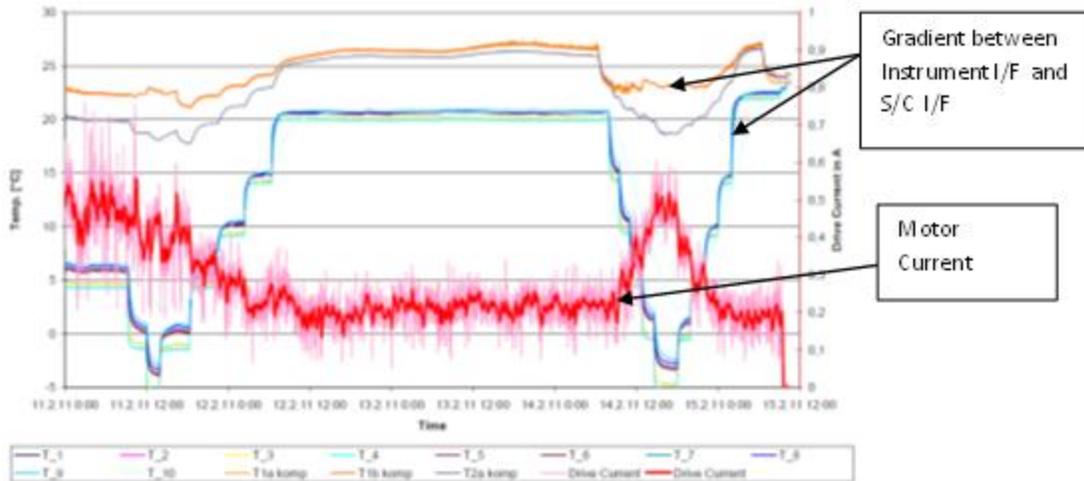
A test result overview is depicted in Figure 15. One can clearly see the influence of the thermal gradients acting between the warm mechanism rotor and the cold S/C I/F flange on the motor current.

The effect can be explained by the fact that the SDM housing as flown on FY3B was manufactured from aluminium whereas the rotor shaft was manufactured from steel. Therefore the gradient between rotor and stator leads to a decrease in diameter of the outer rings of the thin ring bearings, while the inner ring stays stable. In addition, the deflection of the mechanism housing due to the lateral gradient over the SDM mounting I/F, as shown by the finite element model, will influence the bearing configuration.

Figure 15. Influence of the Thermal Gradient to the motor current

The above findings explain well the mechanism behavior during the first mission phase and the associated current increase. The fact that the current and scan performance went back to nominal values after some months of operation can be explained by a run-in effect observed in the new (deflected) bearing configuration which established due to the thermal gradient effects. After a run-in phase of the bearings in the new slightly different configuration, the bearing friction adjusted back to nominal values.

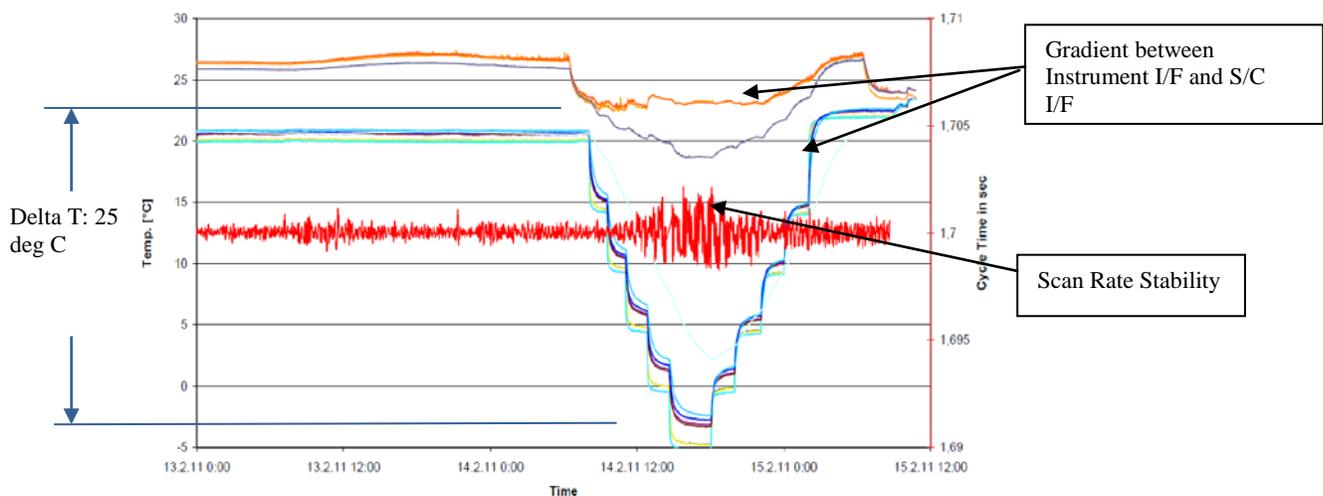
According to Figure 16, we can also confirm the influence of the thermal gradients to the scan rate stability. If the motor current rises due to thermal gradients in the system, the control performance of the scan rate decreases.

Figure 16. Influence of the Thermal Gradient to the scan rate stability

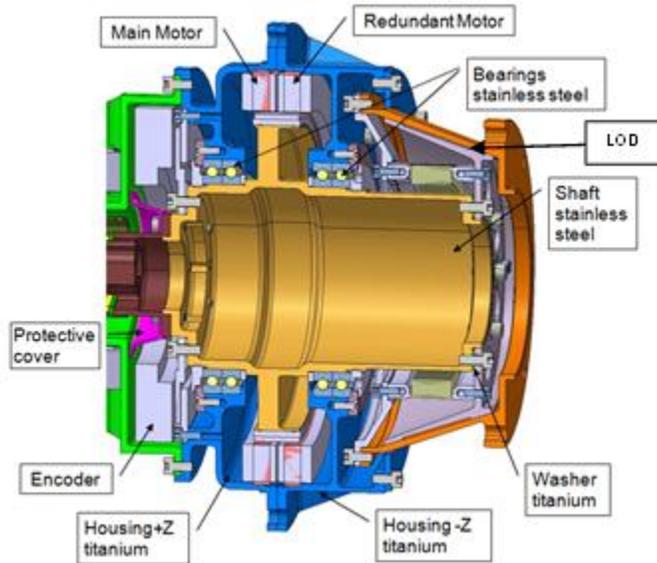
As a consequence of the root cause investigation that confirmed and correlated well with the observed orbit behavior, the relevant findings were transferred into a design modification on the FY3C flight equipment in order to avoid issues as observed on FY3B in the future (see also Figure 17).

Figure 17. Optimized FY3-C Design

- Change the SDM housing material from aluminium to titanium and add additional stiffening ribs:
 - improves insensitivity towards external stresses
 - reduces thermal mismatch due to gradients
- Modify conical I/F of the launch offload device (LOD) to steeper angle (general risk mitigation and improvement of design robustness):
 - improves capability to handle potential instrument CoG shift
 - improves mechanism rotation axis accuracy
- Set bearing preload to 400 N
- Add isolating Ti washer in the I/F to the instrument
 - reduction of thermal gradients in the mechanism

- Add mechanism cover (general risk mitigation and design robustness improvement):
 - dust /contamination protection cover

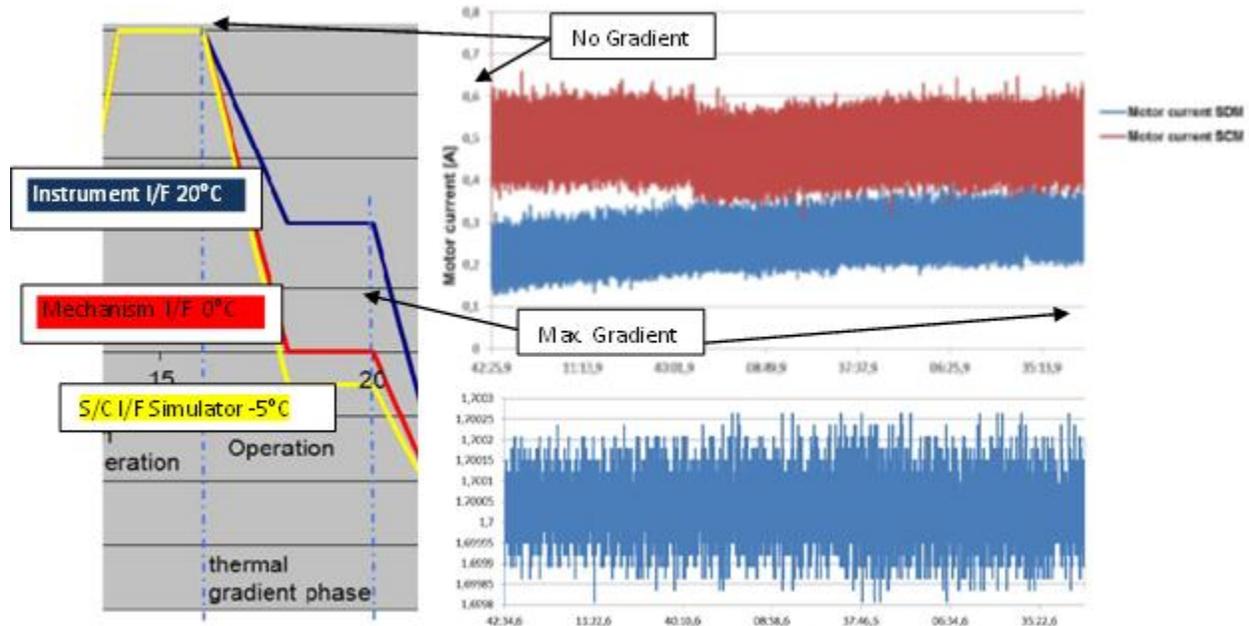
A summary of the TV ground test results after FY3C flight mechanism modification is depicted in Figure 18. It can be seen that the insensitivity of the Scan Drive Mechanism against thermal gradients has significantly improved and that the current only increases only marginally with the temperature gradient. Also the cycle time deviation stays well within the requirement. Due to the fact that the tested flight mechanism is new and un-used, we can expect an additional run-in effect which will decrease the motor current again over time and further improve the scan rate stability.

Figure 18. TV Gradient Test results

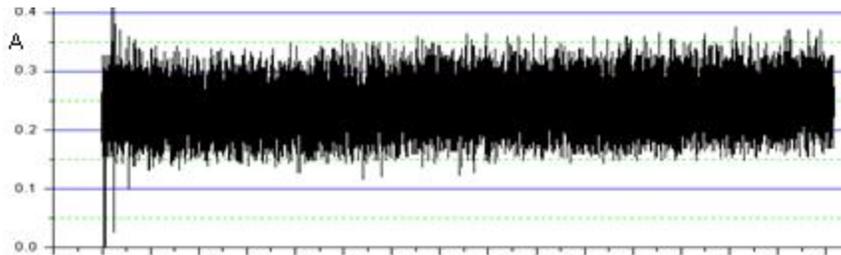
The FY3C S/C was successfully launched at the end of September 1013 and the MWRI instrument went operational some days later. The first telemetry current and performance data achieved over a time frame of one week fully confirm the validity and efficiency of the chosen design modifications (Figure 19 and Figure 20).

Figure 19. SDM current (A) of FY3-C over the first two Months of Mission Time

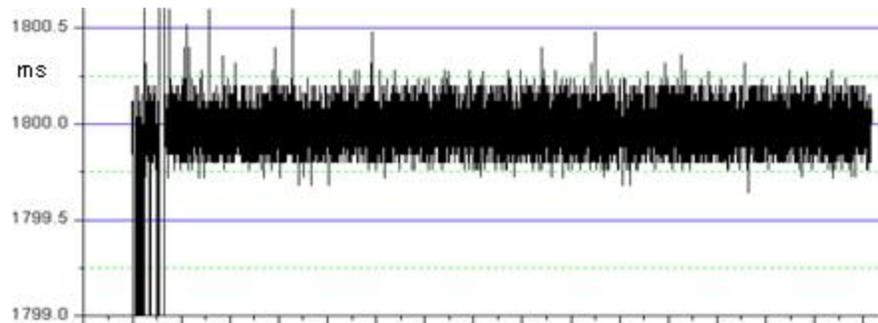
Figure 20. Scan Rate stability (s) of FY3-C over the first two Months of Mission Time
