# Development and Post-testing Anomalies of the Parker Solar Probe Clamshells

## Abstract

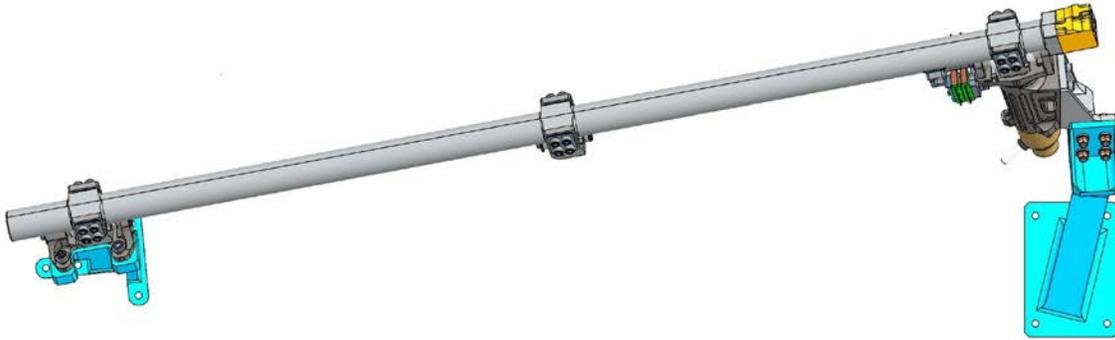
Figure 3: Top view: The clamshell mechanism that corresponds to the V1 FIELDS antenna position.

The PSP clamshell mechanism is comprised of two, half-circular machined aluminum halves, one deployable or active hinge, two follower hinges, redundant deployment telltale switches, and plastic antenna guides that are mounted to the top end of the clamshell. The clamshell halves are 762-mm (30-in) long, have a 22-mm (.875-in) external diameter, and are fabricated from 6061 aluminum, with aggressive mass-reduction features on the inside. The clamshell mounts to the PSP SC bus via features on the top and bottom hinges, on brackets that position each clamshell on a natural tangent of each stowed antenna. These brackets were designed with multiple bolted interfaces to provide multiple degrees of in-plane angular and translational adjustability to ensure proper in-situ alignment with each stowed antenna.

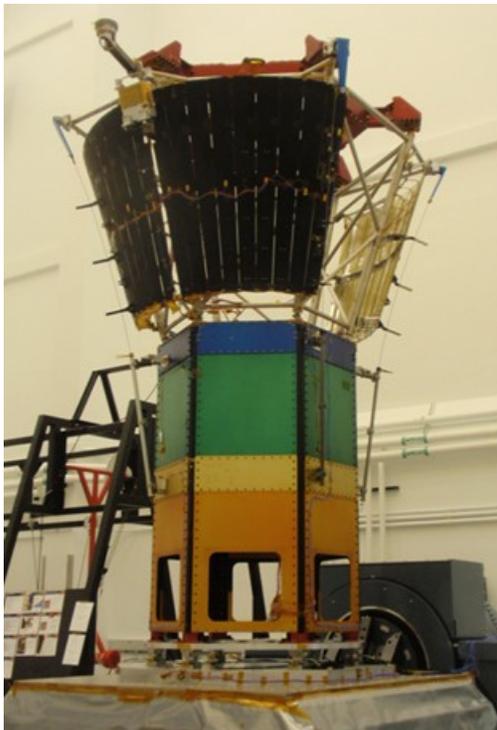
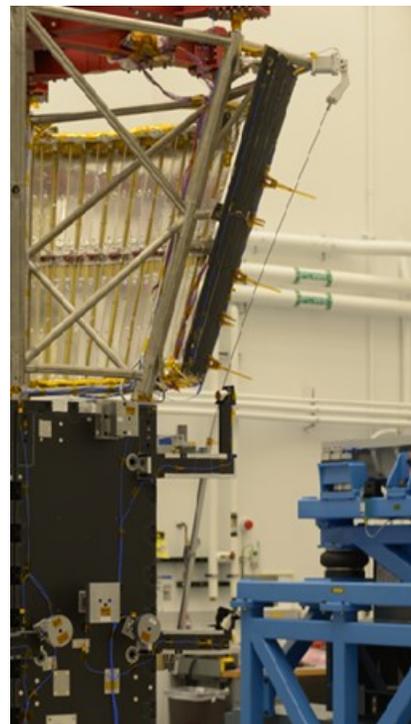
Figure 10: Left: EM Clamshell with preliminary fork configuration.  
Right: EM Clamshells on structure "stiffness simulator"

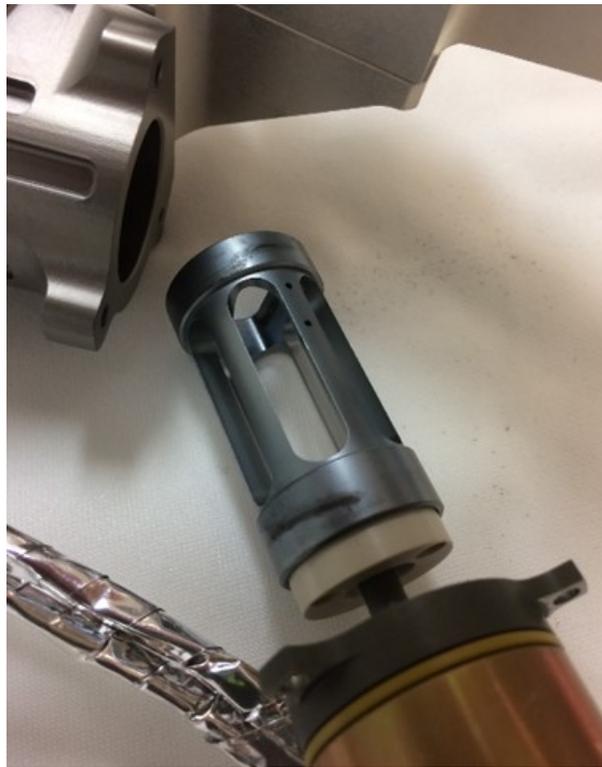
Despite a successful testing campaign of the first and second EM iterations of the clamshell mechanism, an anomaly of the V3-position flight clamshell occurred immediately following protoflight vibration testing. The unit failed to actuate; the proper voltage was sent to the TiNi Pinpuller, a faint click was heard, but no movement was observed. The electrical ground support equipment (EGSE) was checked, determined to be functional, and voltage was applied to the redundant (backup) circuit of the pinpuller, yielding the same result, but with no additional audible click.

The frozen clamshell was carefully photographed in this state, and a course of action was devised. It was unknown at that time if the failure was contained to only the pinpuller, or if was problem at a higher-level assembly and something in the rest of the mechanism was bound. As the mounting screws were being carefully (no shocks or bumps) removed from the top mount to the titanium hinge housing, the clamshell deployed. From this event, it was theorized that perhaps the distortions in the housing caused by the screws prevented the cup from sliding down a perfectly straight bore. This also immediately indicated that the problem was not isolated to the pinpuller, which was maintaining a constant 44-N (10-lbf) pull force, and that there were external effects acting on the greater mechanism. Despite the deployment, a fish scale was attached to the back of the pinpuller to measure the extraction force necessary to remove the sliding cup and pinpuller assembly (Figure 11). 36 N (8 lbf) was measured; it should have been nearly zero. With the addition of the predicted 18-N (4 lbf) disengagement force necessary to actuate the hinge legs, the 53-N (12-lbf) combined force is outside the operational capabilities of the P10. Along with the extraction of the cup, dark, powder-like FOD was observed to come out as well. This FOD was collected for chemical analysis, and it was determined to be comprised primarily tungsten disulfide powder, with a combination of trace amounts of titanium. This was FOD produced from the mechanism itself, and not from an external source. This was not an anomaly that was caused by mishandling or a dirty environment.

*Figure 11: Removal of the sliding cup and pinpuller assembly, immediately after deployment anomaly*
