# Mars 2020 Motor Bearing Failure, Investigation and Response

David Suffern\*, Jeff Mobley\* and Stephen Smith\*

## Abstract

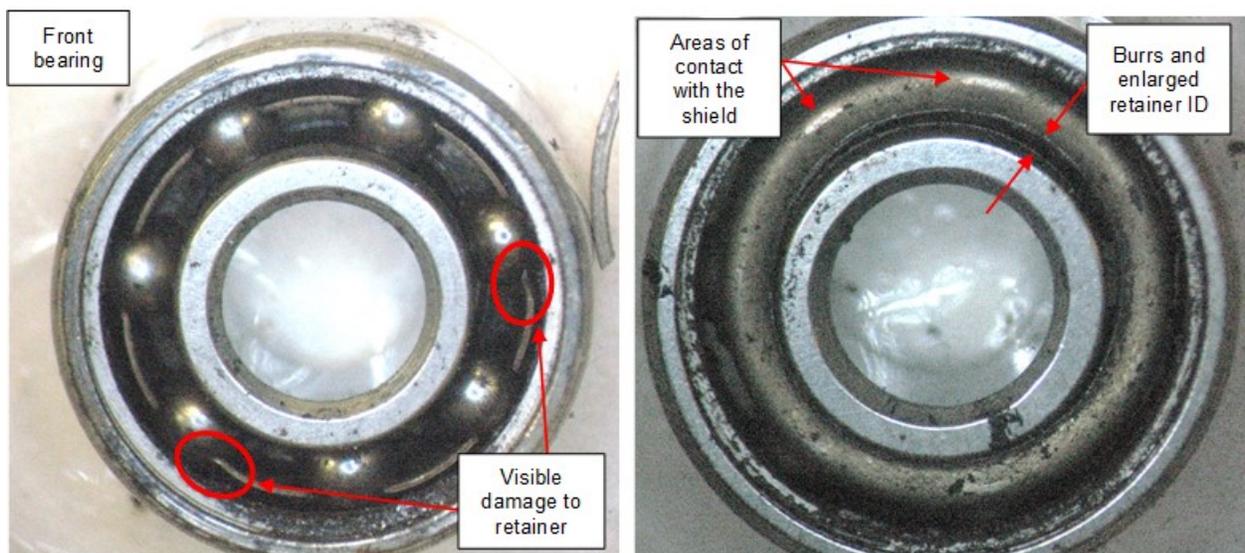
- A significant amount of wear debris was present on both sides of the front motor bearing: motor rotor and motor pinion. See Figure 8.
- The front bearing rotated roughly and caught occasionally. Two fingers of the ball retainer were visibly damaged. The bearing was very dry and empty of both lubricant and wear material (appeared to have been ejected into motor rotor and motor pinion areas). The inner (piloting) diameter of the crown steel retainer included a rolled burr. Further inspection found that this inner diameter was measurably enlarged, allowing radial movement of the retainer to the point where the outer diameter of the retainer could contact the inner diameters of the outer race. Additionally, there were indications that the retainer spine contacted the interior surface of the bearing shield, indicating that the retainer ball pockets had worn to allow excessive axial movement of the retainer. See Figure 9 for the appearance of this damaged front bearing.

Figure 9 – Interior Inspection and Retainer Observations on M45S Front Motor Bearing from ShEI DV Unit

The results of this and other unit teardowns led to the development of the following failure sequence theory:

1. Operation at the -70°C temperature plateau, very close to the lubricant pour point of -72°C, rendered the lubrication scheme ineffective, resulting in lubricant starvation conditions.

2. Starvation conditions, never a desired condition for long life bearing operation, had the most significant effects on the crown steel retainer, wearing first at the inner diameter (ID) of bearing retainer spine, where guided.

3. Retainer wear debris mixed with grease, accelerating wear as the grease became an abrasive mixture with the wear particles.
4. Retainer ID continued to grow with wear, allowing it to move radially out of position.

- a. Ball pockets began to wear against balls, generating debris and burrs.
  - b. Outer diameter faces of the retainer began to wear on the outer ring and inside of shields.

5. Wear debris led to increased drag in the bearings, causing increased noise in the motor current signature.
6. Eventually lubricant was depleted and dry debris was ejected from the bearing.

7. Two types of failure were observed:
  - a. The bearing retainer was jammed between the ball and outer ring, stalling the motor. This mode was the initial life test failure observed in the original ShEI DV M45S motor.

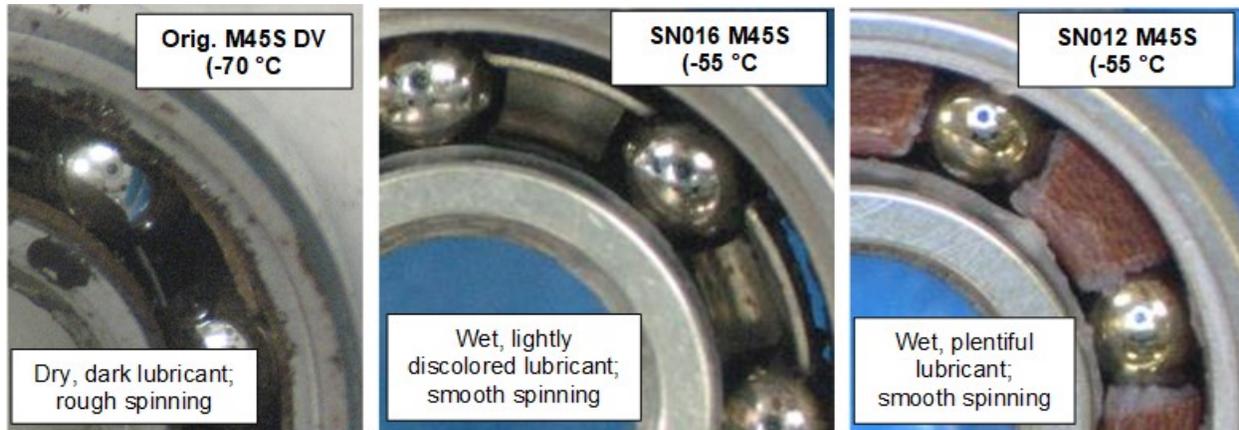
Figure 12 is a comparison of the post-life test condition of the front motor bearing from various units:

- Left: Original M45S DV motor-only life test with mission temperatures of  $-70^{\circ}\text{C}$  to  $+70^{\circ}\text{C}$ . Bearing spun roughly and the lubricant/wear debris was dry and dark.
- Center: M45S SN016 full-speed baseline bearing life test with modified mission temperatures of  $-55^{\circ}\text{C}$  to  $+25^{\circ}\text{C}$ . Bearing spun smoothly and lubricant was still present and slightly discolored around the retainer ball pocket areas.
- Right: M45S SN012 full-speed life test with modified mission temperatures of  $-55^{\circ}\text{C}$  to  $+25^{\circ}\text{C}$  and a phenolic retainer with 22 mg grease/oil slurry fill. Bearing spun smoothly and lubricant was plentiful and minimally discolored.

Figure 12 – Post-Life Condition of Front M45S Bearings

While the end-of-life condition of the bearings with phenolic retainers was superior to those with baseline crown steel retainers, the level of risk and schedule impact associated with replacing bearings installed in flight motors was deemed too significant. Multiple life tests confirmed that increasing the minimum mission life test temperature from  $-70^{\circ}\text{C}$  to  $-55^{\circ}\text{C}$  resulted in the baseline bearing configuration meeting the margined life requirements. The team planned to implement this change in minimum operating temperature by allocating the motor heating power budget proportionally based on the life requirement of each M45S motor application. By October 2019, the robotic arm joint assemblies, using SNC gearmotors containing the M45S motor with the baseline bearing configuration, were qualified for flight after successfully completing their margined life tests utilizing an increased minimum mission life test temperature of  $-55^{\circ}\text{C}$ , providing additional confidence in the chosen solution.
