TESTING AND LESSONS LEARNT OF LISA GPRM

Andreas Neukom⁽¹⁾, Romeo Romano⁽²⁾, Philipp M. Nellen⁽³⁾

RUAG Schweiz AG, RUAG Aerospace, Widenholzstrasse 1, CH-8304 Wallisellen
Emails: ⁽¹⁾andreas.neukom@ruag.com; ⁽²⁾romeo.romano@ruag.com; ⁽³⁾philipp.nellen@ruag.com

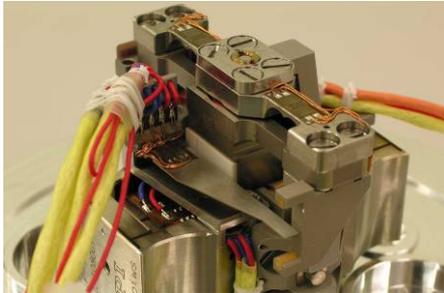
Figure 15: Position sensor

The position sensor consists of a deflectable Titanium blade where on the upper and lower side resistance strain gauges are applied and wired in a full Wheatstone-bridge.

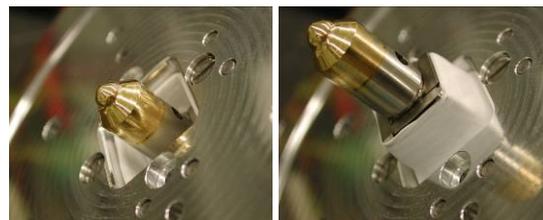
Figure 26: Dust trap membrane

- To prevent any ingress of the particles into the EH a dust trap has been implemented. It consists of an extruded PTFE hose, one end fixed to the actuator bracket (which does not move) and the other end fixed to the linear runner.
