Wan Zhihua , Hao Hong , Zhou Hui , Gou Shining, Hu Hanjun, Yang Lamaocao, Zhang Kaifeng

*Science and Technology on Surface Engineering Laboratory,Lanzhou Institute of Physics,
China Academy of Space Technology,Lanzhou 730000,P.R.China, Email:wzh510@sina.com.cn*

1.1 Harmonic drive gears lubricated with PFPE grease-lubricated W-C:H Coatings

1.2 Harmonic drive gears lubricated with sputtering MoS₂ films

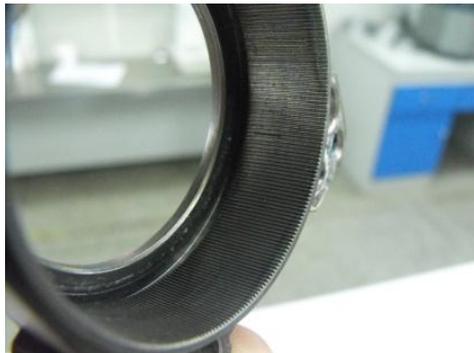
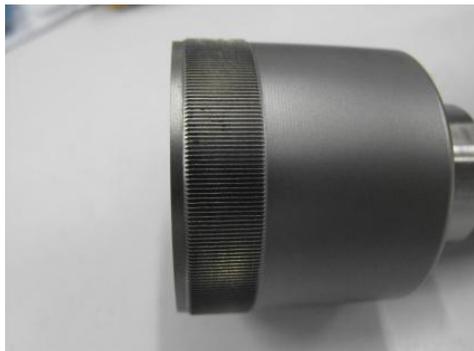
Fig14 Surface morphology of harmonic reducer after the tests

a) circular spline teeth

b) flexspline teeth

c) innerface of wave generator-flexspline.

It could be seen that the circular spline teeth and flexspline teeth showed almost no wear after extreme temperature storage test, thermal vacuum test and atmospheric life test. Only slight wear was found at the innerface of wave generator-flexspline.
