DESIGN AND INTEGRATION OF A DEPLOYABLE ANTENNA WING ASSEMBLY

ABSTRACT

As one combines mechanisms into a larger deployable subassembly, there are things to consider and of course, lessons to be learned. This Antenna Wing Assembly was designed mostly with components that had been flown previously but that did not prevent surprises during integration and test.

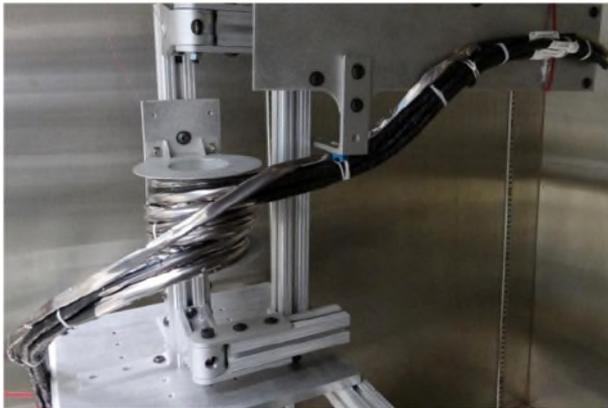
Both the harness configuration that crosses the hinge line and the configuration that crosses the gimbal axes were tested for continuity, resisting torque vs angle at temperature, and life. A simple fixture of 80/20 aluminum (Fig. 3) was connected to a load cell and motor

to cycle the harness. The life test was done at acceptance temperatures for 7000 cycles (1.5x life).

Figure 3. Hinge harness life test set up

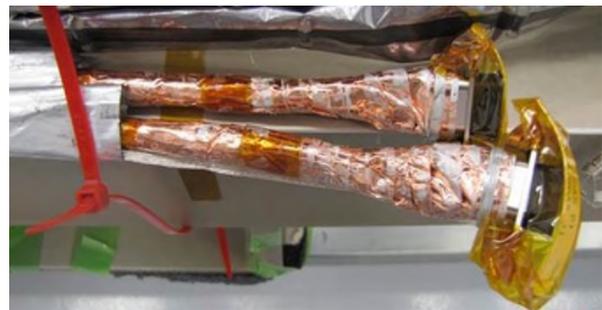
The harnesses have tightly wrapped copper tape that extends approximately 18 cm (7 in) beyond the connector face (Fig. 6). Extensive harness shielding is required for harnesses outside the spacecraft due to the mission’s stringent EMI requirements. This made the harness so stiff that it prevented the harness from being routed around waveguide and structure.

Figure 6. Copper wrapping made the harness very stiff

The solution was to cut off the connector, adjust the harness length to optimize routing, re-attach connector, re-form the harness with the required tight bends, and re-wrap the harness with tape and germanium Kapton® tube. The main issue with this harness build was that it was done on a flat pattern and not on a 3D formboard. To compress the rework schedule, the harnesses were reworked on the flight structure, causing a significant delay to the overall assembly. Anytime harnesses are wrapped they should be built on a 3D formboard so that they can be formed and wrapped in the correct length and shape.

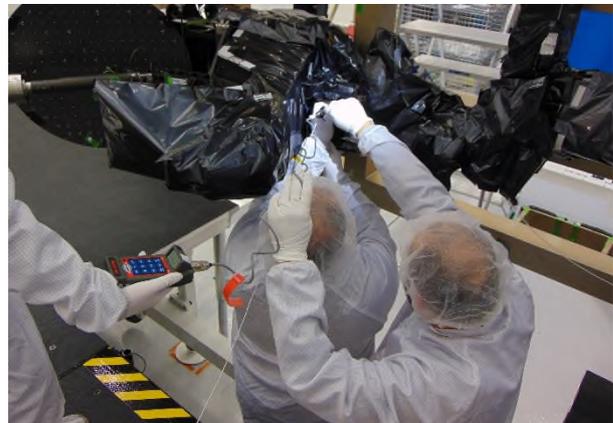
The practice installation check proved to be invaluable. Overall, it resulted in eight drawings needing updates to correct errors and provide clearer direction, the strain gage measurement equipment calibration procedure needed to be modified, the inspection plan updated, and new tools needed for ergonomics and configuration. Actually, in two locations, the LRAs were impossible to install (Fig. 8). New tooling was absolutely needed, but the AWA needed to continue processing toward installation on the vehicle. The new tools were designed and then the technicians used the Lockheed Martin virtual reality center to practice and complete the design. Virtual reality allowed the geographically isolated design, tooling, and manufacturing teams to collaborate closely on the design changes despite pandemic-related restrictions on in-person meetings. The next installation on the vehicle was successful.

Figure 8. Difficult access – a person who has four hands would be helpful!

Even with improved tooling, access to the launch restraint assemblies remained a challenge. Early in the design phase, the LRA was optimized to maximize similarity to heritage and to minimize its size, but these two features came at the expense of the assembly being more difficult to install. Over the course of four installations to the spacecraft, multiple nuts and restraint rods were damaged when tools slipped off the small nut. Adequate spares were available to replace these damaged parts, but this demonstrates how critical it is to have integration reviews early in the design process to ensure designs consider assembly, integration, and test.

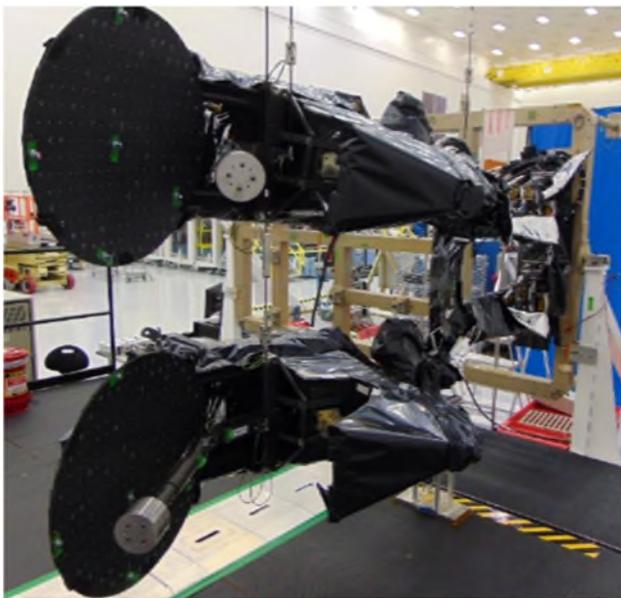
After ambient deployment, prior to antenna range testing, the AWA was cycled to temperature extremes in a TVAC chamber. During assembly and test, the AWA is attached to a strongback (seen in the background of Fig. 9) and would be on this strongback with the hinges deployed while in the TVAC chamber. The release devices were uninstalled to ensure no interaction between the aluminum strongback and the composite structure.

Figure 9. AWA on assembly fixture

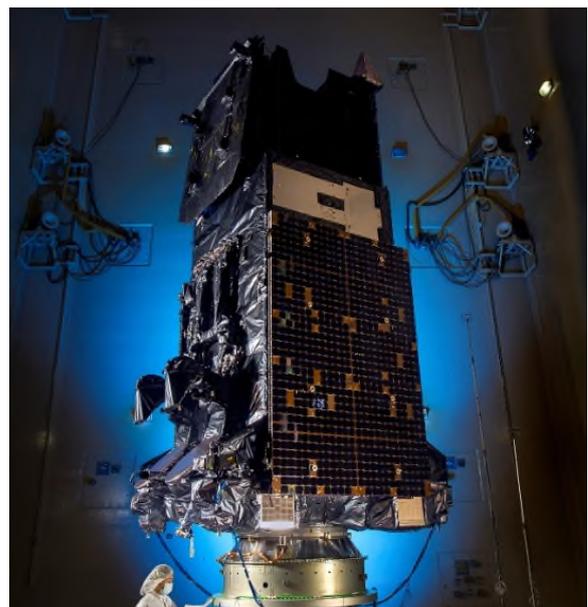
When designing and integrating a larger deployable subsystem, the mechanism engineer needs to consider and have knowledge not only about the usual mechanism parts such as bearings, actuators, and release devices but also possibly such parts as structure, waveguides, and antennas. This Antenna Wing Assembly development provided several lessons that the team learned quickly as the second AWA build went very smoothly. The fully blanketed AWA is shown installed on the spacecraft in Fig. 11. The AWA was successfully deployed on orbit.

Figure 11. AWA installed on side of spacecraft
