MINIATURE MOTORIZED ANTENNA FOR LOW-FREQUENCY RADAR OF THE HERA-JUVENTAS MISSION

ABSTRACT

There is still a lot to explore in asteroid science and it is time to utilize a low-frequency radar onboard Juventas CubeSat of the Hera mission. Four antennas, one of the world's smallest of that type, are located in the corners of the 6U cubesat to constitute the mechanical part of the radar - S/C primary payload.

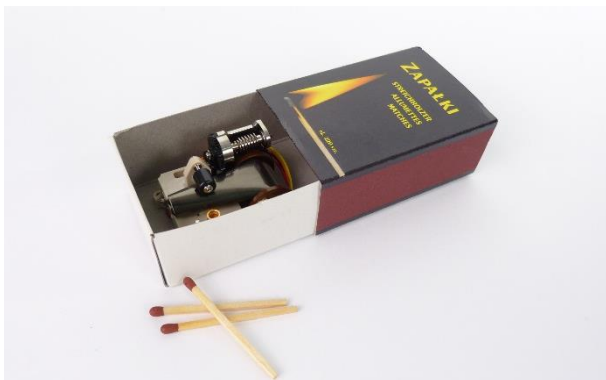
Figure 1. Antenna size

Astronika was responsible for the development & delivery of four motorized, deployable & retractable antennas, each not much larger than a box of

matchsticks when stowed (See Fig 1). Deployed part of each antenna is 6 mm in diameter and 1.25 m long.

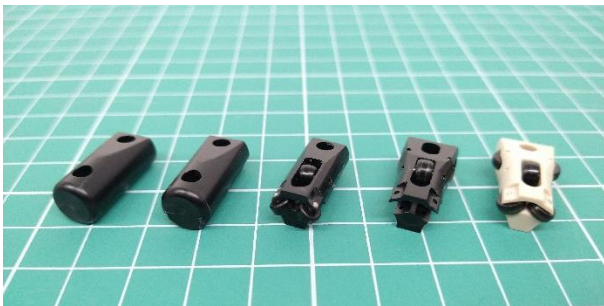
Guiding rod's function is to stabilize the antenna while it is being deployed. In bigger devices, complicated multi roll systems may be used, but for the Juventas antenna very small and simple, cylindrical part was used (see Fig. 5, left-most part). During TVAC failure investigation it appeared that guiding rod is creating a friction force with the value high enough to be worthy optimizing. Whole evolution process took several weeks in parallel to other optimizations. In the end 1-part guiding rod turned into quite sophisticated 11-part mechanism offering good guiding with the low friction. Step-by-step evolution process is depicted in Fig. 5.

Figure 5. Guiding rod evolution
