INSPECTION OF SEPARABLE SURFACES – LESSONS LEARNED

ABSTRACT

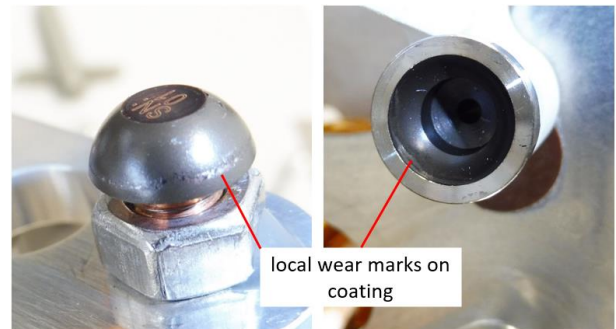
Figure 14 Wear marks on coating

With four of these interfaces, the launch lock is mechanically overdetermined. This is required to achieve the necessary stiffness in launch configuration, however increases the risk of local gapping and sliding, since the preload is depending on the alignment precision and the stiffness distribution.

As a consequence of this, sliding on the edge of the ball joint occurred with local wear marks on the coating of both parts were detected.

With the dissimilar materials of the interface parts and since no plastic deformation or debris was detected, this effect was accepted and several of these mechanisms released successful in orbit.

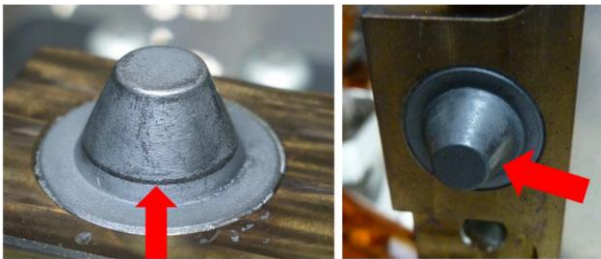
Figure 16. Cones with different compression marks

Due to the misaligned installation, the cup-cone connection was statically loaded and exposed to vibration and thermal cycles. During visual inspection, local shiny rings were observed, as shown in Figure 16 on the left. On previous assemblies, as shown in the same figure on the right, the shiny compression marks are distributed more uniformly over the entire cone. Since these compression marks alone are not critical, the cones were examined for plastic deformation. This was done with rulers and LED light from the opposite side. With this method, no plastic deformation of the shiny ring area was found.

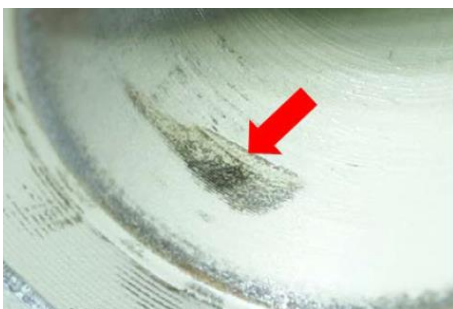
Figure 17. MoS2 transfer to the aluminium cup

On the cup side, the inspection could not identify plastic deformation either but transfer of the MoS2 lubricant from the Vitro-Lube, as shown in Figure 17. In case the binder material would be transferred as well, this would be critical. For the Vitro-Lube however, the binder is ceramic and only small amounts of MoS2 powder is transferred, which is commonly observed.
