Brake Failure from Residual Magnetism in the Mars Exploration Rover Lander Petal Actuator

Louise Jandura*

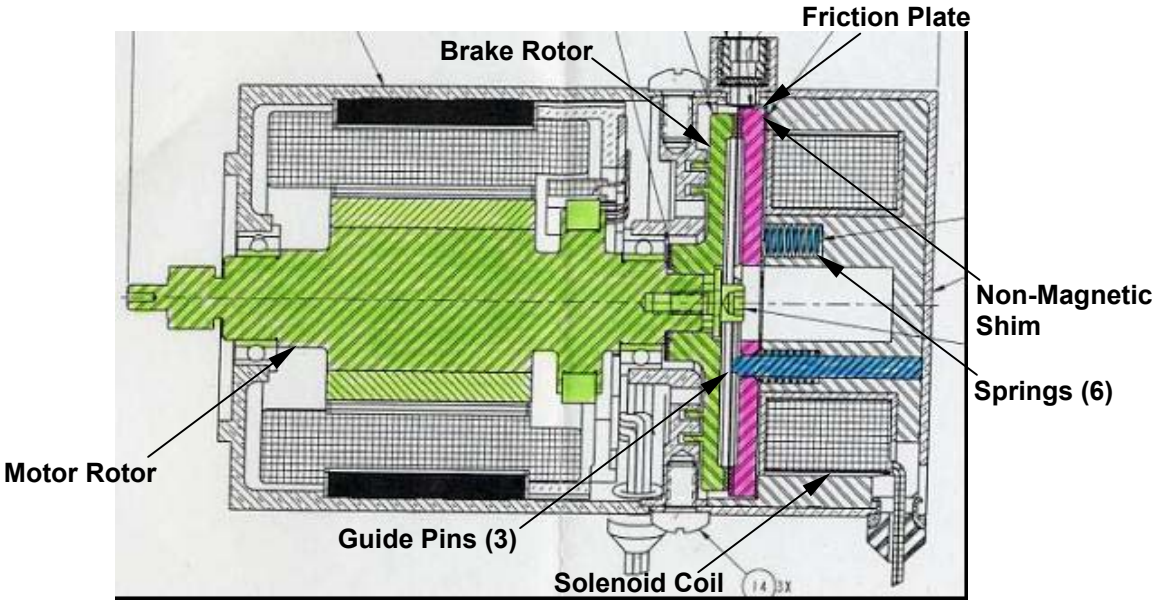
Figure 5. Cross-section of the Lander Petal Actuator motor/brake assembly

power to the LPA motor to initiate petal motion. At the conclusion of motion, power is first removed from the LPA motor and then the LPA brake to avoid clamping the brake rotor at high speed. All LPAs were tested over temperature at the actuator level to restrain 3300 N•m externally applied to the output shaft. The brake design is a standard spring-applied, power-to-release configuration as shown in the motor/brake assembly cross-section (Figure 5). The brake rotor is attached to the motor rotor. With the brake unpowered, 6 compression springs push the friction plate against the brake rotor, preventing motor rotation. When the brake is energized to release the motor, the friction plate is guided on 3 pins and pulled against the springs by the solenoid. The total stroke of the friction plate is 0.13 mm. There is a 0.051 mm annular non-magnetic shim between the friction plate and the solenoid to break the magnetic flux path and prevent residual magnetism from permanently retaining the friction plate on the solenoid (the stuck-open position).

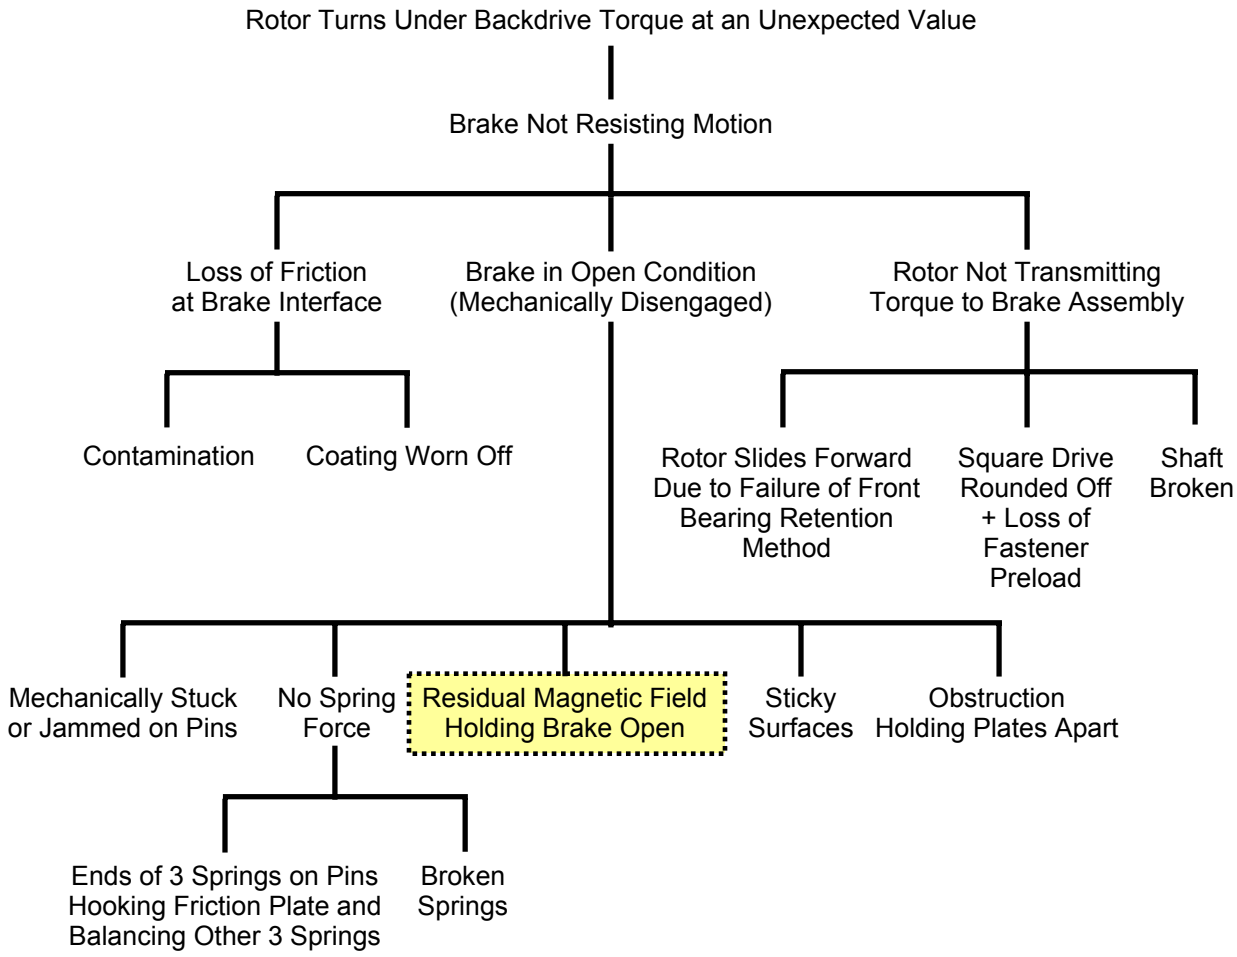
Figure 6. Fault tree for LPA brake failure with the actual failure highlighted in the dotted box

The evidence at this point only indicated that the brake was not resisting motion. Many different failure possibilities were considered which fell into the following general categories: “Brake in Open Condition”; “Loss of Friction at Brake Interface”; or “Rotor Not Transmitting Torque to Brake Assembly” (Figure 6). Many of the failures could only be observed through disassembly of the brake and some of these had the additional unfortunate characteristic that disassembly could cause the loss of the failure. After visual examination of the LPA indicated nothing unusual, the motor was operated with no power to the brake. Motor current indicated no-load operation, which meant the failure was still intact. Real time X-ray examination revealed the brake in a fully disengaged position even though no power was applied to the

brake. This observation eliminated two of the three branches of the fault tree, leaving only the failures listed under “Brake in Open Condition”. No tilting of the friction plate was apparent and nothing unusual was observed in the brake assembly. The only failure remaining that could be determined without disassembly was “Residual Magnetic Field Holding Brake Open”. While still under X-ray examination, a reverse polarity voltage was slowly applied to the brake starting at 0 volts, a demagnetizing action for the friction plate. At negative 0.3 volts, the friction plate moved to the engaged position against the motor rotor indicating the failure was caused by residual magnetism holding the friction plate against the solenoid even though a non-magnetic washer was in the assembly to prevent this particular failure. The motor stalled when operated again with the brake unpowered proving that the demagnetized brake was now fully mechanically engaged. Residual magnetism was the source of the failure in this LPA!

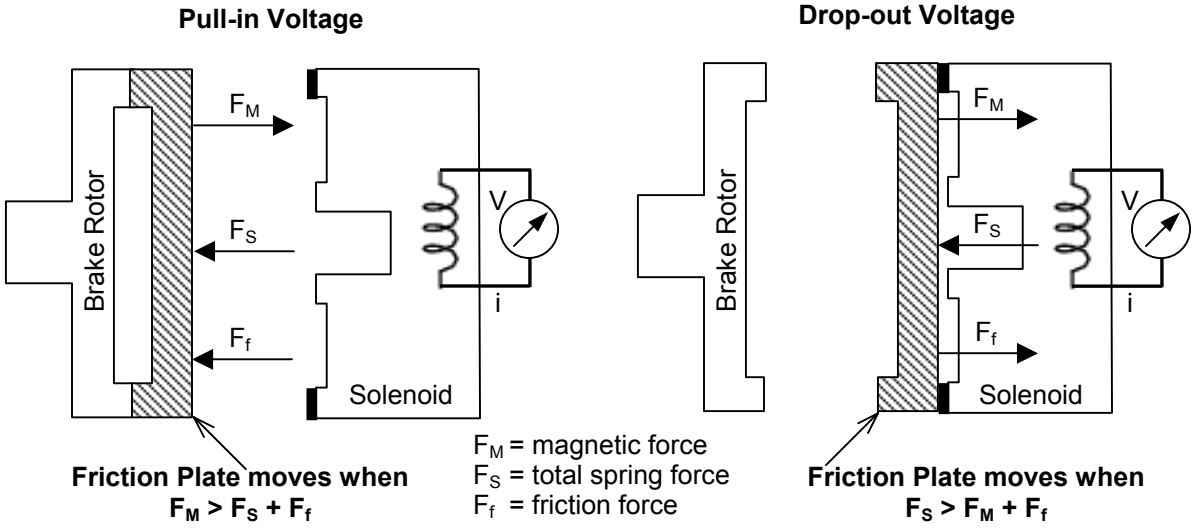
Figure 7. Force balance for brake pull-in and drop-out voltages

Drop-out voltage is then measured by slowly lowering the voltage until the friction plate releases from the solenoid, mechanically engaging the brake rotor again. Figure 7 illustrates the force balance for drop-out. Decreasing the voltage across the solenoid reduces its current and therefore the magnitude of the

the friction plate moves away from the solenoid and reengages the brake rotor. Once motion begins, the friction plate moves quickly to the engaged position since F_M decreases much faster than F_S as the air gap increases. In the case of the failed brake, the condition in equation 2 was not met even though the solenoid voltage and therefore current was zero. F_M was non-zero due to residual magnetism.

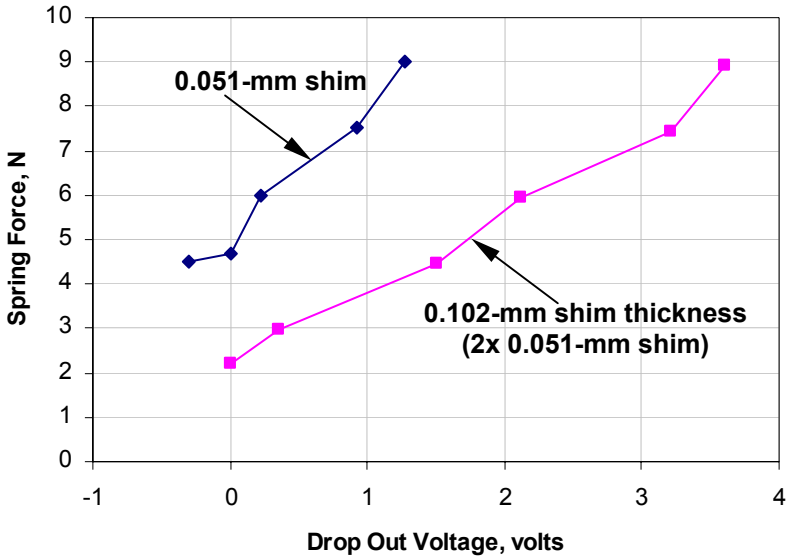
Figure 8. Test data from a spare brake assembly characterizes the variation of drop-out voltage with spring force for two different shim thicknesses.

There is no way to take a direct measurement of force in the brake assembly on the fully assembled LPA, therefore there is no way to directly verify the force margin for drop-out on each LPA. Since drop-out voltage is the only easily acquired measurement on the fully assembled LPA, what was needed was a relationship between drop-out voltage and force so that a minimum force factor of safety of 2.0 could be guaranteed. A series of tests was performed on a spare brake assembly to determine how drop-out

voltage varied with spring force. The nominal spring force was calculated from the spring constant and the geometry of the brake assembly. Starting with the friction plate pulled in against the solenoid, the voltage to the brake was lowered until the plate moved under the force of the springs. Reducing the number of springs in the brake assembly decreased the spring force pushing on the friction plate until the brake plate no longer dropped out at zero voltage (Table 2). At this condition, the residual magnetic force is greater than the spring force attempting to push the brake plate off the solenoid. An additional test was performed with no springs in the brake assembly. The voltage to the brake was reduced to zero and a measurement of the force required to separate the friction plate from the solenoid was recorded (Table 3). The same measurements were taken after adding a second non-magnetic 0.051 mm shim between the solenoid and the friction plate (Tables 2 and 3). Adding the second shim raised the drop-out voltage significantly (Figure 8) without changing the pull-in voltage substantially. These tests enabled a method to determine the force margin and illustrated a rework path that could increase that margin.

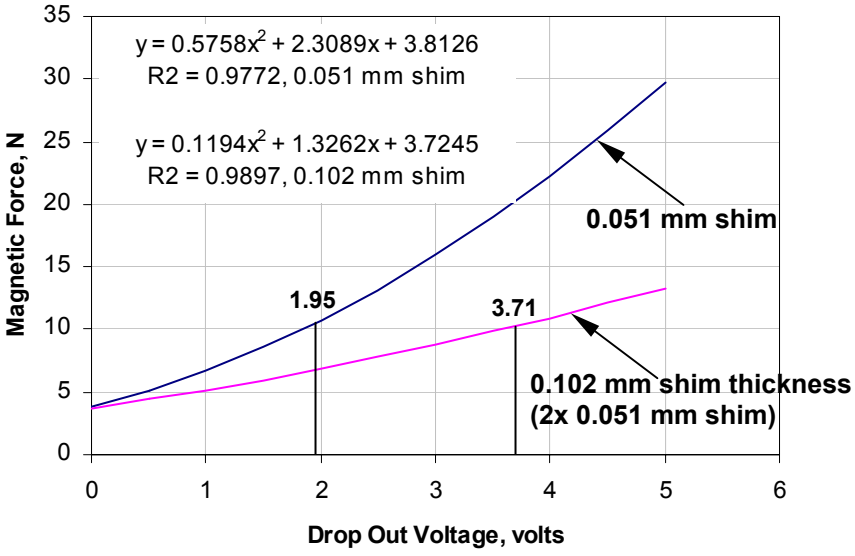
Figure 9. Regression curves from test data are appropriately shifted and used to determine the drop-out voltage required for a minimum 2.0 factor of safety.

with a, b, and c all constants. Setting c equal to the minimum possible spring force of three springs minus the maximum possible friction force from the alignment pins shifted the curves. This ensures that when six springs are present, there is a minimum factor of safety of 2.0 on the force required to create drop-out at the zero voltage condition. The two shifted regression curves are plotted in Figure 9, one curve for a single, non-magnetic 0.051-mm shim and one for a double, non-magnetic shim or a 0.102 mm total shim thickness. The final margin point for each shim thickness was calculated from the regression curves as the drop-out voltage values corresponding to the maximum possible force from 6 springs plus an additional two times the friction force. An additional 0.1 VDC was added to account for measurement scatter resulting in required minimum drop-out voltage values of 2.05 VDC for the 0.051-mm shim thickness and 3.81 VDC for the 0.102-mm shim thickness. It should be noted that the drop-out voltage of 0.6 measured during acceptance testing of the failed LPA works out to a force factor of safety of 0.97. This was a unit that clearly should have failed.

Two flight units, SN 003 and 008, had drop-out voltages of 0.79 VDC and 1.25 VDC respectively, well short of the minimum drop-out voltage of 2.05 VDC required for one shim per the margin analysis. These two units were removed from the second flight lander and transported to Aeroflex Laboratories, Inc. for rework. Rework consisted of adding a second, non-magnetic 0.051-mm shim between the solenoid and the friction plate resulting in a total shim thickness of 0.102 mm. A shim was removed between the brake rotor and the motor rotor to maintain the same brake actuation stroke. The rework was relatively straightforward, however the schedule intensity of the activity was increased substantially due to the proximity of the second launch and the criticality of the LPAs to mission success. The brake housing was carefully removed from the motor housing (Figure 10) after heating the brake housing up at the bond line and removing three screws. Brake housing removal was performed with the brake leads powered so the friction plate was secure against the solenoid. This prevented the friction plate and the compression springs from falling out of the housing during disassembly. The two brake plates are visible in Figure 11a. The brake rotor was removed so that its shimming could be adjusted. The six compression springs are visible after power was removed from the brake assembly to enable removal of the friction plate from the brake housing (Figure 11b). This is the location where the second shim was added after the assembly was cleaned up and inspected. The brake was reassembled. After rework, SN 003 and 008 had drop-out values of 4.09 and 3.85 VDC respectively, which met the minimum requirement of 3.81 VDC for the 0.102 mm shim thickness. Table 4 indicates the performance of these two LPAs, before and after rework.

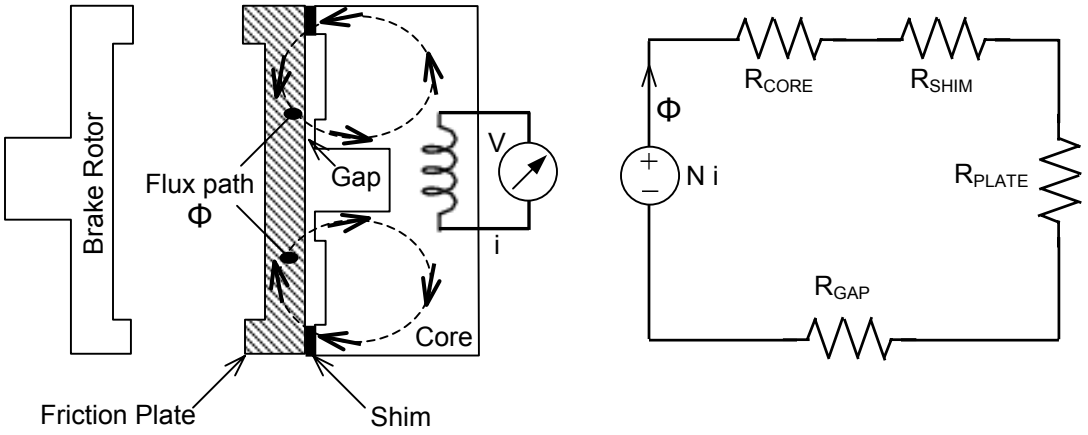
Figure 12. Magnetic circuit model

Since force on the friction plate is inversely proportional to the square of the plate's distance from the solenoid, the shim thickness has a large effect on the force balance in the brake assembly. This effect is larger when the friction plate is closer to the solenoid, which is why the addition of a second shim in the brake assembly has a significant effect on the drop-out voltage while having a minor effect on the pull-in voltage. This sensitivity allows the shim modification rework to be effective.

Equation 6 as written contains the assumption that the only source of magnetomotive force in the solenoid is the brake coil. However the evidence of the residual magnetism in the failed brakes indicates differently. The flux flowing through the solenoid when the brake coil is energized causes the friction plate to magnetize. When power is removed, the friction plate continues to behave as a weak permanent magnet, making it an additional source of magnetomotive force in the solenoid. This behavior is caused by the large hysteresis loop in the B-H curve of the 15-5 PH stainless steel. The core material has a B-H curve with an extremely small hysteresis loop therefore it retains no field. When the additional source of magnetomotive force from the friction plate is added in series with the other elements in the magnet circuit model, equation 6 becomes
