FRETTING WEAR ANOMALY OF FINAL CUBESAT EJECTION TESTS: EXPERTISE, SOLUTION TESTING, AND LESSONS LEARNT

Guillaume Colas [(1)*], Romain Petre-Bordenave [(2)], Yann Michel [(2)], Pierre-Henri Cornuault [(1)]

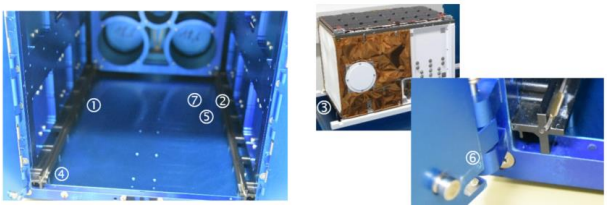
Figure 2: Sampling areas

During visual inspections, we noticed that at least 3 areas were subjected to abnormal wear and a lot of particles were present. Two of these areas are located near

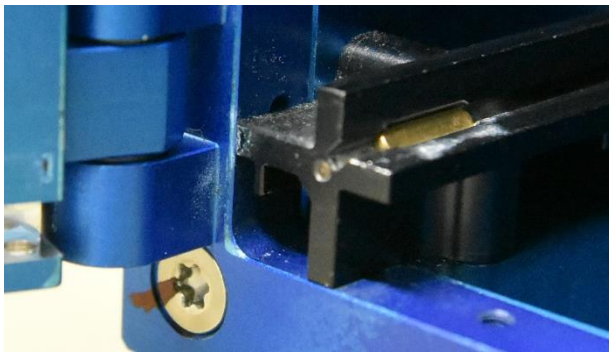
switches of the deployer rails. The corresponding areas on the satellites rails exhibits also a lot of wear.

Figure 3: Wear and particles near a switch

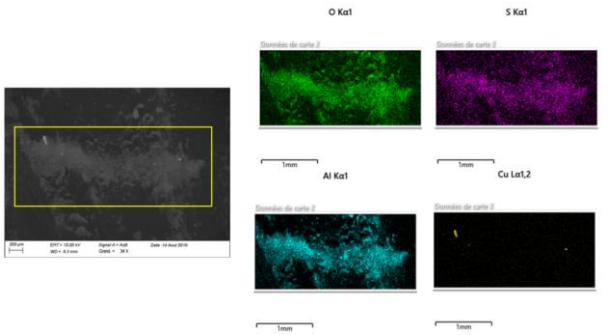
Particles were sampled using carbon adhesive on SEM stubs and were analysed using SEM and EDX. The results showed that the particles were mainly composed of alumina. Traces of Ziconium, Titanium and fluor were also found. On satellite side the rails are made of Al7075 treated by hard anodic oxidation and surtec 650. On the deployer side the rails are made of Al7021 treated by Hard anodic oxidation and interflon. The composition of the particles is thus consistent with the materials in contact.

Figure 4: Example of an EDX analysis

At this stage, the hypothesis of an external contamination acting like a third body in the contact and increasing the wear was excluded. All the particles came from the contact itself and the third body is not an external contamination but the product of the wear itself.

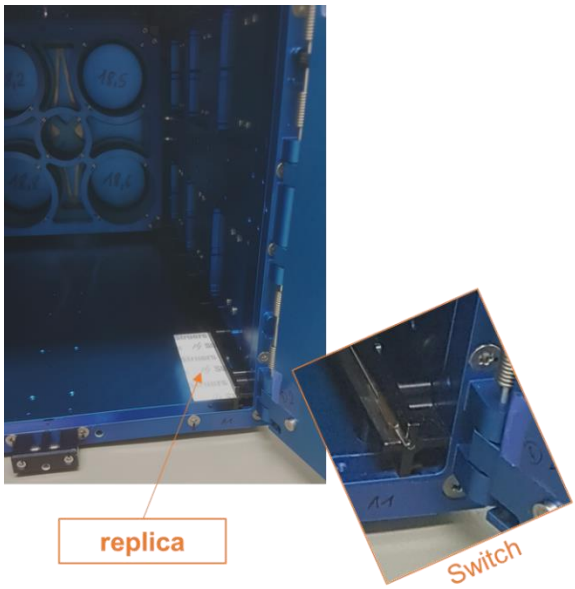
Figure 5: Example of a silicone replica on the deployer rail

The wear area on the Figure 5 shows almost no wear. The mean surface in the area is 800nm above the original mean surface. We also notice that the surface in the wear area is smoother than the original surface.

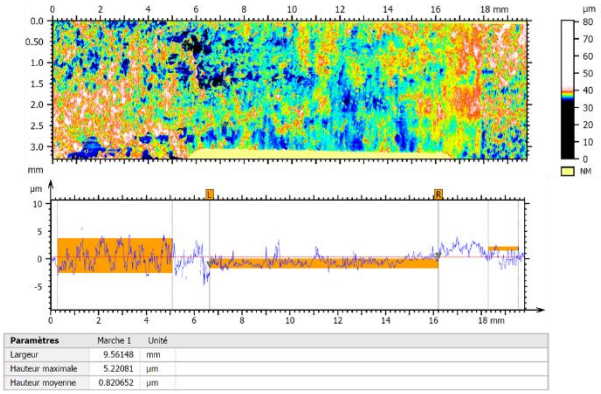
Figure 6: Profilometry on the deployer rail

With a closer look on this surface we were able to see that the weared surface could be locally 5 to 6µm above the original surface.

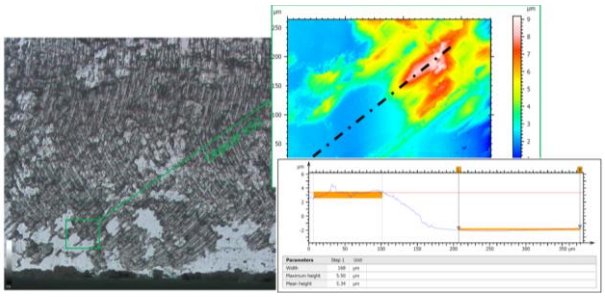
Figure 7: Material trapped in the roughness of the deployer rails

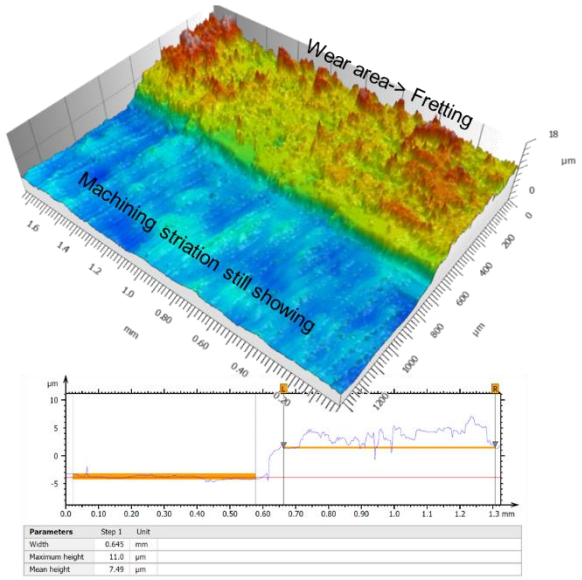
Figure 8: Profilometry on a wear zone of the satellite rail

The same analysis performed on the satellite rails exhibited more than 7µm of wear in average. Wear areas are well defined and it is not hard at all to define a frontier between the wear and the original surface. Moreover the bearing surface at 7µm of the satellite tracks if 100%. Meaning that the bearing surface can no longer increase with wear (locally at least) and that the wear phenomenon is not behaving like a run-in but will continue without any counter-measures.

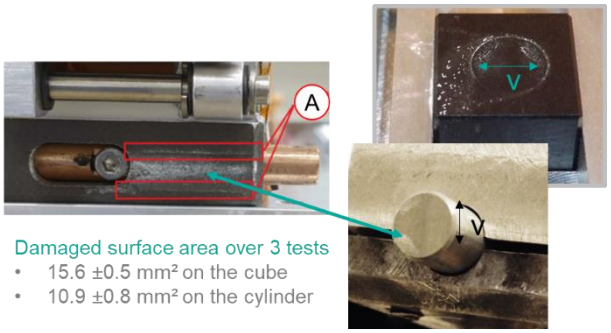
Figure 9 allows to compared the aspects of the worn surfaces on the satellite and on the tribometer scale

samples, after tests in dry conditions. Features, morphology (surfaces and debris) are successfully reproduced. Contact effectively occurs over few large spots. Over the 3 unlubricated test samples, the damaged area remains quite constant and varies little from one test to another.

Figure 9 - Comparison of damaged areas from satellite and from tribometer tests samples. The arrow v displays the sliding direction during the friction tests

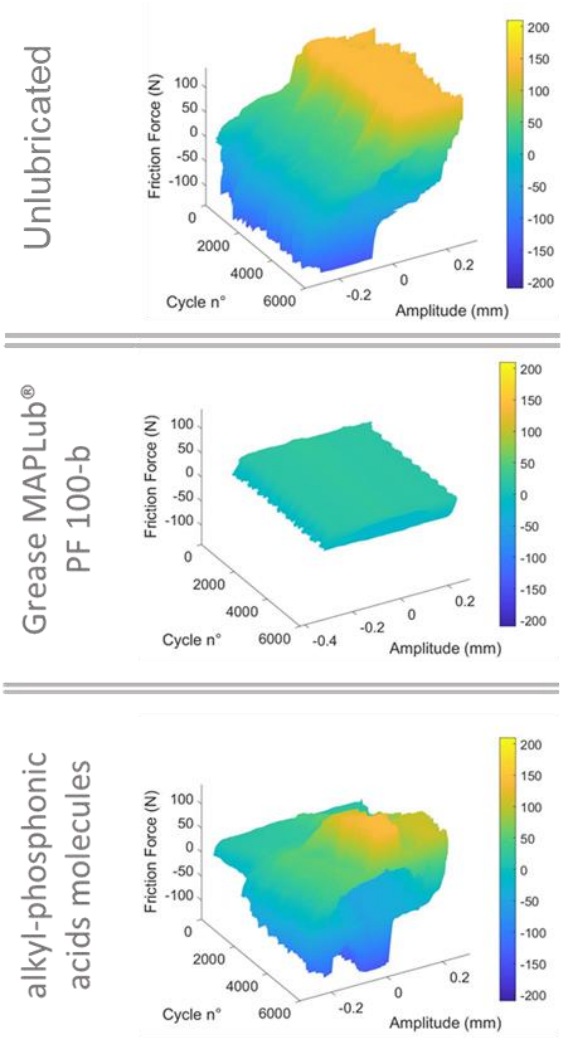
Figure 10 - Fretting loops of the fretting unlubricated and lubricated tests. The loop shape, with curvy sides, is typical of high adhesion fretting in sinusoidal displacement

Figure 10 is showing the fretting loop obtained during the fretting test in unlubricated condition, and in lubricated conditions after lubricant is applied on the damaged surfaces. It can be seen that in the unlubricated case, the friction demonstrates partial slip and very high amplitude of friction force, up to 100N in average (0.7 friction coefficient), pic at 140N (1 friction coefficient). During the test, particles are rapidly created and ejected continuously outside the contact, as evidenced on the cubic sample in Figure 9. White debris are indeed observed in the left side of the contact area. White 3rd body patches, are observed inside the friction tracks, in the mostly loaded areas. amount may have not been sufficient to sustain lubrication over the full test.

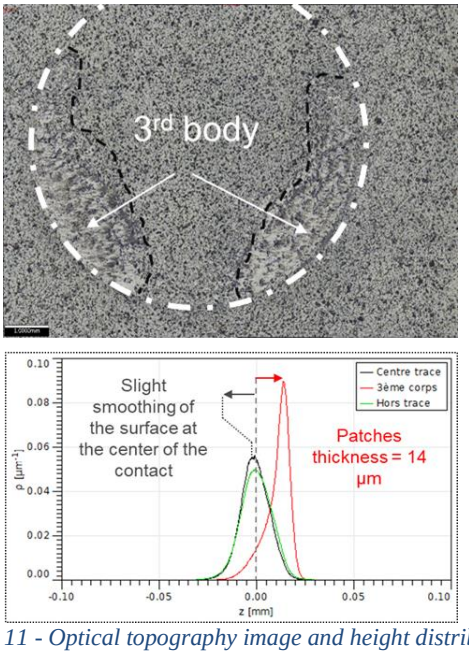
The optical analysis of the unlubricated samples shows that the worn samples is mainly the samples emulating the satellite. It also and that the 3rd body accumulate to form thick 3rd body patches. Figure 11 indeed shows that the cubic sample is not demonstrating significant wear, the surface at the centre of the contact is slightly smoother than the pristine surface. At the mostly loaded areas, 3rd body accumulates to create patches reaching a thickness of 14 µm above the overall sample surface. The cylinder surface (not shown) demonstrate mostly few microns deep worn region. Areas with accumulated 3rd body demonstrate 3rd body whose thickness may locally reach 2 µm. EDS analysis shows that debris and 3rd body are only coming from the cylinder (satellite-based material)[1]. Note that no fluorine is detected on the cubic samples (layer too thin?) but it on the cylinder material. Surtec650 is indeed containing fluorine [4]. The oxygen content is however significantly higher than what it is detected on the pristine materials, which is typical of tribo-oxidation seen during fretting tests in air [2,5].

Figure 11 - Optical topography image and height distribution of the 3rd body.

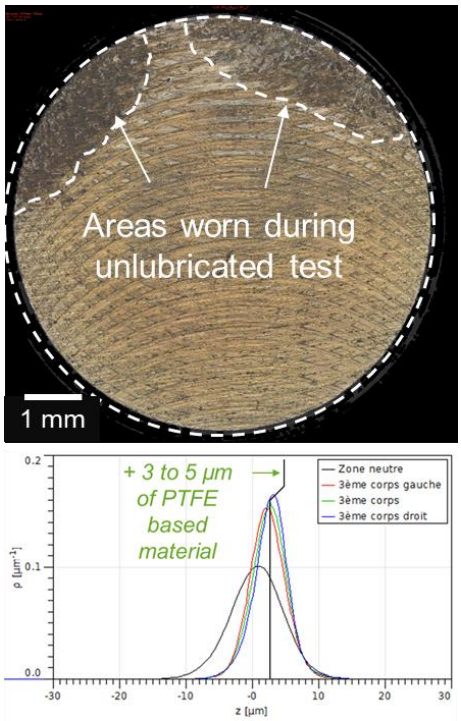
Figure 12 - Optical topography image of the cylinder sample demonstrating large accumulation of PTFE based lubricious material in previously worn areas

The grease lubricated test sequence demonstrates very stable pure sliding friction with a friction force of 15N in average (0.1 friction coefficient). The optical topography shows accumulation of 3rd body from coming from the grease and remaining rigidly bounded to the initially worn areas of the surfaces. This demonstrated on the mostly worn samples, the cylinder (Figure 12). Such PTFE layer formation behaviour has been shown to happen with grease containing PTFE particles [6]. While PTFE appears to bind only on the initially worn areas on the cylinder (i.e. on the satellite material), it is found everywhere in the contact on the cubic samples (i.e. deployer material), with slightly thickest patches in initially worn areas.

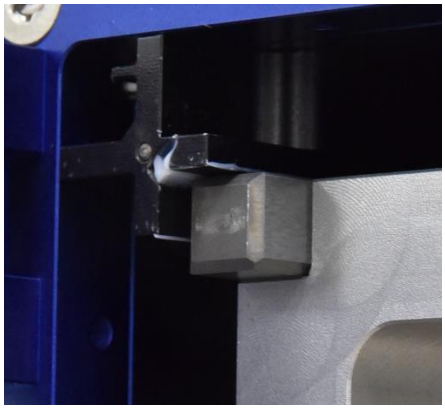
Figure 14 detail view of a rail after satellite dummy installation in deployer (QM)

Satellite dummy was then inserted into the deployer with a particular care on Sat/deployer alignment in order to avoid removing greases from the lubricated surfaces (cf. Figure 14).

Both satellite dummy and deployer rails were cleaned meticulously with isopropyl alcohol. MAPLub PF100b grease was applied on deployer side as shown in Figure 13 with a particular attention on the amount of grease: groove of the rail was filled of grease and a dedicated tool was used to spread the rest of the grease (0.2mm film thickness) while removing lubricant excess (cf. Figure 13 C).

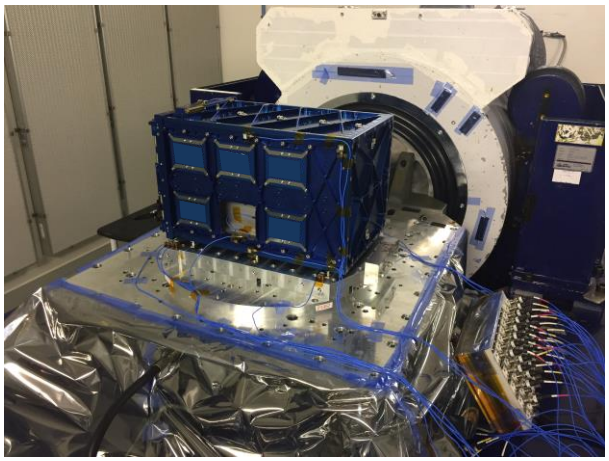
Figure 15 Deployer QM with satellite dummy on MID shaker

Both satellite dummy and deployer QM were submitted to a full mechanical vibrations qualification sequence (@qual level for 2 minutes, cf. Figure 15). Grease behaviour was observed during vibrations on bottom rails through an opening in the deployer. A grease bulge was observed and confirmed a satisfying grease circulation in the contact (cf. Figure 16).

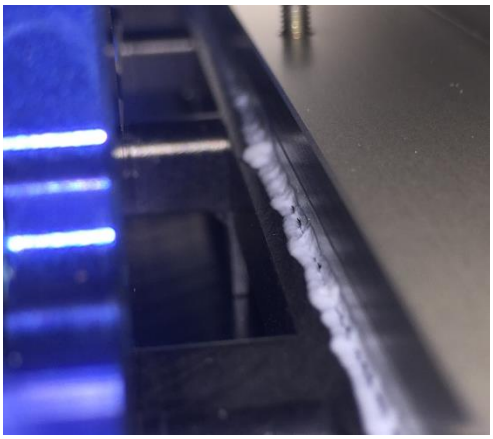
Figure 16 Grease bulge showing grease circulation on bottom rails

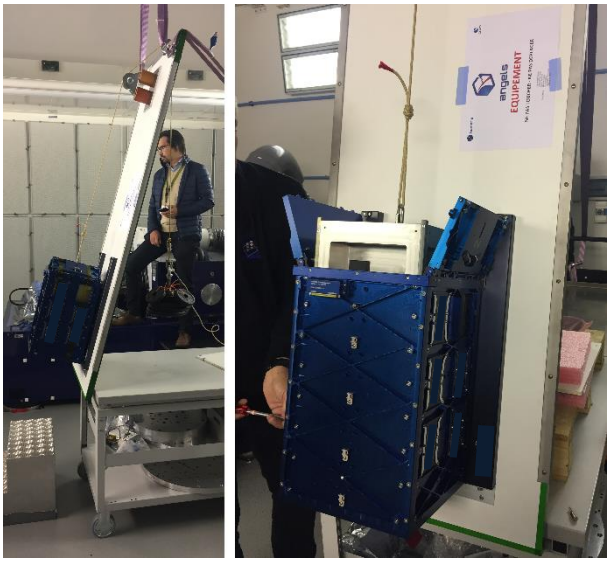
Figure 17 ejection test configuration

An ejection test was then performed at 75° (cf. Figure 17) in order to limit gravity effect on friction (with 1g compensation). A particular care has been paid in transporting the deployer on the ejection test GSE to avoid "unsticking" the satellite from the rails. Satellite dummy was successfully ejected from the deployer with satisfying margin. In addition, no wear or fretting marks were observed on both the satellite dummy and the deployer rails (cf. Figure 18). Grease was indeed observed on all sliding surfaces as expected. This successful test confirmed the choice of the corrective actions to solve ejection anomaly.
