# Space Shuttle Orbiter Atlantis Liquid Oxygen Pre-Valve Detent Roller Cracking Investigation

## Abstract

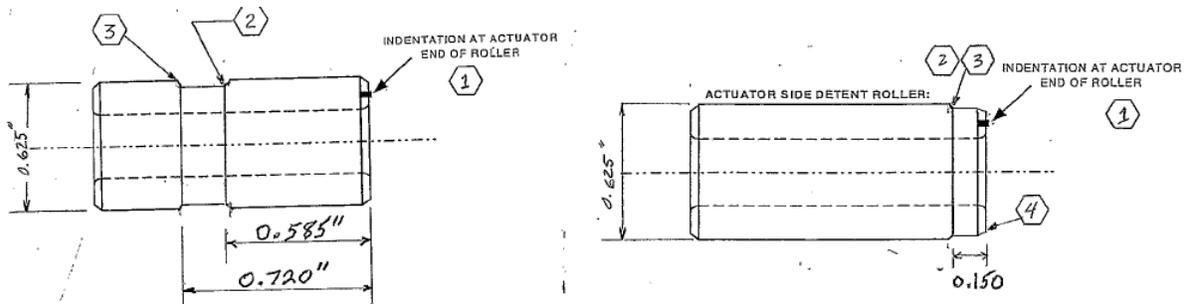
**Figure 7: Drawings showing how these rollers are machined to avoid discrepant areas on valve visors**

Some rollers within the fleet are specially machined to have a smaller diameter in specific locations. The purpose of this process is to reduce the effect of rough or high spots on that specific valve's visor. During inspections after the initial flights of the OV-103 and OV-104, several rollers in the LH<sub>2</sub> and LO<sub>2</sub> systems were found with rough gouges at specific distances along their lengths. Borescope and visual inspections concluded these instances of damage were due to wear associated with the high spots on each visor. Two rollers showing this type of damage are shown in Figure 6. Examples of specially machined rollers with gaps to avoid a high spot on a discrepant visor are shown in Figure 7.
