The Mars Climate Sounder In-Flight Positioning Anomaly

Bruno M. Jau* and David Kass*

Abstract

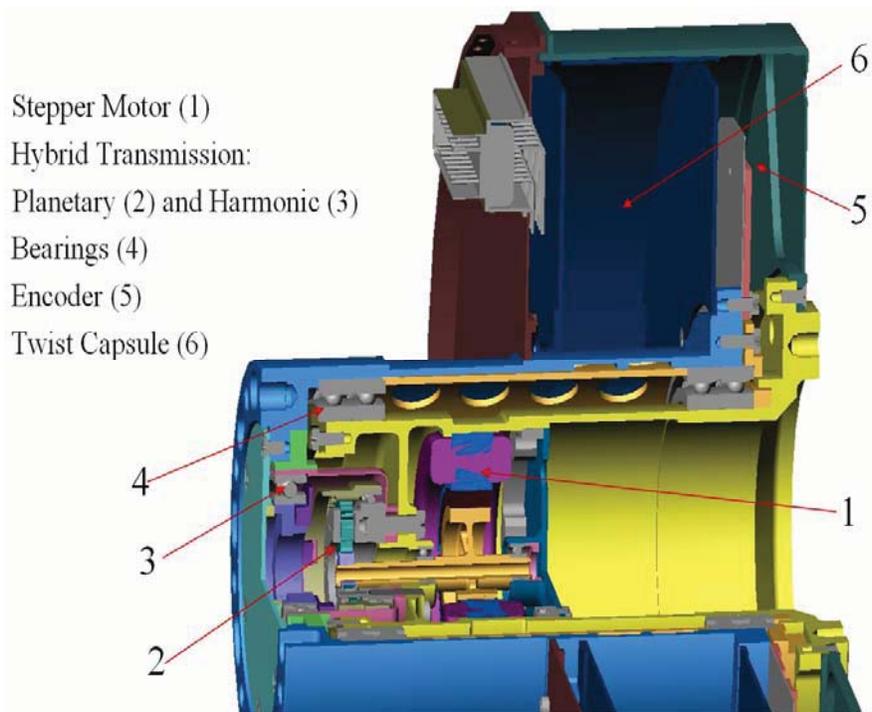
Figure 6: The Azimuth Actuator/Twist Cap

A disk (near item 5 in Fig. 6) normally blocks the light path between the light emitting diode (LED) and the phototransistor. The disk has one slot, allowing diode light to pass through when the slot passes a sensor. The slot size had to be made quite large (approx. 1-1/2mm) for sufficient light from the diode to pass through. Therefore, the sensor is triggered for up to six steps during each diode passage.

If the actual joint position does not correspond to the commanded position (due to whatever causes the anomaly), the position error has to be at least 3 steps away from the commanded position to be detected by this sensor system, having a 6 step diode trigger window. A sensed error reading is recorded but not reported immediately, thus complicating the error analysis (see "Error Discussion" below). Error cancellation is also possible if a subsequent error is in the opposite direction. However, if the flight software detects an error, it will reinitialize (see below), even if a subsequent error (hysteresis effect), should cancel it out.
