# Failure Analysis and Recovery of a 50-mm Highly Elastic Intermetallic NiTi Ball Bearing for an ISS Application

Christopher DellaCorte\*, S. Adam Howard\* and Lewis E. Moore III†

## Abstract

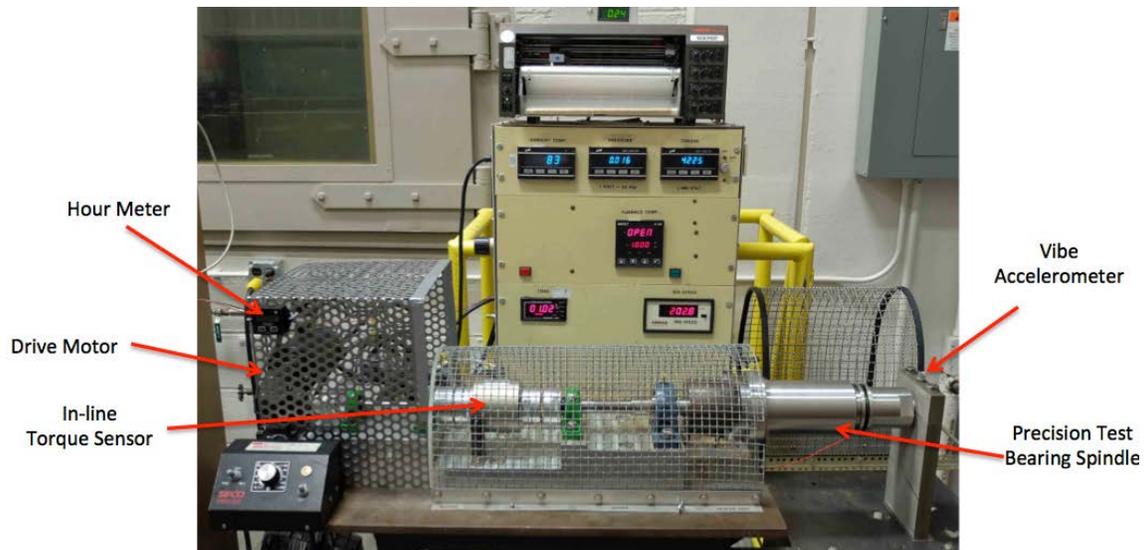
**Figure 8. NASA Glenn's DA centrifuge bearing test rig. The present failure corroboration tests are run without water and heat.**

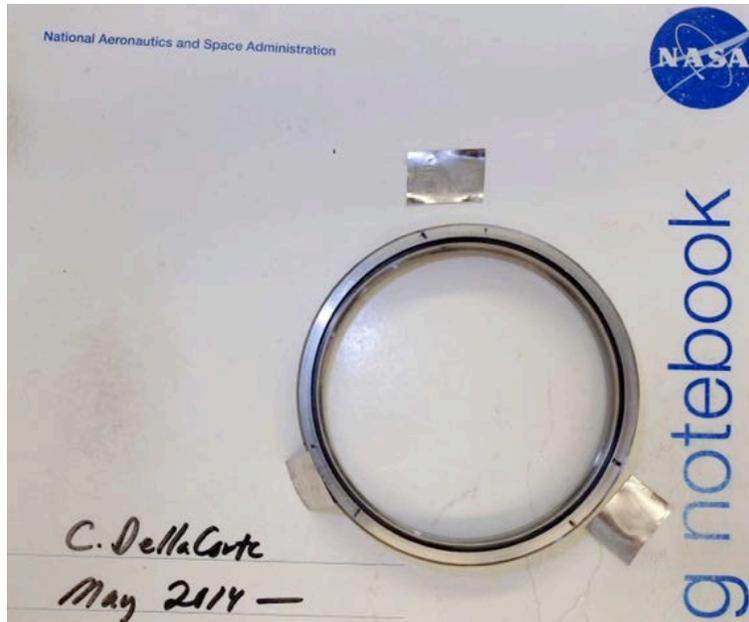
**Figure 9. Shims used to deform the bearing outer race to match operating conditions in the DA that lead to the premature failure**

The first test undertaken was to duplicate the hub-side bearing fit conditions that are believed to have caused the premature bearing failure. This could be achieved by manufacturing a new test rig bearing housing with the same three spoke structure and fit as the DA. Instead, a simplified approach was used that did not require extensive fabrication. The existing cylindrical housing was retained and three small pieces of stainless steel shim stock were placed between the bearing outer race and the housing. These three shims were approximately the same circumferential length and depth as the DA spokes. The shim thickness was selected to deform the bearing outer race approximately the same magnitude as the DA hub side housing. The use of shims is not an exact simulation of the physical race deformations in the DA but it is a fair approximation of the clearance reduction and tri-lobe shape variation. Figure 9 shows a photograph of the bearing outer race and the three shims used for the deformation experiment.

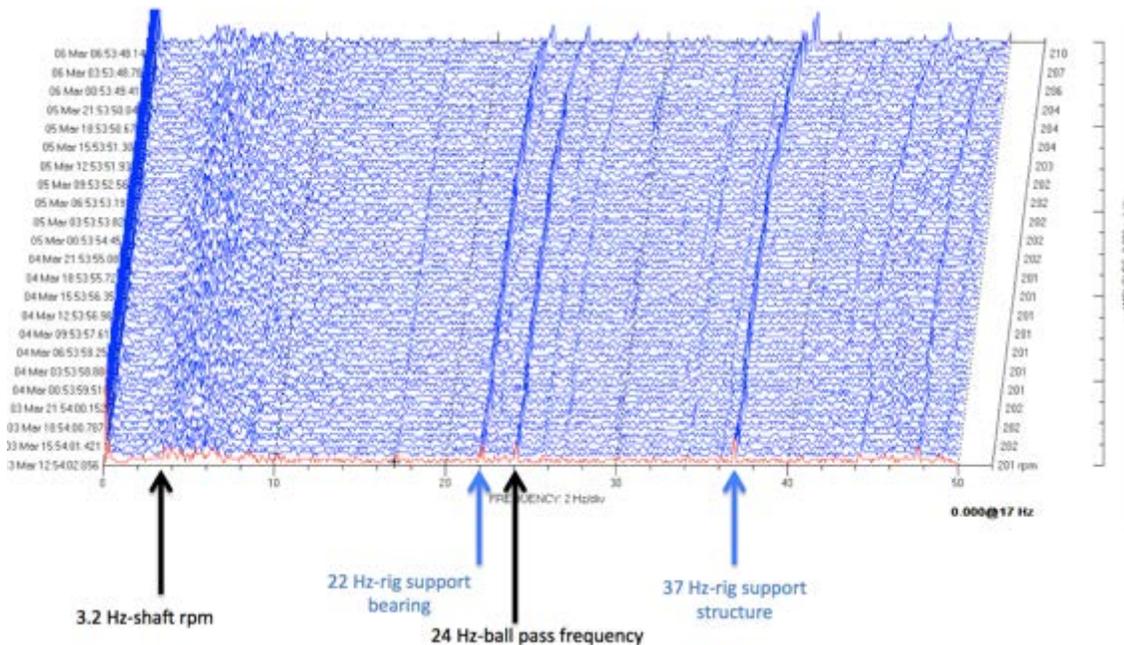
The cascade vibration plot provides a convenient visual method to judge bearing condition. Each peak in the spectra corresponds to different aspects of the test rig and test bearing. For example, vibration at the rig speed (3.2 Hz or 200 rpm) would arise from any anomaly associated with the drive motor, couplings or drive shafts. Vibrations generated by the test rig support bearings arise at 22 Hz owing to the number of rolling elements and internal geometry of these bearings. The test rig structure has some activity at 37 Hz. A key test bearing frequency for health monitoring is 24 Hz. This frequency represents the ball pass frequency on the inner race. Slight roundness and other variations will lead to vibration at this frequency. Any significant increase in the amplitude at 24 Hz could signal raceway surface damage in the ball path. Thus the cascade plot serves as a snapshot of bearing health.

**Figure 12. Cascade plot of hourly test rig vibration spectra captured during a three-day test period. Overall vibrations are very low and consistent**
