Lubricant Degradation in High-Load, High-Cycle Actuator Test Using Heritage Harmonic Drives for the Multi-Angle Imager for Aerosols Instrument

M. Michelle Easter*

Abstract

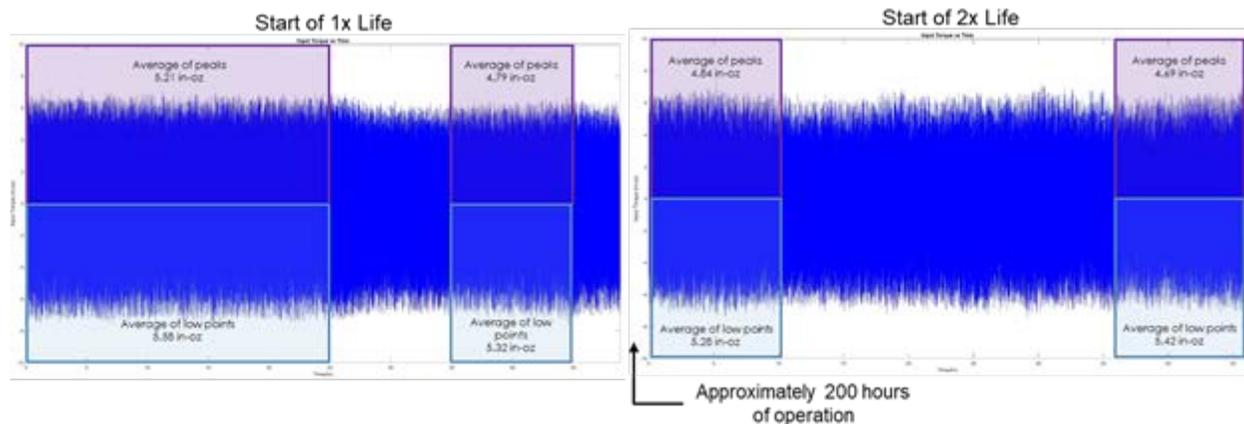
Figure 3. Comparison of input torque observed over the initial 45 hours of the first and second lives.

However, after about 30 hours, the speed and input torque seemed to level back out, ending with an average input torque of ~38.1 mNm (5.4 in-oz) and an output rate of about 8.0 deg/s. The first life was complete, reaching over 250 hours of as-run test time. Despite the variation along the way, the consistent starting and ending input torque and speed measurements seemed like indicators of a successful first life. The startup torque was re-measured, and an average value of 4.8 mNm (0.68 in-oz), still defined as passing, was observed. The sustained 11.3 Nm (100 in-lb) no-ratchet test was successful again, and life two was ahead.

At the onset of life two, the average input torque was back down to 35.7 mNm (5.06 in-oz), which corresponded nicely to the run-in value seen after the first life settled. As shown in Figure 3 and, although the speed was around 12% higher than it was at the close of the previous test, the lower measured torque reduced concern associated with the higher speed, and the test proceeded. Both measured values climbed slowly to 38.1 mNm (5.4 in-oz) and 9.0 deg/s over the course of the following 75 hours. Then, another change appeared with about a 0.5 deg/s speed drop over a half hour period, accompanied by an input torque increase to 41 mNm (5.8 in-oz).

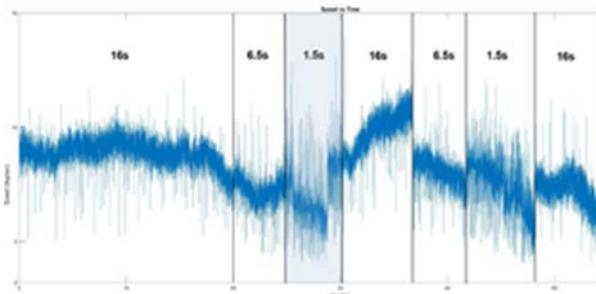
Figure 4. Output Speed Variation Observed During the Second Life

At the start of each event type to follow, as well as in between, the motor voltage was readjusted to obtain the desired speed, and the input torque would swell in response and subside again as the speed would drop back down, like a snake swallowing prey (or a system without speed control). The effect of one such adjustment can be seen in the middle of the 1.5 second dither time test event in the shaded center panel of Figure 4. After 34 hours, the system stopped cycling, and the measured input torque seemed to change exclusively in the uphill direction, until it reached an average of almost 72 mNm (10.2 in-oz), or double the observed value at the start of life two. See Figure 4 and Figure 5.

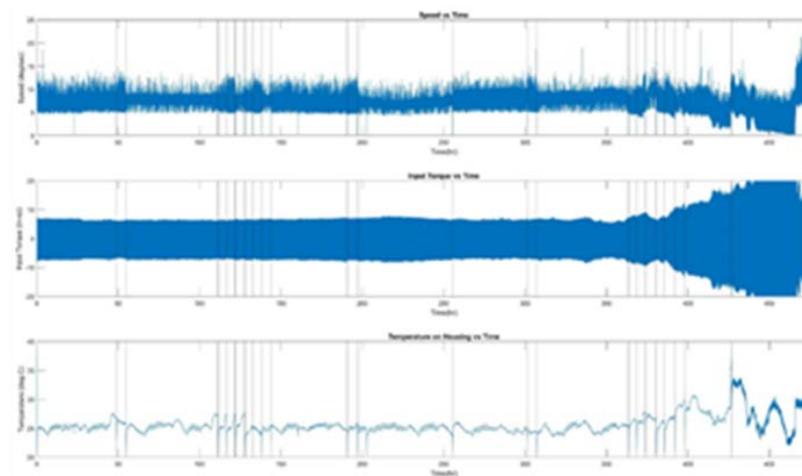
Figure 10. From top to bottom, speed, input torque, and housing temperature for entire test, including finally executed 16s dither time added test event. Vertical lines indicate test event separation points. Sawteeth in temperature data induced by local thermostat.

Then, the system turned a strange corner. The input torque dropped, about 40 minutes before which the titanium housing temperature climbed 5 degrees Celsius in about 20 minutes. The output speed experienced a major noise reduction at the onset of this temperature increase, and proceeded to exceed 10 deg/s, the highest value observed yet. A few blips followed, before the input torque necked down to 77.7 mNm (11 in-oz). See Figure 9. After seven hours, the rollercoaster ride ended, as the motor began to stall. See Figure 10 for the full test dataset. The time had definitely come for disassembly. Beforehand, the start-up torque and no-ratchet torque tests were conducted. The no-ratchet torque was successful again, and the start-up torque test pushed the acceptable limits, with a peak measured value of 24.7 mNm (3.5 in-oz).

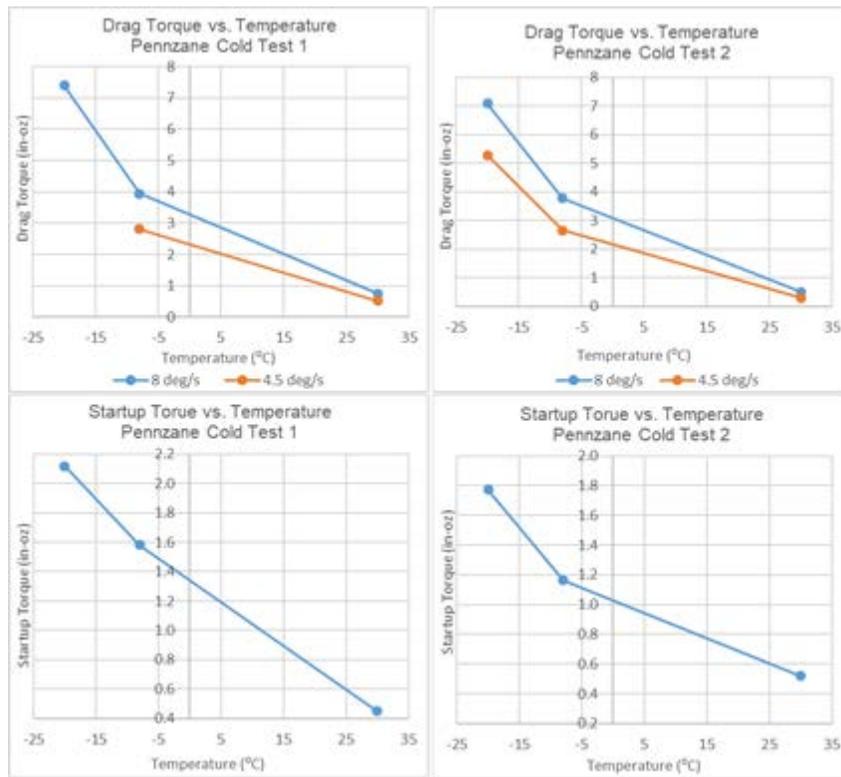
Figure 13. Test Data from the Cold Tests Conducted to Define Grease & Oil Fill Quantities.

The HD and duplex bearings were then reinstalled into the Drive Output Subassembly, which was installed into the Endurance Test fixture. The system was run with no applied load at speeds of 8.0 and 4.5 deg/s and temperatures of -20°C, -8°C, and 30°C. Startup torque tests were also conducted over temperature. The results of this testing are shown in the panels indicated as “Cold Test 1”, of Figure 13.

Another test was run with updated ratios, to understand the effect of reducing the oil percentage while increasing overall mass of applied slurry. The Nye Synthetic Oil 2001/Rheolube 2000 ratio this time was 39/61 by mass for the Wave Generator Bearings, and 36/64 for the duplex bearings. The resultant drag and startup torque values obtained over temperature are shown in the panels indicated as “Cold Test 2”, of Figure 13. See Table 2 for lubricant parameters related to both Cold Tests.

The second tested lubricant configuration was chosen due to the improved performance, combined with the additional slurry mass of the assembly. The desire for a higher slurry mass was to minimize any future risk of lubricant starvation. The drag torque values were acceptable, thanks to the high-torque output of the re-wound Duplex motors, and the relatively high current available from the instrument power bus.

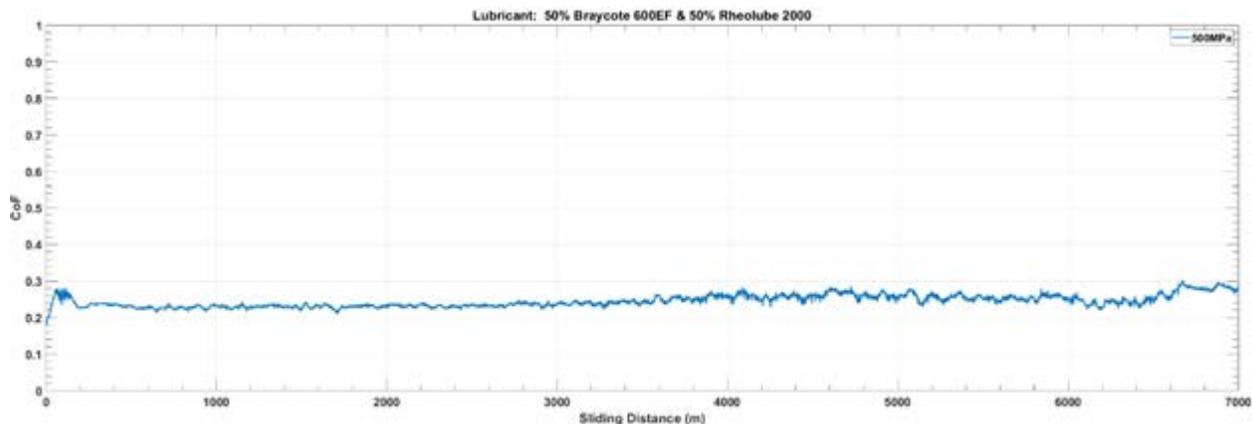
Figure 14. Pin-On-Disc Results for 50/50 by Mass Braycote 600EF/Rheolube 2000 Lubricant on 440C (58-62 HRC) Substrate in a Uni-Directional Test Configuration with a Pin Pressure of 500 MPa and Rate of 0.77 m/s.

To address the concern of cross-contamination damage due to potential inter-mixing of Pennzane and Braycote, Pin-On-Disc testing was conducted with a 50/50 by mass mixture of Braycote 600EF and Rheolube 2000. The test was conducted at a 0.77 m/s rate in one rotational direction, with a pin pressure of 500 MPa. The result is shown in Figure 14. An increase in the coefficient of friction (CoF) was seen at the test onset, which settled relatively quickly after about 200 m, staying constant until around 3.5 km. After this, the measurement noise and the CoF both increased and fluctuated slightly until the test was completed after 7.5 km of pin travel through the lubricant mixture. The test demonstrated that there would be no significant detriment to performance with a potential long-term mixing of the Rheolube and the Braycote.

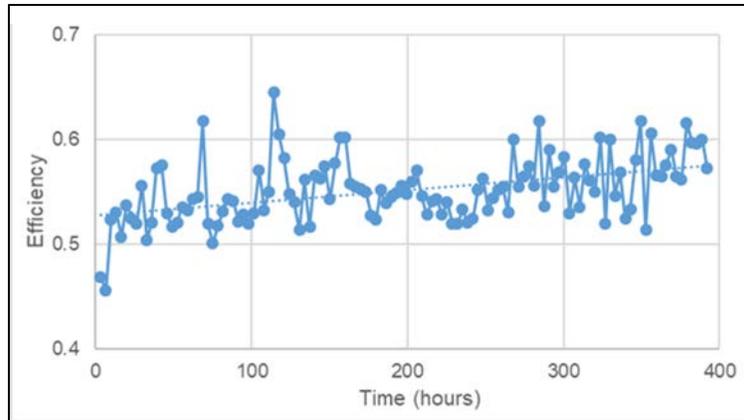
Figure 16. Harmonic Drive Lifting Efficiency vs. Time during the Final Endurance Test

Initial startup torque values were low with an average measured value of 6.0 mNm (0.86 in-oz), compared to the 11.1 mNm (1.57 in-oz) for the Braycote 601EF initial measurement. Variations seen in input torque and output speed across this test series were due to operator error in tuning of the bi-directional applied load and speed setting. Despite some setting errors, the telltale sign of the success of the Pennzane Endurance Test was the slight but steady increase in the HD lifting efficiency over the total 400 hour period. Corresponding with the increase in efficiency over the two times one mechanical life, the final measured startup torque after test completion had actually reduced from 6.0 mNm (0.86 in-oz) to 5.1 mNm (0.72 in-oz). The test was finally over.
