Thermal Vacuum Testing Lessons Learned for Small Stepper Motors and a CubeSat Translation Mechanism

Alex Few*, Lynn Albritton* and Don McQueen*

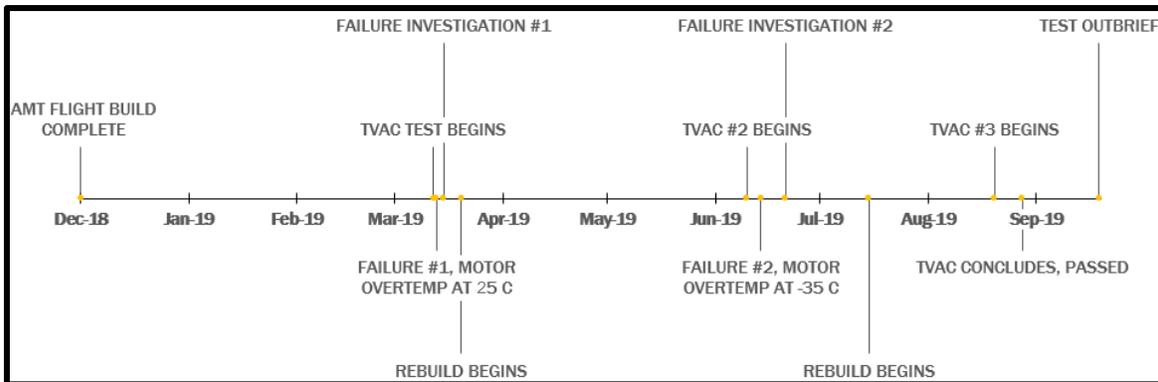
Figure 1. NEA Scout AMT TVAC Test Phase Events

During the two failure investigations—the first lasting about 13 weeks and the second about 9 weeks—the design and test team met with subject matter experts from both MSFC and from the NESC MSDT to identify possible causes of the motor overtemperature failures, realistic remediations, and new methods to capture test data. The major events between December 2018 and September 2019 are illustrated in Figure 1. Each of these events will be discussed at greater length.

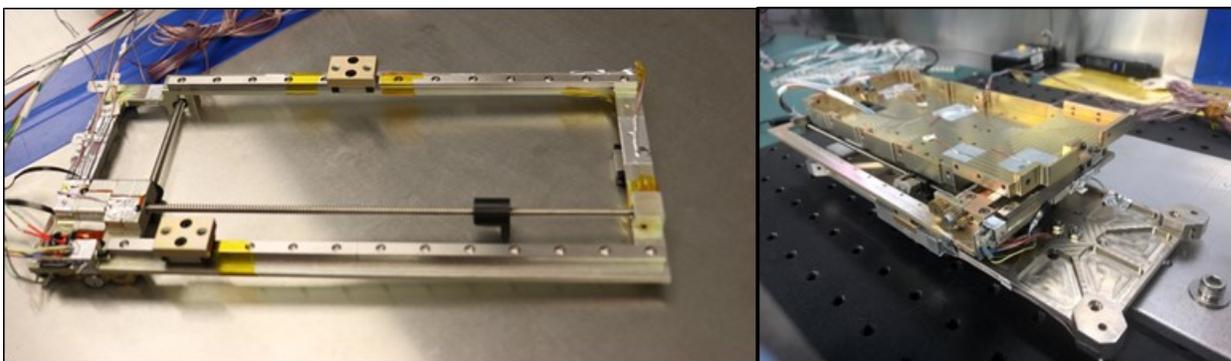
Figure 2. NEA Scout AMT and Test Configuration

The flight NEA Scout AMT, shown in Figure 2 left, was assembled in December of 2018 to the exact specification represented during the EDU TVAC testing earlier that year. Notable differences include:

1. Stepper motor manufacturing lot.
2. Use of flight-like mechanical interfaces, shown in Figure 2 right
3. Use of flight spare Motor Controller Board (MCB) instead of a protoboard
4. Different power supply
5. Test chamber setup, including new LED lights, thermocouples and cold plate interface

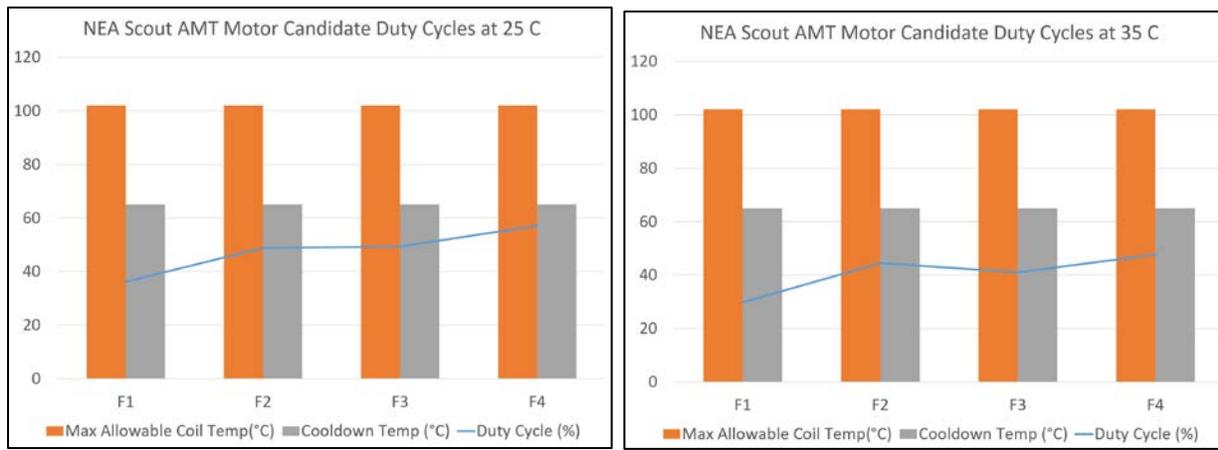
Figure 9. Duty cycles for AMT flight motor candidates at 25°C and 35°C.

The four motor candidates shown above were from the exact same vendor lot and were run with the same max allowable coil temps and cool down targets, but the duty cycles ranged from 36% to 57% at 25°C and 30% to 48% at 35°C.

A duty cycle is determined as the amount of time the motor is allowed to run in a specific environment before forcing a rest/recovery period. The run and rest times were, in this case, selected to limit the coil maximum temperature, and cool to a minimum temperature selected by the team before running again. Determining duty cycles were actually a by-product of the conditioning test series, and were established and recorded along the way. This testing would also demonstrate each motor’s individual capability to survive operation in a vacuum environment. Overall performance during the test series would be used as a basis for ranking flight motor candidates. A sample of the motors final duty cycle is shown in Figure 9.

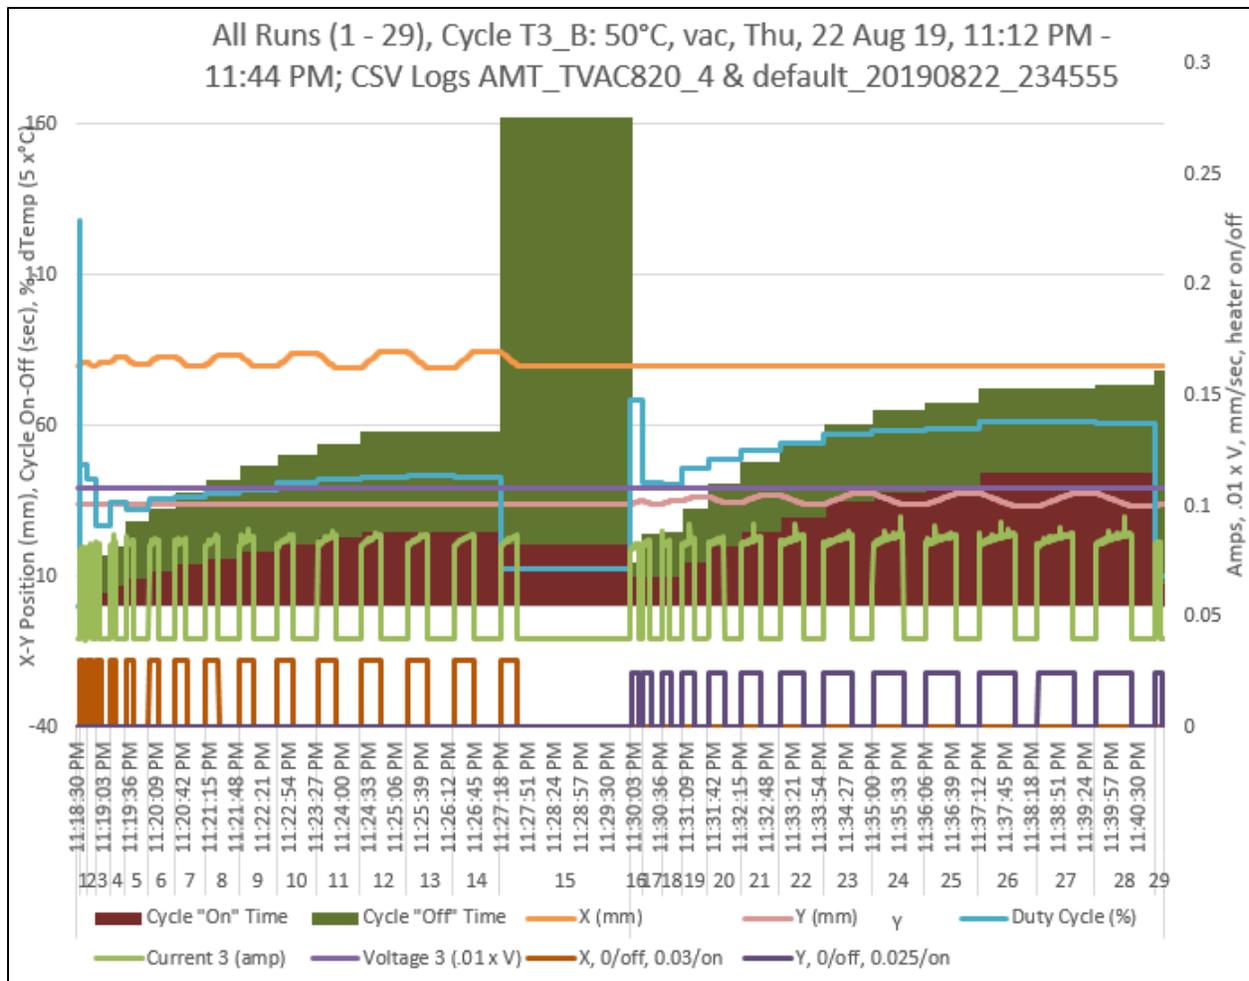
Figure 10. Duty Cycle Data for two Stepper Motors

The data shown in Figure 10 is extensive, but still reduced from the total data set (a sample of which is shown in Figure 11) the team used to finalize a duty cycle for flight operations. The most pertinent data is the red and green boxes, which show the increasing run and cool down times as the approach a final value. For the left sample, this time was about 20 second run time, followed by a 55 second cool down. The right sample had a 35 second run time and a 70 second cool down. The teal line shows the duty cycle as a percentage of run vs. cool down time. Note the differences between the two identical motors, further indicating some thermal differences resulting from manufacturing variance. A final data point of note is the light green line, showing the current draw during a duty cycle. The upward sloping nature during each on cycle is indicative of the heating coil. As the coil temp rises, the resistance does as well. The motor driver hardware sends more current as a response. The peaks of the green line during a cycle could be charted to give a maximum coil temp trend. The peaks remained horizontal for this data set, hinting that the coil temperature maximums were holding constant across the cycles. If the peaks were rising gradually, the coil temp could be assumed to be rising as well and the duty cycle could be adjusted accordingly. The same is true if the peaks were falling, except the coil temps would be decreasing and the duty cycle could be adjusted in kind.

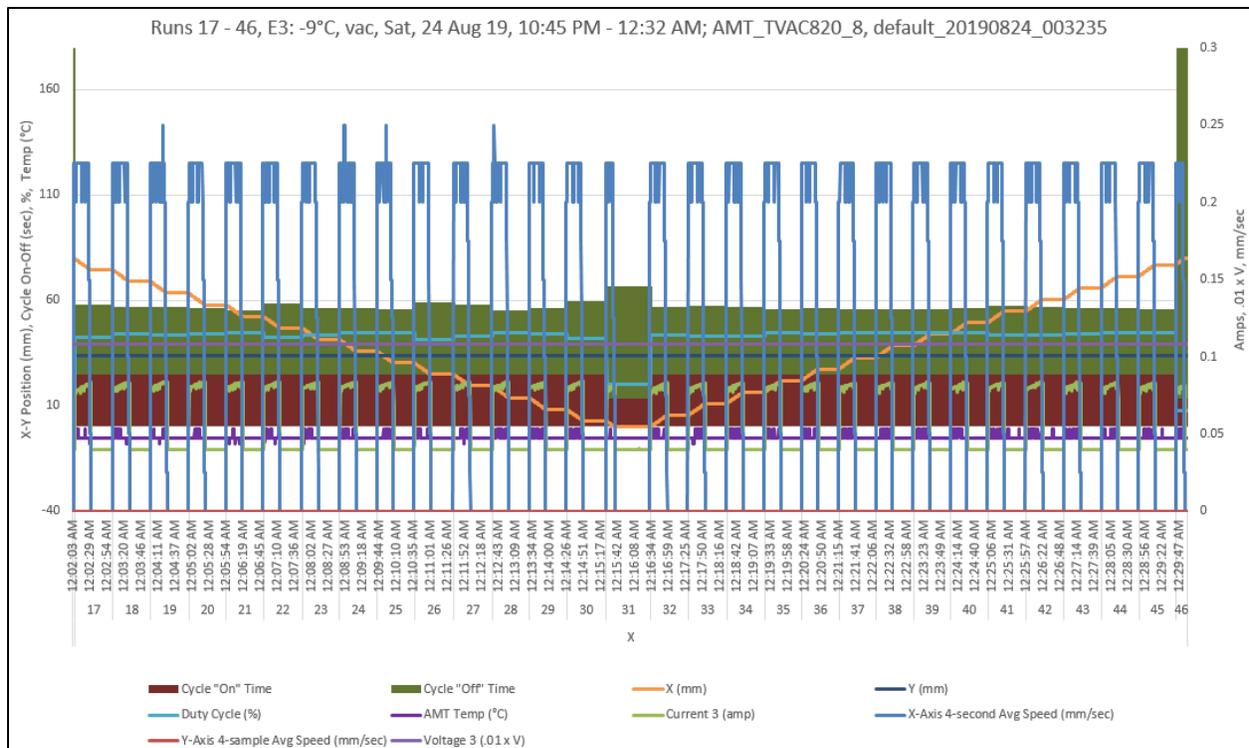
Figure 11. Combined data set. Note orange line documents X axis change in position. Duty cycle = 40%.

The final flight TVAC test plan included even more data capturing requirements: (1) Local temperatures on AMT logged at 1 Hz, (2) Chamber control temperature taken logged at 1 Hz, (3) Chamber pressure logged at 1 Hz, (4) Motor circuit current and voltage data logged at 5 Hz, (5) Control Board Memory and Commands logged at 1 Hz and (6) Motor Winding impedances taken immediately after operation termination. These data sets were combined into a master data set where temperature, current, pressure, and operation speeds could be compared at each thermal cycle. An example of the combined sets is shown in Figure 11.

The extensive measures taken to understand the details of the motors' internal design paired with the meticulous process of duty cycle determination and burn in testing yielded a long-awaited successful test. The third iteration of the NEA Scout AMT test passed with flying colors. The motors, though unable to perform in vacuum under typical operation, showed an ability to operate in vacuum for thousands of duty cycles and an acculative run time of over 10 hours.
