MSG SCAN DRIVE UNIT – FM5 LESSONS LEARNT

The Scan Drive Unit (SDU) is a linear actuator developed as a subassembly of the SEVIRI (Spinning Enhanced Visible and Infrared Imager) for Meteosat second generation program.

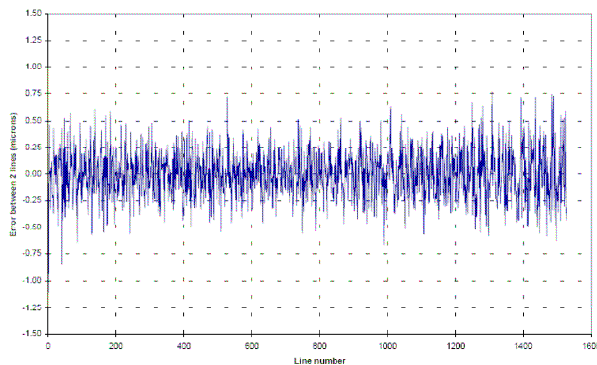
FIGURE 3: SDU QM OPTO-MECHANICAL PERFORMANCES

The measured error between two lines is characterised by the plot Figure 3:

The line to line error being defined by $E = E_L - E_{L+1}$ with E_L the difference between the actual position and the theoretical one given by the regression line over one image.
