# DELAYED RELEASES ON ORBIT – ONE SOLVED, ONE NOT SOLVED

Edward A. Boesiger<sup>(1)</sup>, Donald Gibbons<sup>(1)</sup>

## 1.0 ABSTRACT

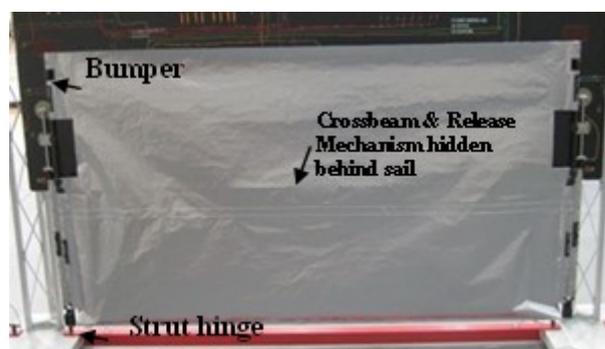
Figure 2. Trim Tab in Stowed Position

The shock of the bolt fracture to release imparts energy into the bracket and crossbeam. There is little to no force to generate friction between the crossbeam bracket and the Frangibolt® bracket, and the bumpers (Fig. 2) mitigate any sticking of the sail to the panel. So the requirement for the kickoff spring force is little to none. Thus, the design was changed to remove the possible bolt that could cause interference by taking out half of the kickoff spring (Fig. 6). Problem solved – well, until Flight 3 when once again the Trim Tabs were commanded to deploy and nothing happened.

The Trim Tab bumper from the outboard panel lined up the edge of the Trim Tab bracket on the mid-outboard panel (Fig. 10). The bumper is shown in Fig. 2 stowed against the panel. It is a stack of silicone rubber snubber blocks held together with Kapton® tape with a hole such that the sail tube can pass through. These bumpers are not dimensionally measured after the tape was applied; measuring the existing flight hardware still on the ground showed them to average 0.9 mm (0.025) in larger than the drawing requirement.

The theory for how these bumpers could cause the delayed deployment and then release is as follows. The Trim Tab crossbeam (Fig. 2) contracts at cold and causes the bumper to conform around the bracket edge that is 1.5-mm (0.060-in) thick. The bumper becomes more rigid at cold, locking around the bracket edge. As the panels warm, the crossbeam expands and the bumper becomes less rigid, and the panel releases.

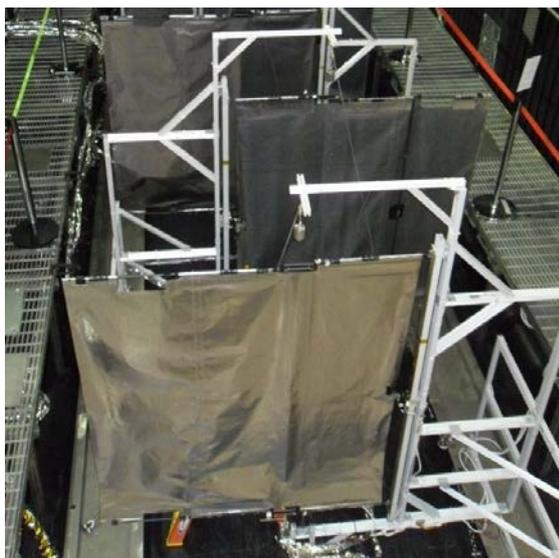
Figure 3. Trim Tab Thermal Vacuum Deployment

The Trim Tab mechanism is also fully analyzed and tested. Each strut hinge has a torque test (hysteresis loop for torque and friction), the assembled Deployable Trim Tabs are tested at ambient conditions for timed deployment, sine vibration, thermal vacuum timed deployment at -60°C and +85°C (Fig. 3), and a final ambient manual release timed deployment.
