ARIEL M2M ACTUATOR DERISKING

This de-risking activity consists in the development of the ARIEL Mirror Mechanism (M2M) cryogenic actuator including its design, manufacturing and qualification testing.

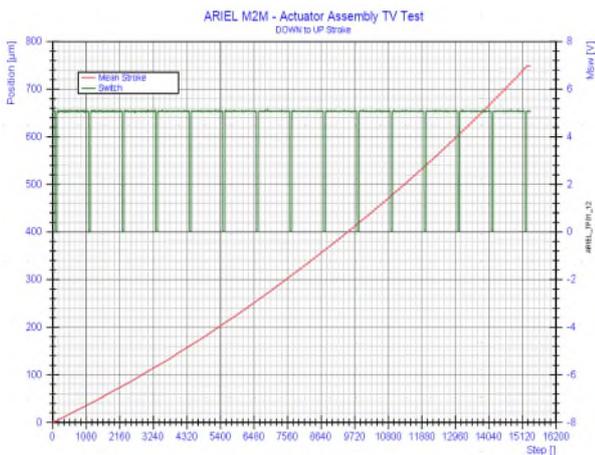
Figure 5 Stroke and telemetry verification

The stroke between end stops is 749µm. The displacement of the output of the actuator was calculated as the mean value of three capacitive sensors.

The telemetry operated adequately: Microswitches were activated at every actuator turn (15 times).

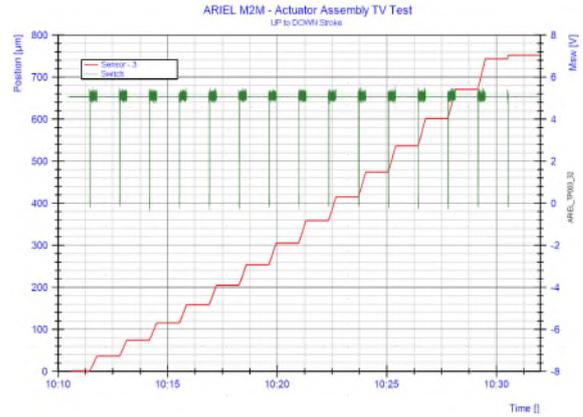
Figure 9 Stroke and Telemetry verification

Performances at 40K		Success Criteria
Operational Stroke [µm]	714	> 700
Maximum Error [µm]	1.75	< 2
Resolution [µm/step]	<0.067	< 0.1

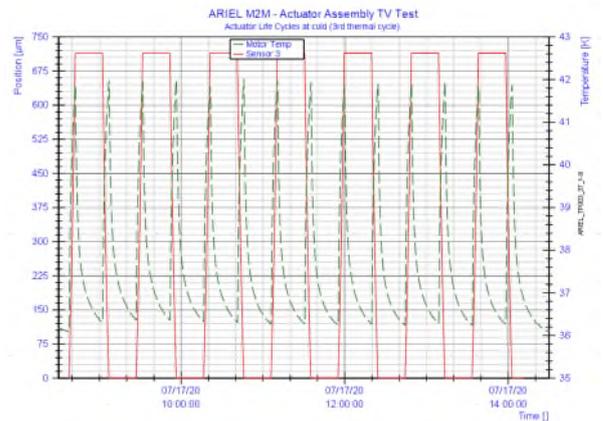
Figure 10 Actuator typical behaviour at 40K

- During life cycling a non-usual behaviour was detected in actuator displacement. In cycle number 50 (motor turn number 750.966) the operational stroke was not completed. After some additional movements, the actuator stopped.

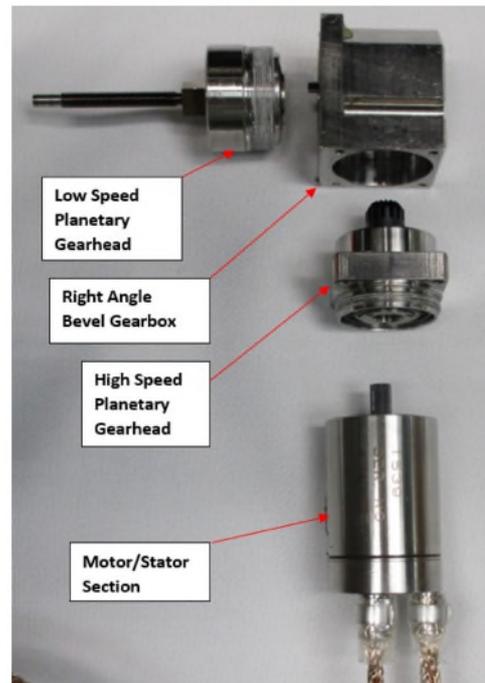
Figure 14 Motor and gearhead modules

- The Low Speed pinion output shaft was able to be fully backdriven by hand.
- The Right-Angle pinion was able to be fully backdriven by hand and found to rotate smoothly against the bevel gear within its gearbox.

- There was a visible wear band where the motor pinion meshes with the planet gears of the high-speed gearhead. The wear allowed the underlying base metal of pinion to become visible. Attempts were made to backdrive the motor rotor by hand, but it felt very crunchy and there were a couple of blocking/high spots detected which prevented its full rotation.

A large amount of brown debris was identified in and around the motor rotor's rear bearing. The debris was also found within the stator bore in the rear bearing's location after it was removed.
