TESTING AND LESSONS LEARNT OF LISA GPRM

Andreas Neukom⁽¹⁾, Romeo Romano⁽²⁾, Philipp M. Nellen⁽³⁾

RUAG Schweiz AG, RUAG Aerospace, Widenholzstrasse 1, CH-8304 Wallisellen
Emails: ⁽¹⁾andreas.neukom@ruag.com; ⁽²⁾romeo.romano@ruag.com; ⁽³⁾philipp.nellen@ruag.com

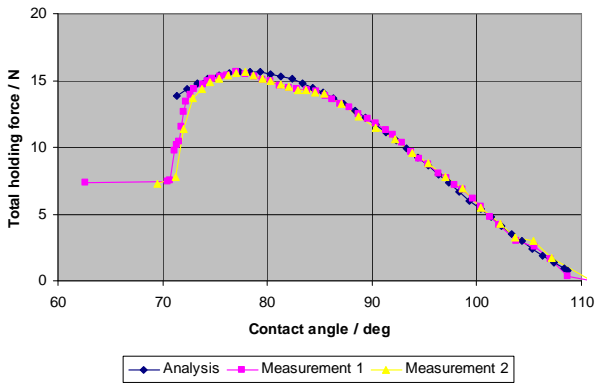
The force profile when travelling over the launch lock was analysed and verified by test. The analytical model fits well with the measured values.

Figure 11: Holding force profile of launch lock

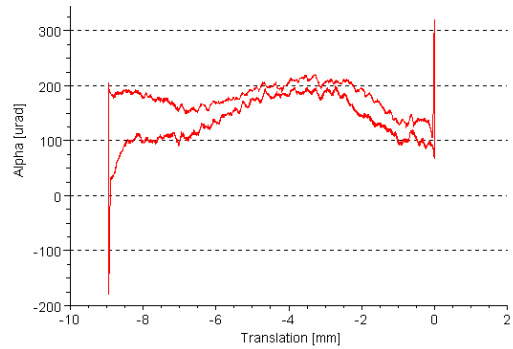
Most of the hysteresis is related to a rotation of the grabbing finger. Since the position sensor contact point is laterally displaced with respect to the movement axis a rotation of the grabbing finger influences the position sensor signal. Tests with an autocollimator confirmed that a kick of the tilt angle occurs when the movement of the grabbing finger is reversed.

Figure 13: Angular position of grabbing finger

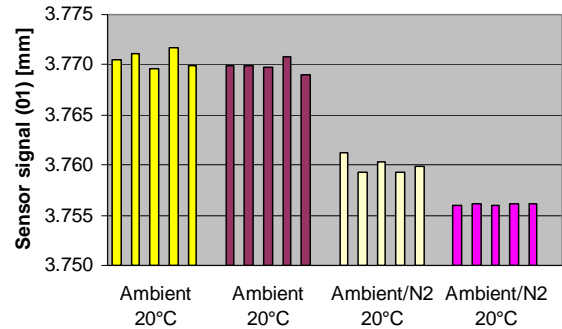
The position sensor is also needed during integration of the GPRM into the CM. It has not only to operate in vacuum but also in ambient condition and under dry Nitrogen (for measurements at low temperature). Figure 17 shows sensor signals at the same geometrical position but in different environments.

Figure 17: Position sensor signal in different environments

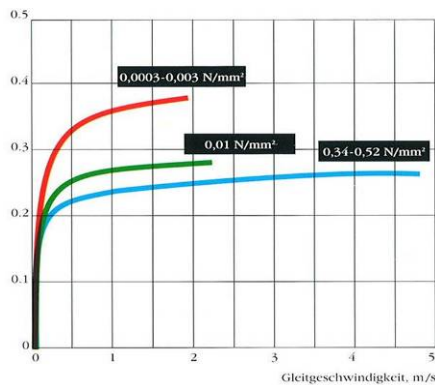
Since the measured friction coefficient is far above the maximum required value of 0.06 alternative materials for the side guiding system were investigated. It was found that only pure PTFE can reach the required value since low friction requires low speed and low pressure loads. With an effective speed of 0.1 mm/sec and an effective pressure of 1.5 MPa these conditions are clearly fulfilled.

Figure 19: Influence of speed on PTFE friction

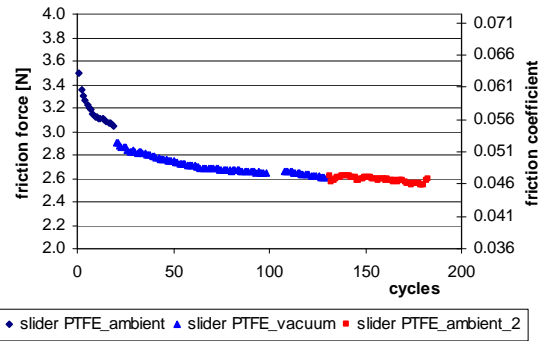
The friction test was repeated with PTFE sliders. After a run-in of about 100 cycles a friction coefficient of less than 0.05 is reached. In contrast to Vespel SP3 it does not increase when operated in air.

Figure 20: Friction coefficient of PTFE sliders

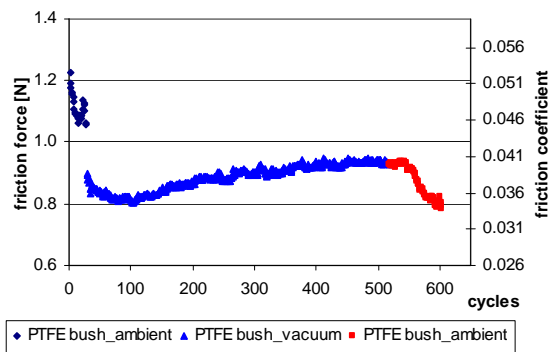
An additional friction test between PTFE coated bushings (Glycodur bearing) and a Titanium shaft was performed. Initially the friction coefficient is 0.05 and becomes after only a few run-in cycles 0.04 which even slightly decreases in ambient conditions.

Figure 21: Friction coefficient of PTFE coated bushings

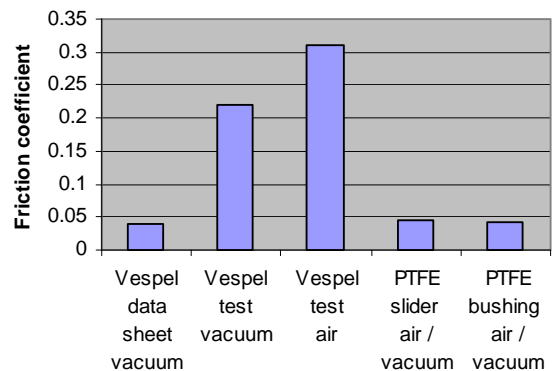
The results of the friction tests are shown in Figure 22. Changing the material for the side guiding sliders and rollers from Vespel SP3 to PTFE leads to a ECSS compliant motorisation factor.

Figure 22: Comparison of friction coefficients

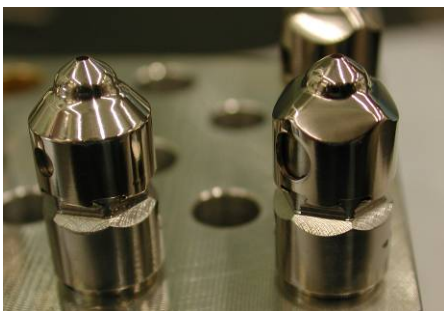
The GF was originally made out of Titanium and its tip was gold coated. This design was changed by fixing a cap made out Platinum-gold to the front part of the GF. The caps were cast by a dental technician who also tried several fixations to the Titanium base material such as welding, glueing and riveting which all did not work. At the end a goldsmith found the correct method which was border crimping.

Figure 24: Platinum-gold caps on Titanium GF
