# Preliminary Assessment of Seals for Dust Mitigation of Mechanical Components for Lunar Surface Systems

Irebert R. Delgado\* and Michael J. Handschuh\*\*

## Abstract

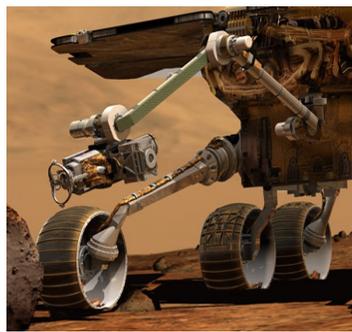
**Figure 1 Mars Exploration Rover Instrumentation Deployment Device.**

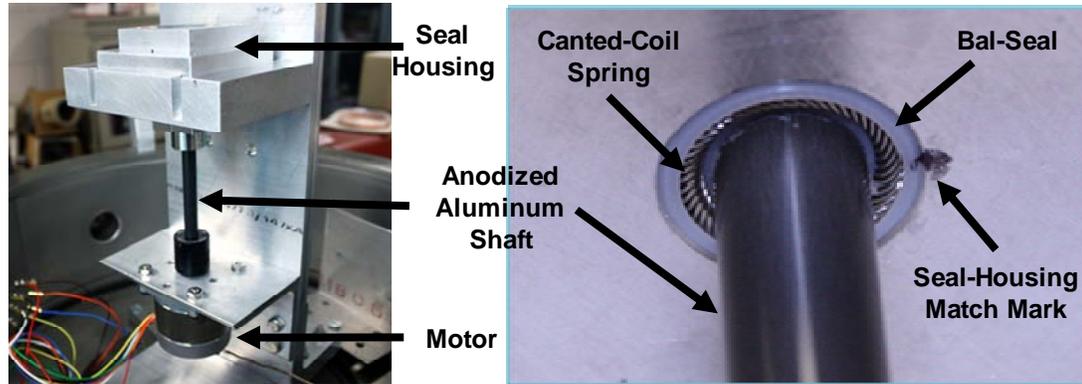
The test set-up is composed of a test stand, motor, seal housing, seal, and shaft as shown in Figure 3. The assembly is arranged in a vertical orientation to allow lunar simulant to enter the seal-shaft interface through the top of the assembly. The top of the seal housing is designed with a coned interior to funnel simulant towards the seal-shaft interface.

**Figure 3 Rotary seal rig test set-up and view of underside of seal within seal holder.**

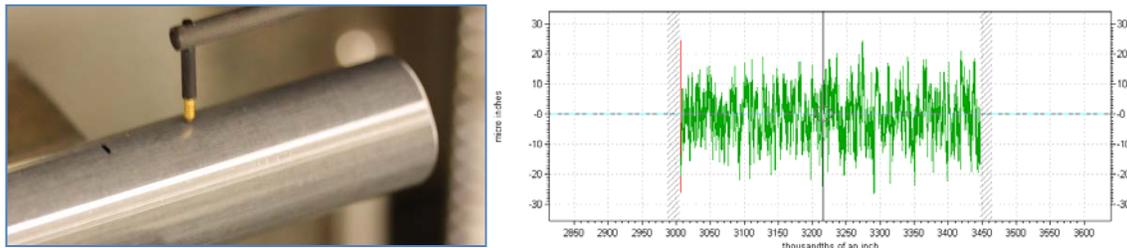
Prior to testing, the seals were first cleaned with Alconox, rinsed with ethanol alcohol and dried to remove any residual oils or other residue. Pre-test photos were taken of the seals and weight and inner-diameter measurements were recorded. Pre-test photos were taken of the shafts as well, and their surface roughness profiles were recorded. Shaft roughness averaged  $0.102 \pm 0.013 \mu\text{m}$  ( $4.020 \pm 0.514 \mu\text{in}$ ) for the stainless steel shafts and  $0.145 \pm 0.019 \mu\text{m}$  ( $5.691 \pm 0.758 \mu\text{in}$ ) for the anodized aluminum shafts. A representative profilometer plot of the surface roughness measured around the shaft circumference is shown in Figure 4.

**Figure 4 Profilometer stylus measuring anodized aluminum shaft surface and sample shaft roughness profile.**

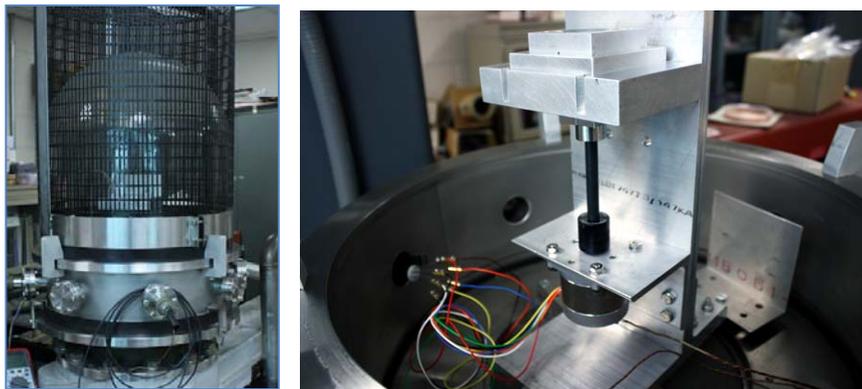
For tests in vacuum, a vacuum-rated motor was used in place of the dry-room motor. The rotary seal rig was placed within a bell jar capable of  $10^{-7}$  Torr, Figure 5. The chamber was then pumped down overnight until approximately  $4 \times 10^{-7}$  Torr was reached. Tests were also run at 10,000 cycles and 20 RPM. Disassembly and examination procedures of both the test seal and shaft were identical to dry-room post-test procedures.

**Figure 5 Bell Jar vacuum chamber containing rotary seal rig test set-up.**

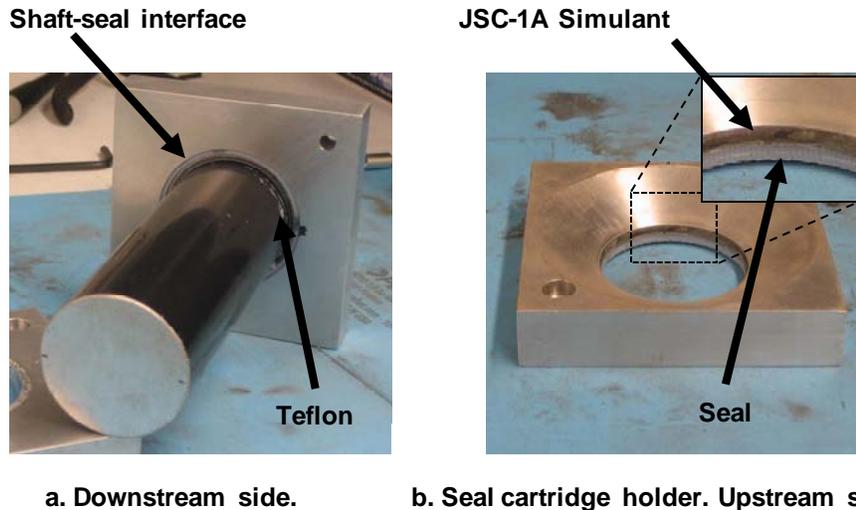
For all tests run in the dry-room or in vacuum with either JSC-1A or LHT-2M, no simulant was observed to pass through the seal-shaft interface, as shown in Figures 6a and 6b. Note that only Teflon flakes were observed on the downstream side of the seal-shaft interface. This is indicative of some seal wear as will be quantified later in the discussion. Also note that the simulant was observed to go no further than approximately half-way down the inner diameter of the Bal-Seal.

**Figure 6 Typical seal-shaft observations for tests run with either JSC-1A or LHT-2M.**

- No simulant was observed to pass through the seal-shaft interface.
- A minimal amount of wear was observed on both seal and shaft. Seal weight loss was minimal with only Teflon 'flakes' observed on the downstream side of the seal.
- Shaft profilometry generally show a slight deterioration in shaft surface roughness with simulant use. Inconsistencies between surface roughness and seal weight loss require further analysis.
- Infrared microscopic analysis of the anodized aluminum shaft surface has revealed the presence of Teflon which is beneficial as a lubricant between the seal and shaft during operation.

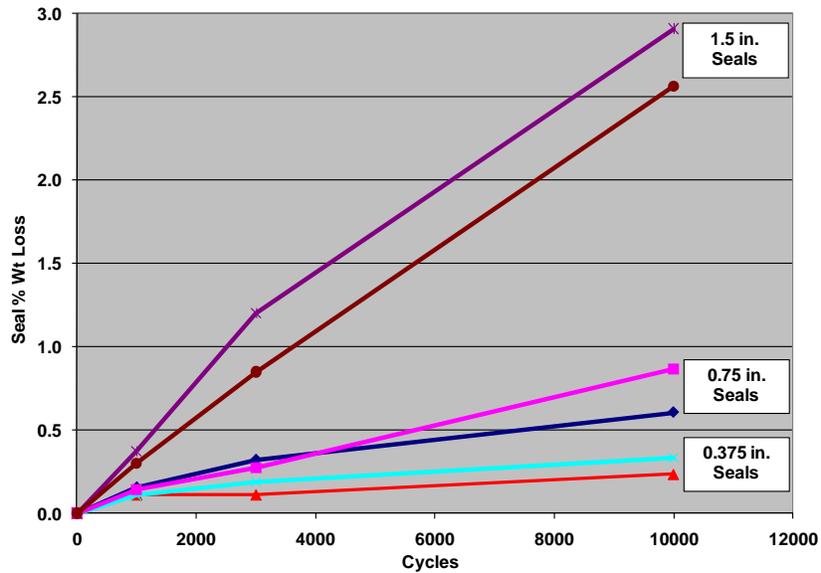
Table 2 shows results of Bal-Seal tests through 10,000 cycles. In general, seal weight loss was greater for increasingly larger seal diameters due to a larger contact area and increased surface speed due to increased circumference. For example, for dry-room tests run without simulant, the average seal weight loss ranged from 0.11 to 0.33% for the 9.5-mm (0.375-in) diameter seals, from 0.07% to 0.66% for the 19-mm (0.75 in) diameter seals and from 2.63 to 3.0% for the 38-mm (1.5 in) diameter seals. Post-test roughness profiles for dry-room test shafts run without simulant (Tests A22, A23, B7, B20, C17, C18) were inconclusive ranging from -7.34% (smoother surface) to +2.72% (rougher surface). In comparison, these same tests run with JSC-1A (Tests A12, B10, C6, A17) showed a more definitive roughness change of +15% (rougher surface) on average. Preliminary tests in vacuum show minimal seal weight loss through 10,000 cycles. In fact seal weight loss was identical at -0.11% for the 9.5-mm (0.375-in) diameter seal tested without and with JSC-1A (Tests A13 and A15, respectively). Seal weight loss was doubled at -0.22% for the same sized seal tested with LHT-2M (Test A16). Although the vacuum test results are encouraging, repeat tests are necessary to validate these results. Unfortunately, a malfunction in the vacuum motor occurred after these 4 tests. Thus further testing was postponed. Post-test surface roughness profiles for the vacuum tested seals were again inconclusive with results ranging from -13.87% (smoother surface) to +6.90% (rougher surface). Preliminary tests of Bal-Seals against stainless steel shafts show seal weight losses comparable to the anodized aluminum shafts. However, the large change in surface roughness for shaft S-10 does not appear to be consistent with the -0.11% seal weight loss of Seal ID A18. In fact, this inconsistency between seal weight loss and change in shaft surface roughness is apparent for a large portion of the test results. Further analysis in data and procedures is necessary to reconcile these differences in surface roughness with seal weight loss. Supplementary testing was performed to determine cycles versus wear for three seal sizes. Results are shown in Figure 7. As expected, the larger contact surface area of the 38-mm (1.5 in) seals incurred more wear through 10,000 cycles than the 19-mm (0.75 in) or 9.5-mm (0.375-in) seals. Further long-term testing is necessary to determine if the seal wear rate remains constant, increases, or possibly stabilizes to some final seal weight loss. Note that these tests were run at constant speed and that future tests may involve start-stop cycles, ramp-up and ramp-down in speed, etc. Finally, infrared microscopy has confirmed the presence of Teflon being transferred to the anodized aluminum shaft surface. The presence of Teflon on the rotating surface provides additional lubrication between the shaft and seal which could potentially increasing seal-shaft life. Further tests are needed to assess the performance of this lubricating layer through extended operations.

**Figure 7 Seal percent weight loss versus cycles.**
